B.8 Waterway Barrier Works Technical Report

Waterway investigation and fish community survey in relation to the Scenic Rim Agricultural Industrial Precinct project.

Technical Report – April 2020

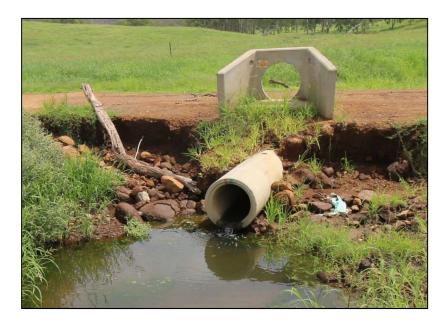
Despite fish colonisation into the site after recent rainfall, no fish were recorded within the middle to upper reaches of the amber waterway (site five and above). This is despite the middle reach having semi-permanent fish habitat within the site (Table 1; Appendix A). The most obvious reason for the lack of fish within this site was the presence of a downstream barrier, that is preventing fish from migrating upstream. The barrier to fish passage in this case was a narrow pipe culvert (reinforced concrete pipe 450mm diameter, 7.4m long) part of an internal road crossing at site four. It appears that the area below the culvert has eroded away and at the time of the site visit the outlet for the pipe was above the water level within the downstream pool (Figure 5).

Figure 5. The waterway crossing that is acting as a barrier to fish passage.

Many small bodied Australian native fish have relatively poor swimming speeds (Watson *et al.* 2020), do not jump to migrate upstream and are unlikely to have migrated through this pipe during higher water levels. Although fish may migrate past such a barrier, if there was enough

At the time of the field investigation there was a noticeable congregation of fish below this structure. For example, the catch per unit data from fish sampling indicates that there were over twice as many fish in this location, compared to the two sites located further downstream (sites 1 and 2). Waterway barriers often cause high congregations of fish and impact fish communities in many ways. Impacts include increase predation and disease, block access for recolonisation, spawning and feeding habitats. The impacts of barriers to fish migration are widely recognised in Australia (Mallen-Cooper, 1997; Walker, 1985; O'Connor *et al.*, 2006) and have been implicated in the decline of native fish in Australia over the previous 100 years (Mallen-Cooper, 1999).

Waterway crossings will be constructed in compliance with the relevant accepted development requirement (ADR) for operational work that is the construction or raising of waterway barrier works (DAF, 2018). The internal vehicle crossing, identified above as a barrier to fish passage, will be upgraded in compliance with the accepted development requirements for a replacement culvert crossing on a moderate risk (amber) waterway.

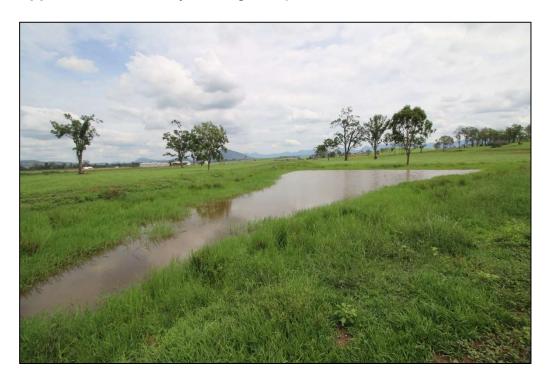
Site 1 – Shallow pool on diversion channel near north-eastern property boundary.

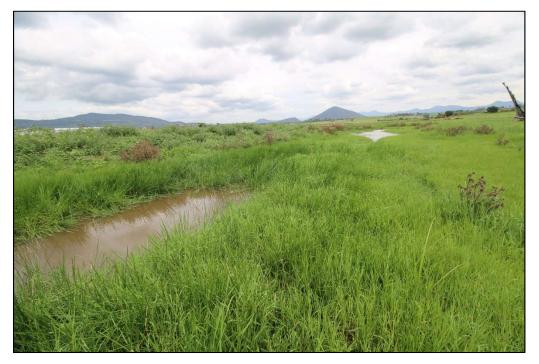
Site 2. Shallow pools within diversion channel next to levee bank.

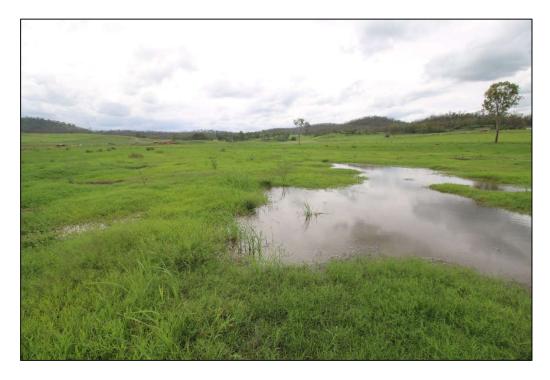
Site 3. Very shallow standing water (maximum depth 50mm) within water treatment wetland.

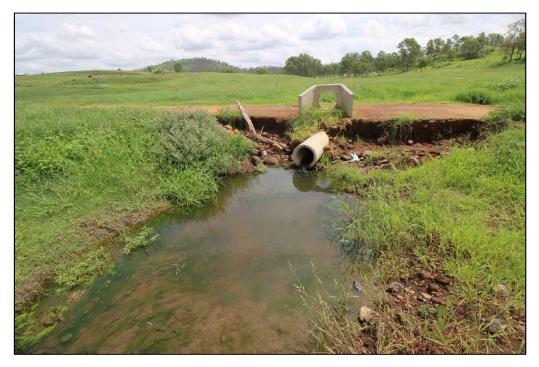
In the lower section of the amber waterway (between sites 2 and site 4) the waterway features became less defined. At site four a waterway crossing with a 450mm diameter pipe culvert concentrates flow creating waterway features including a downstream scour pool and defined bed and bank immediately below the crossing. Downstream of site four the amber waterway did not contain any waterway features and becomes very shallow without defined bed or banks (Table 1).

$\label{eq:steady} Site \, 4-\text{Small pool below culvert crossing contained fish. Culvert acting as barrier to fish passage.$

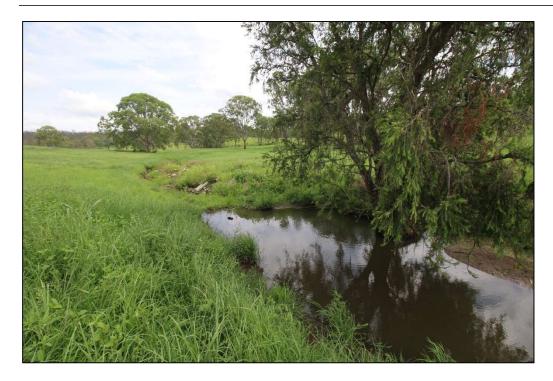
Site 5 - Pool habitat and dry channel upstream. No fish present.

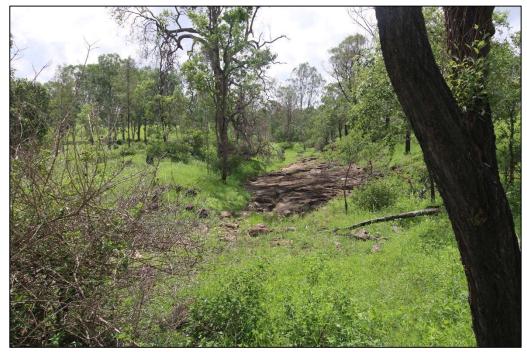
Site 6 – Dry channel

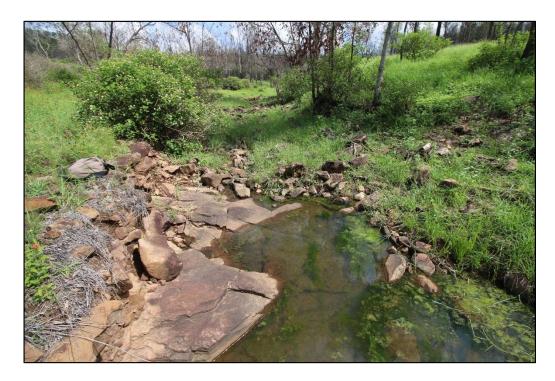
Site 7 – Isolated shallow pool and dry upstream channel.

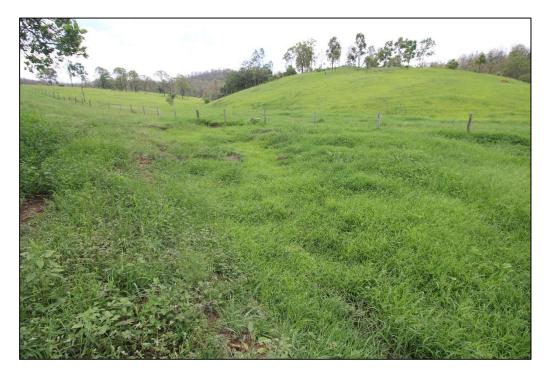
Site 8 – Dry gully with no waterway features.

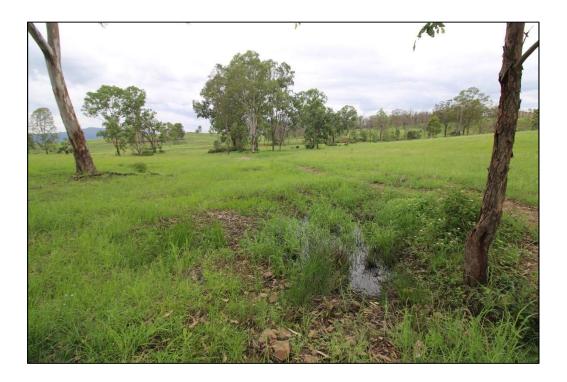
Site 9 - Gully with no waterway features.
