PROPOSED DEVELOPMENT SOILCO PTY LTD BOONAH ROAD, BEAUDESERT

BROMELTON COMPOST MANUFACTURING FACILITY

Project
Bromelton Compost Manufacturing Facility
Lot 4 Mitchell Road Bromelton 4285

Cultural Heritage and Native Title Duty of Care Assessment

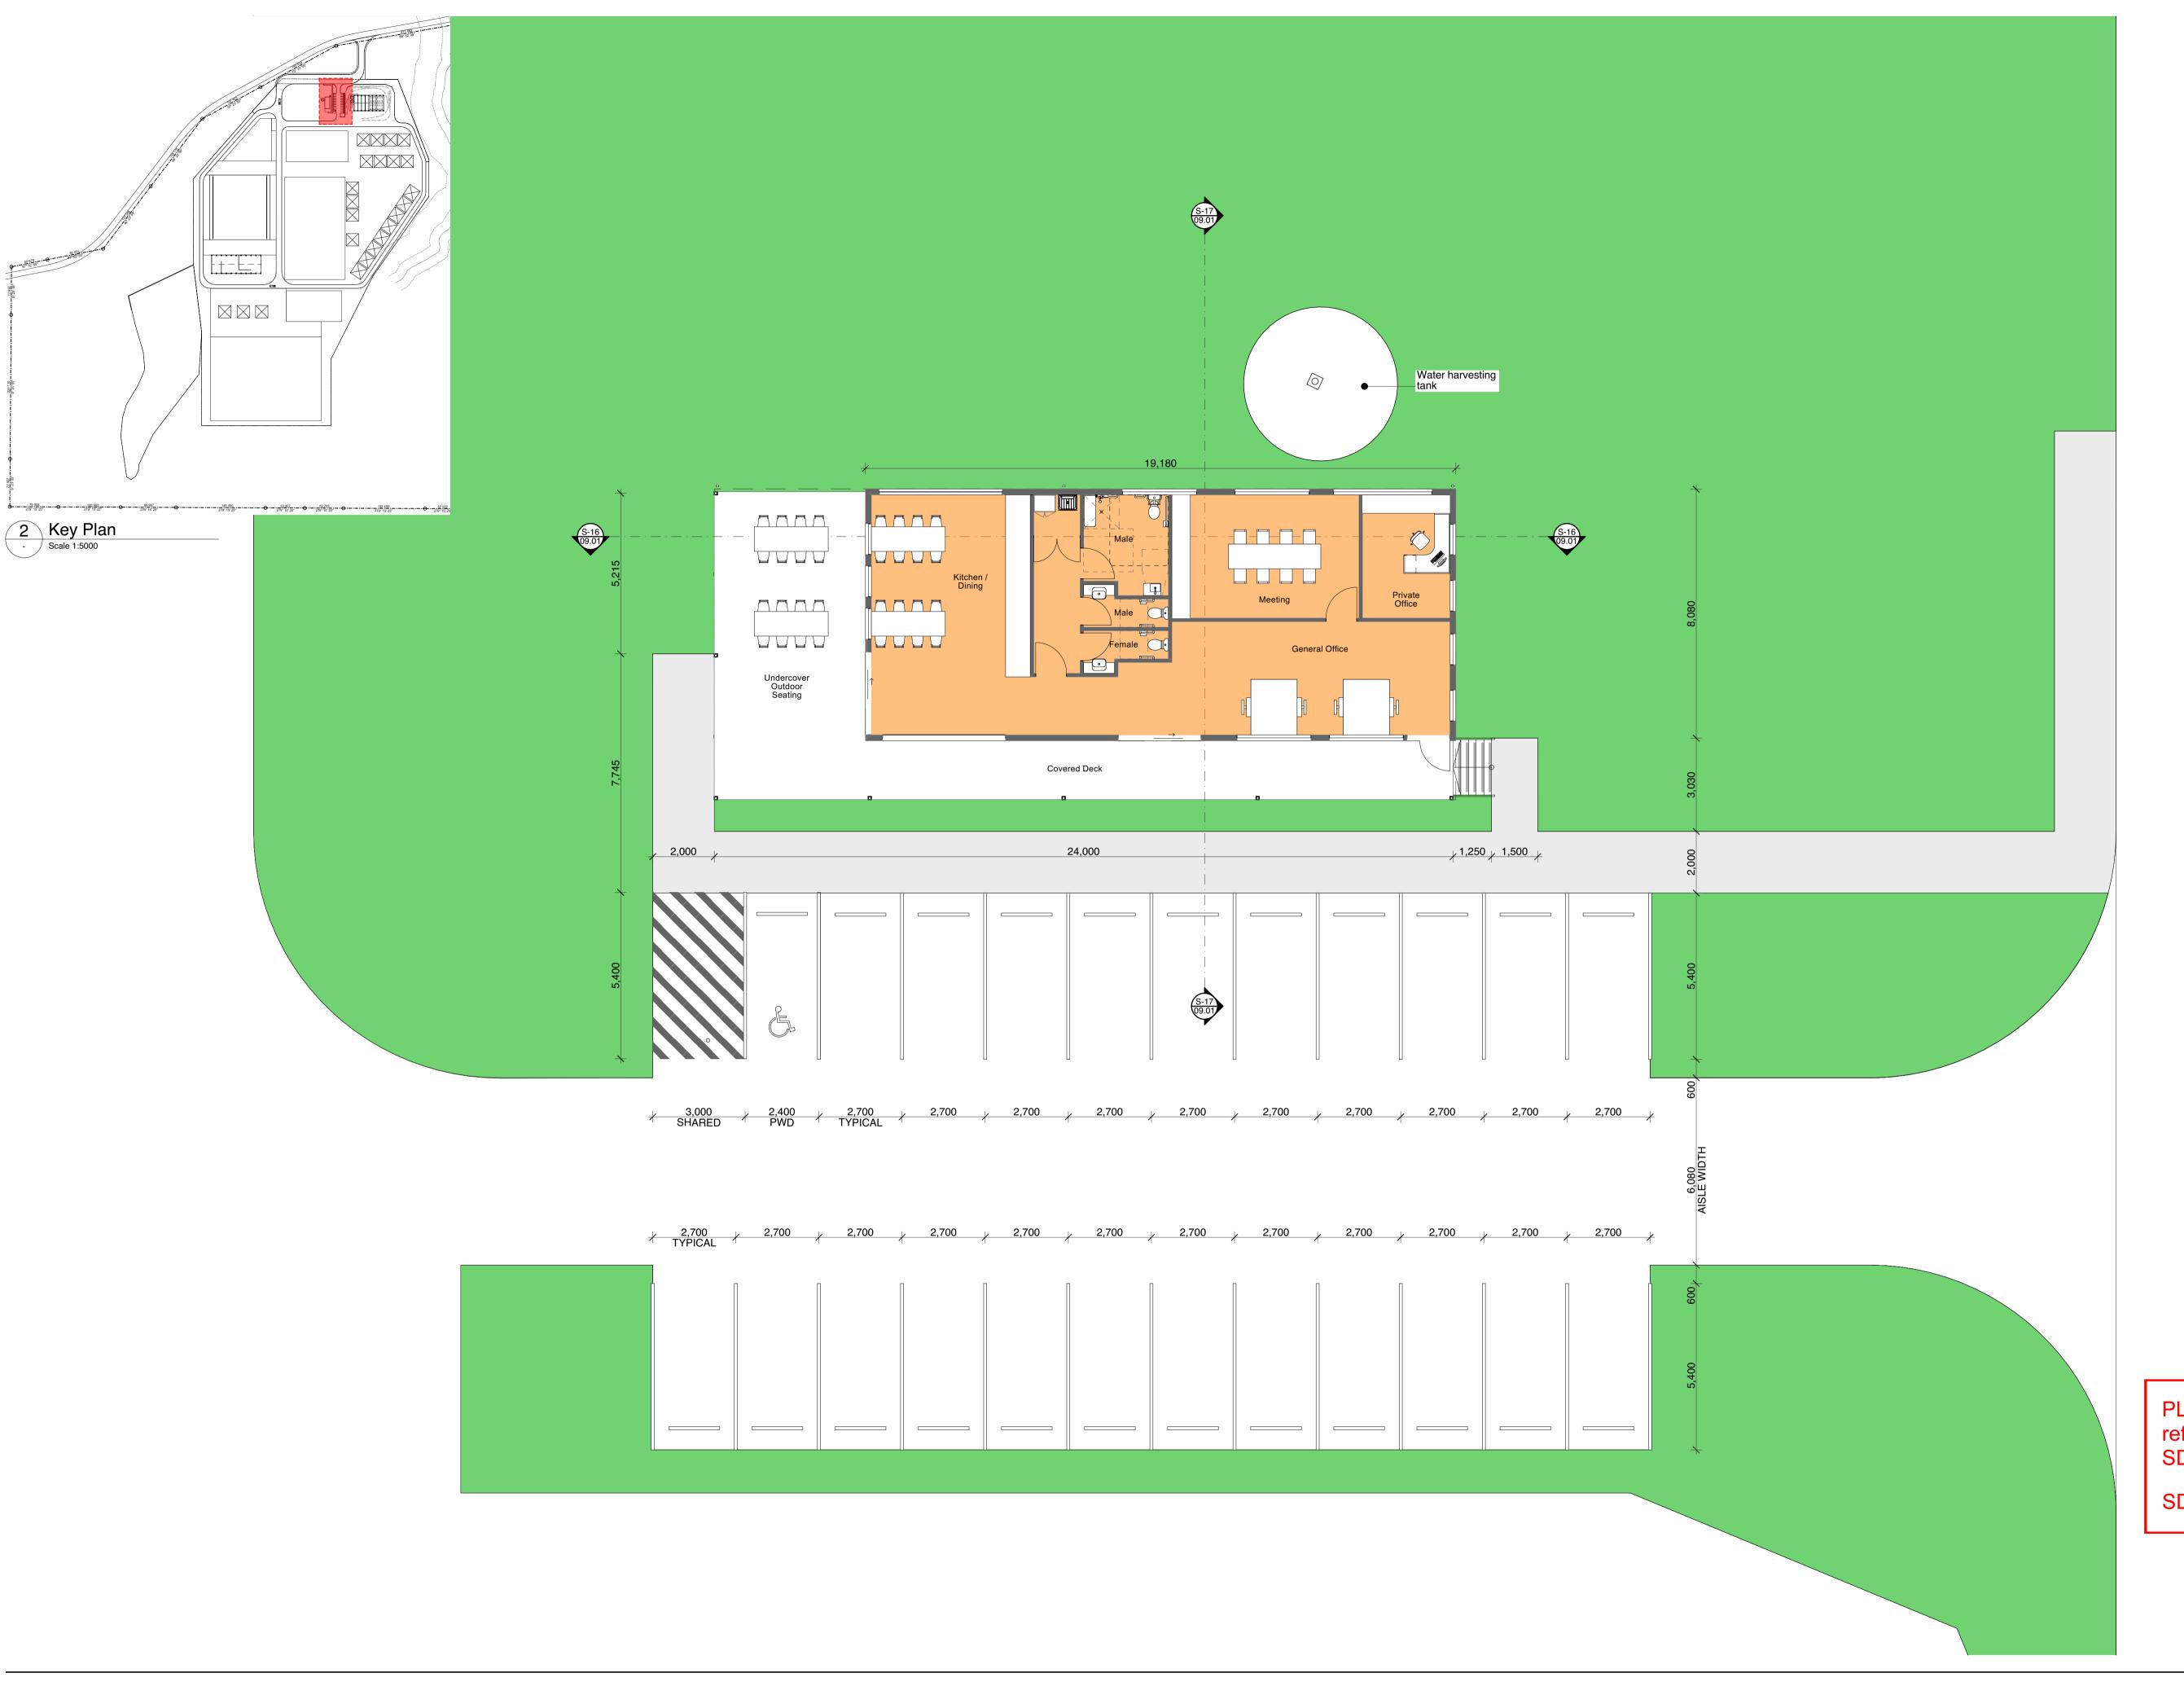
A-DA-03.01

Floor Plan - Ground - Office & Amenities

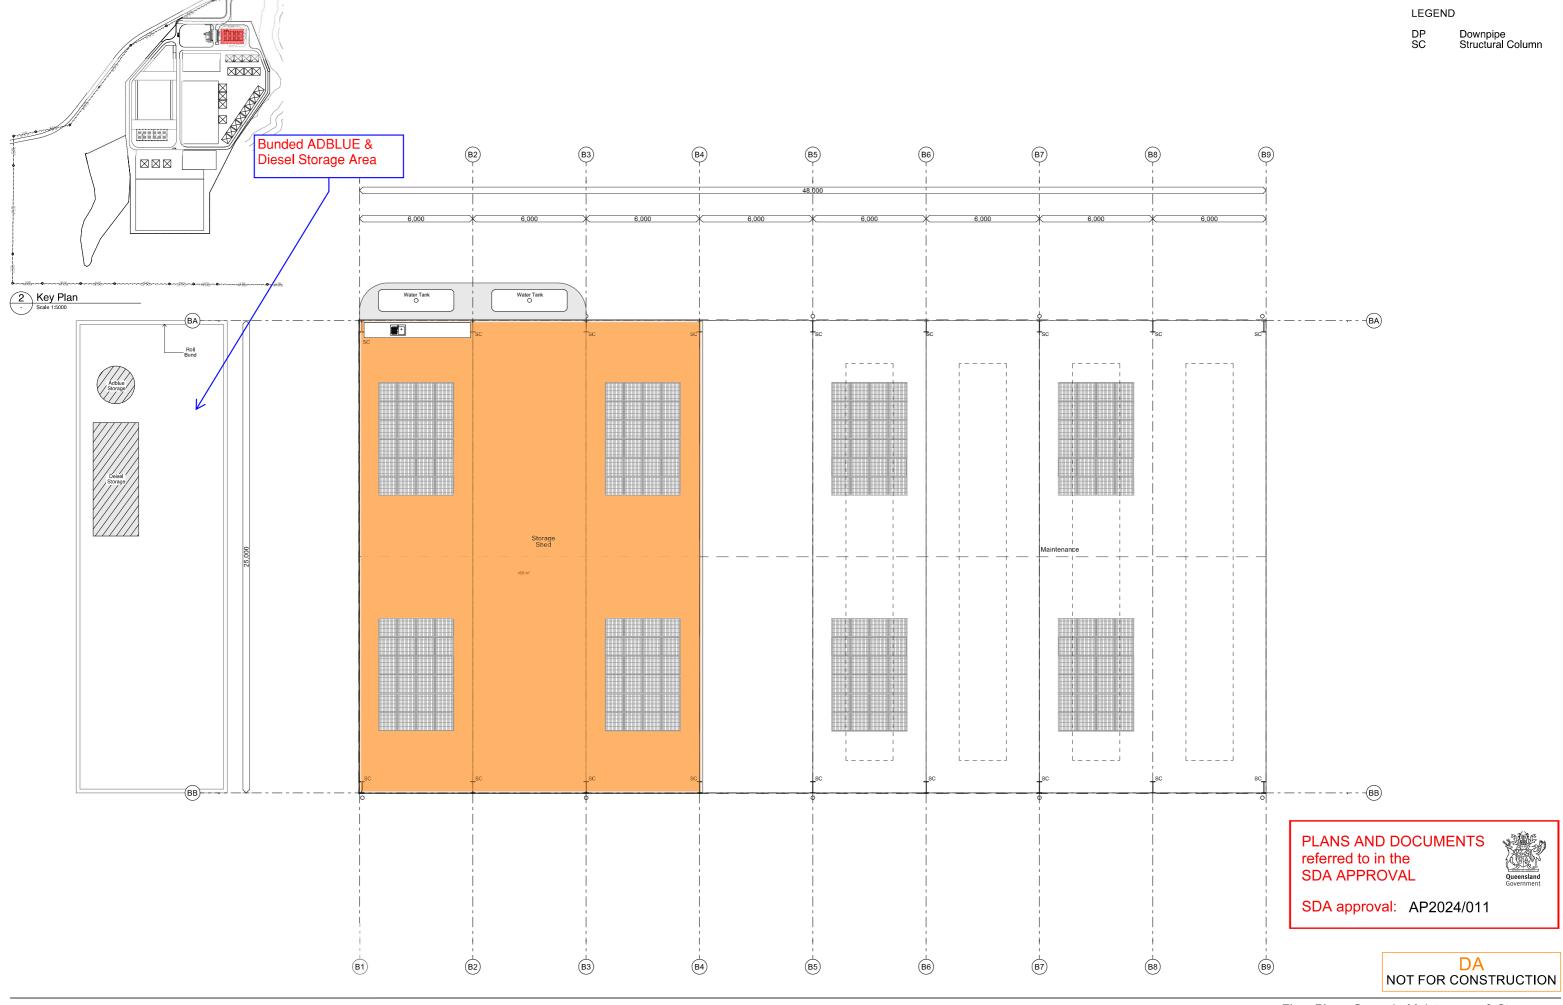
A-DA-03.02

Floor Plan - Ground - Maintenance & Storage Shed

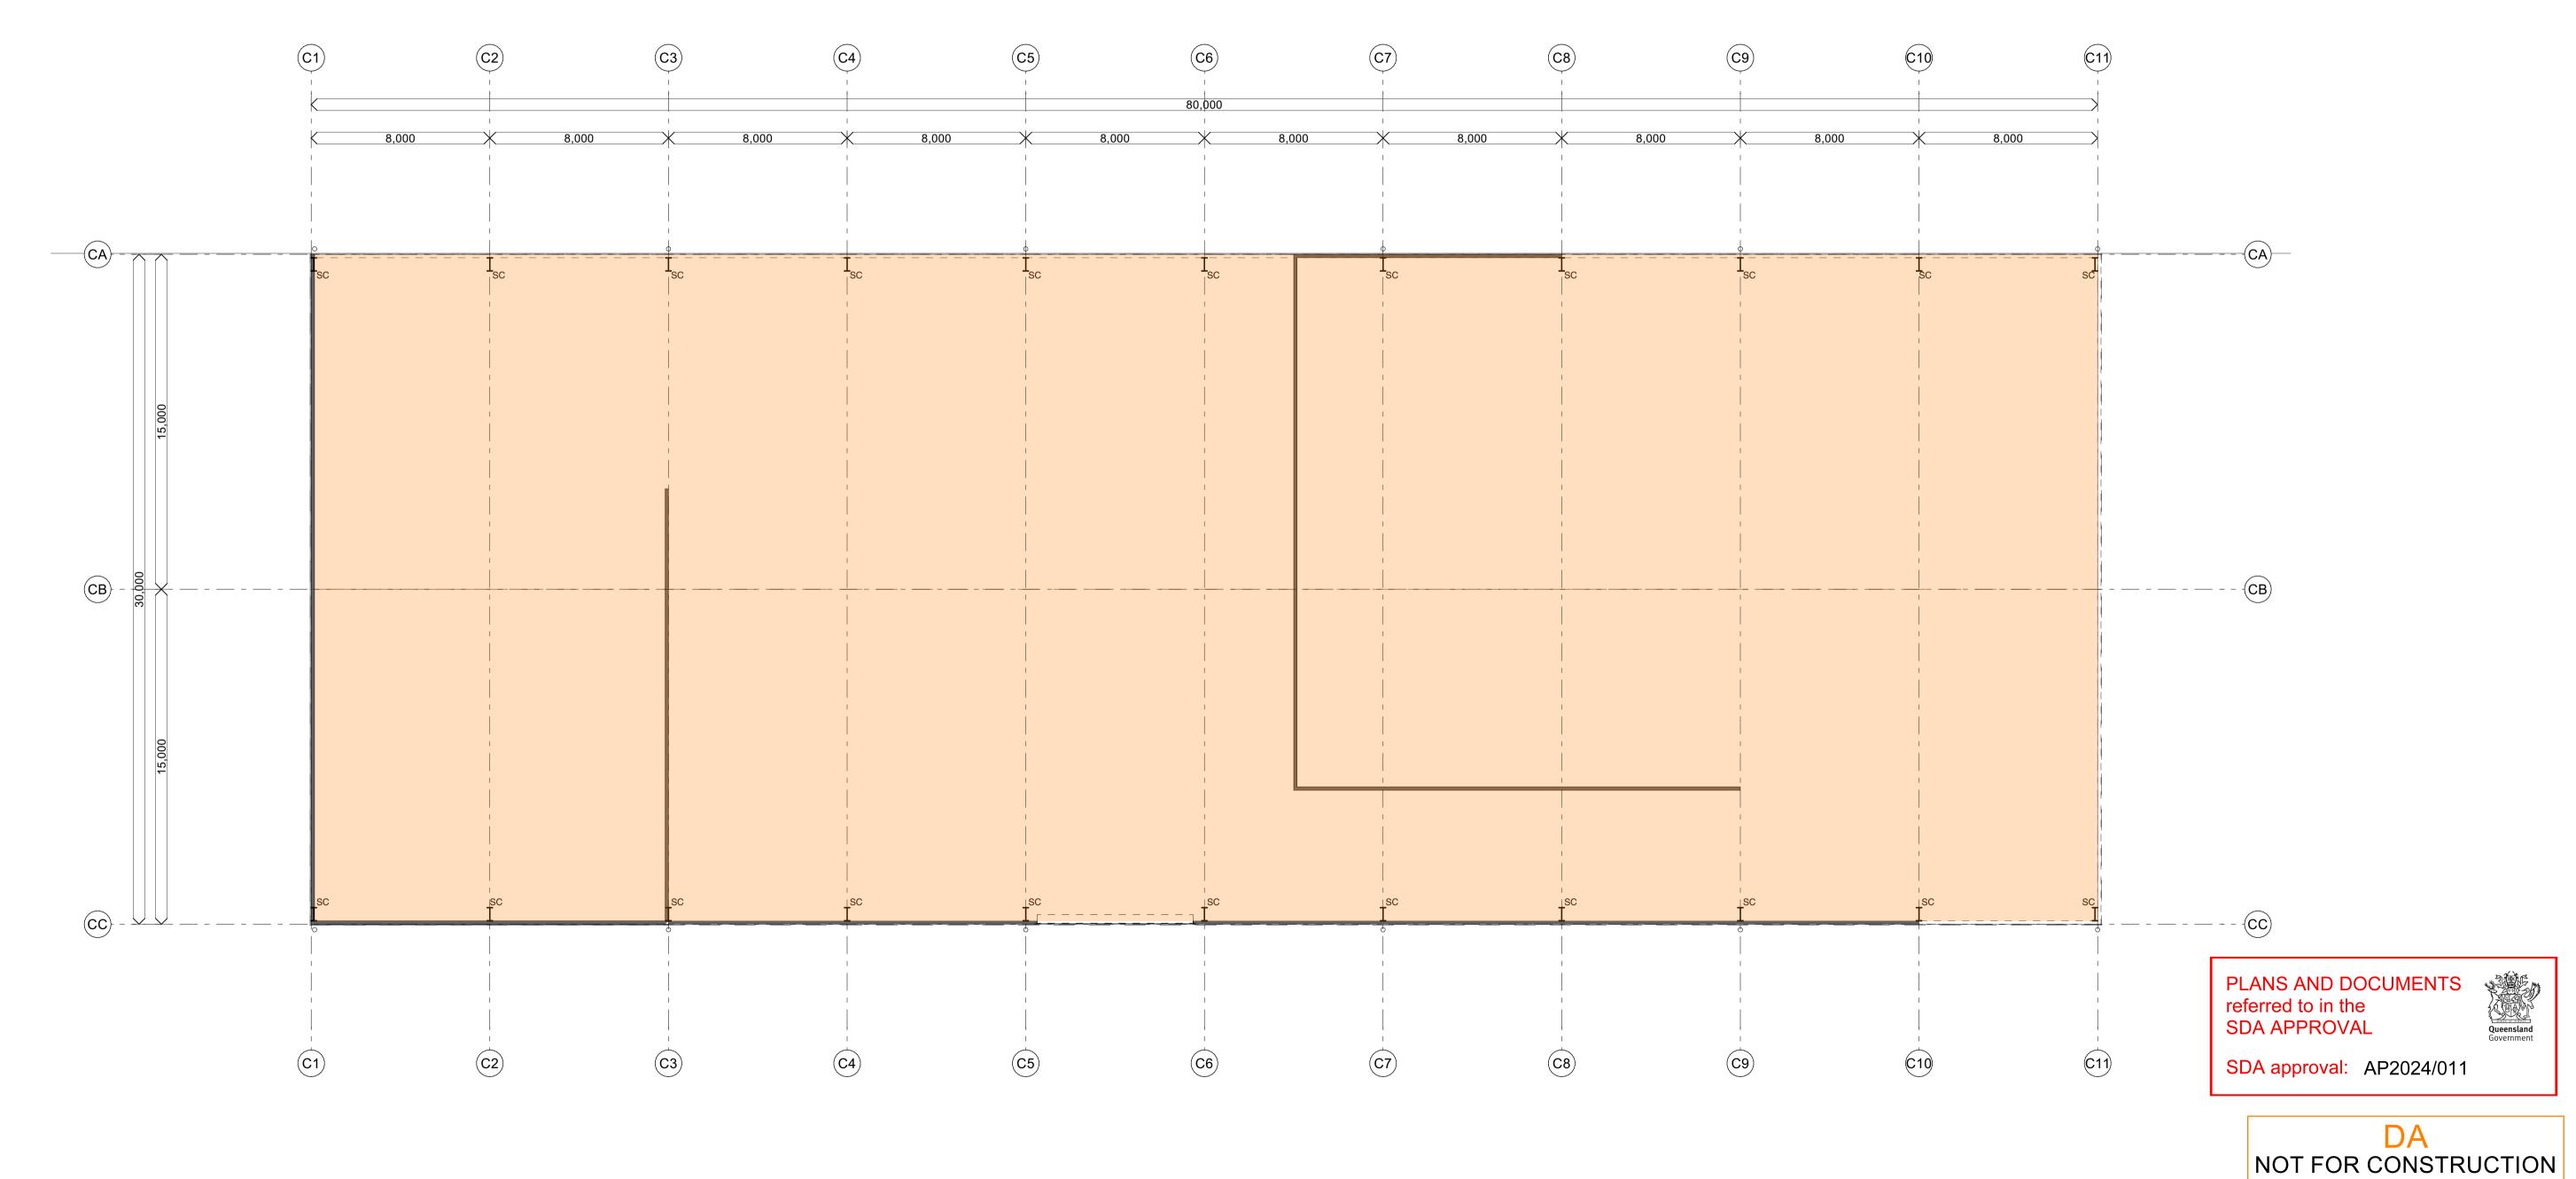
A-DA-03.03

Floor Plan - Ground - FOGO Receival & Sort

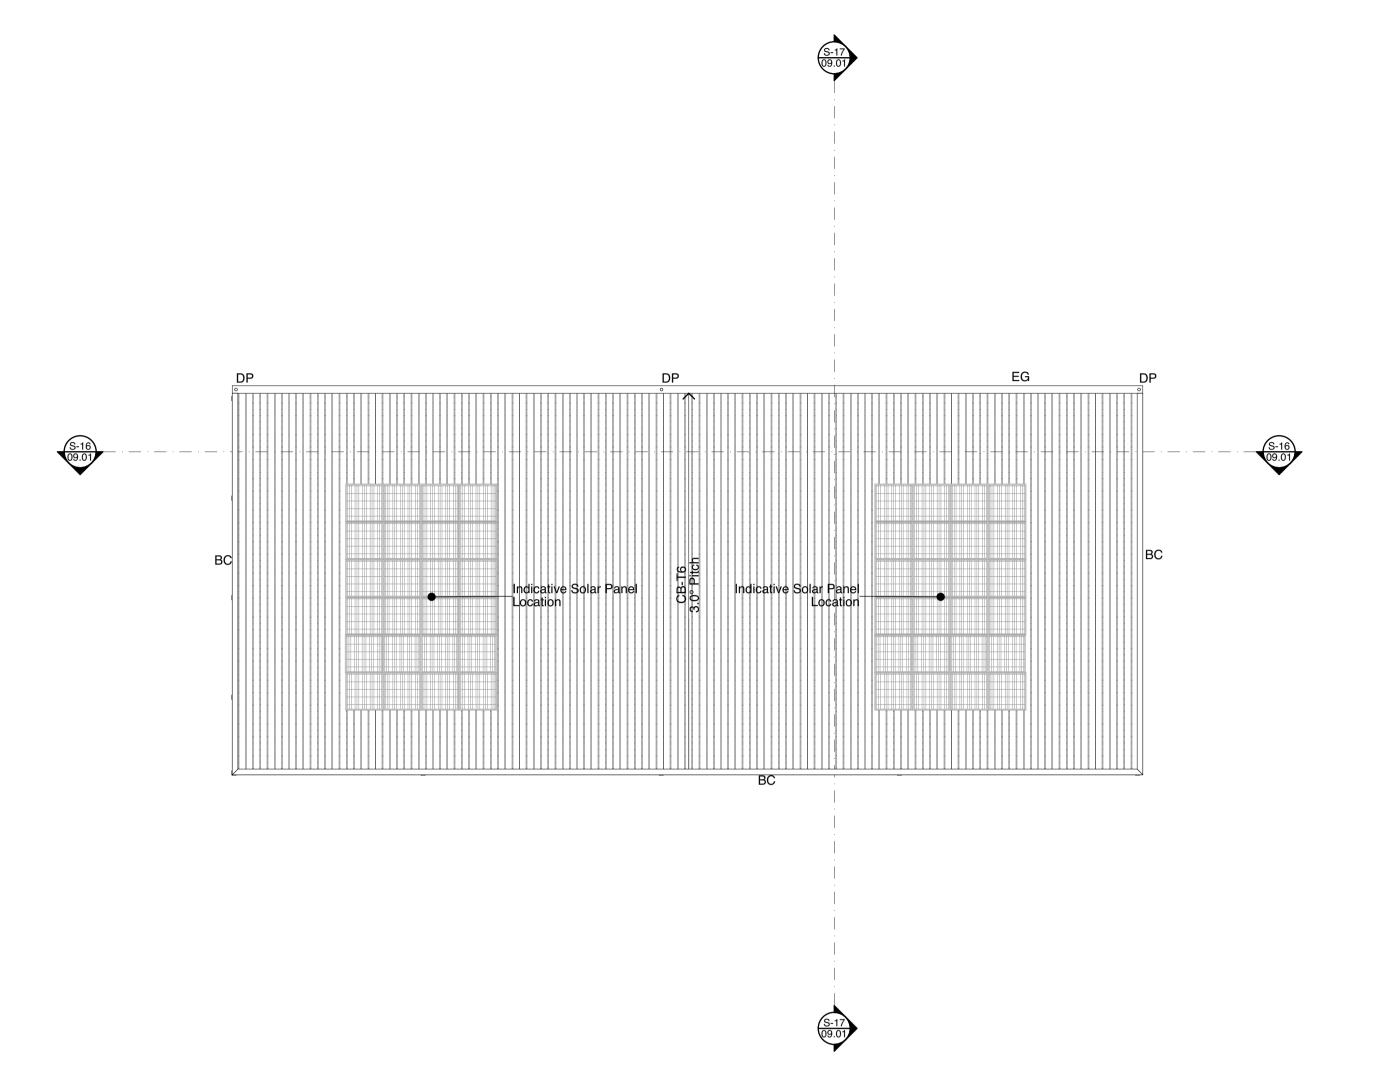
A-DA-04.01

BC DP EG Barge Capping Downpipe
Eaves Gutter
Metal Roof Sheeting
Colorbond Trimdek
Ridge Capping

Roof - Office & Amenities

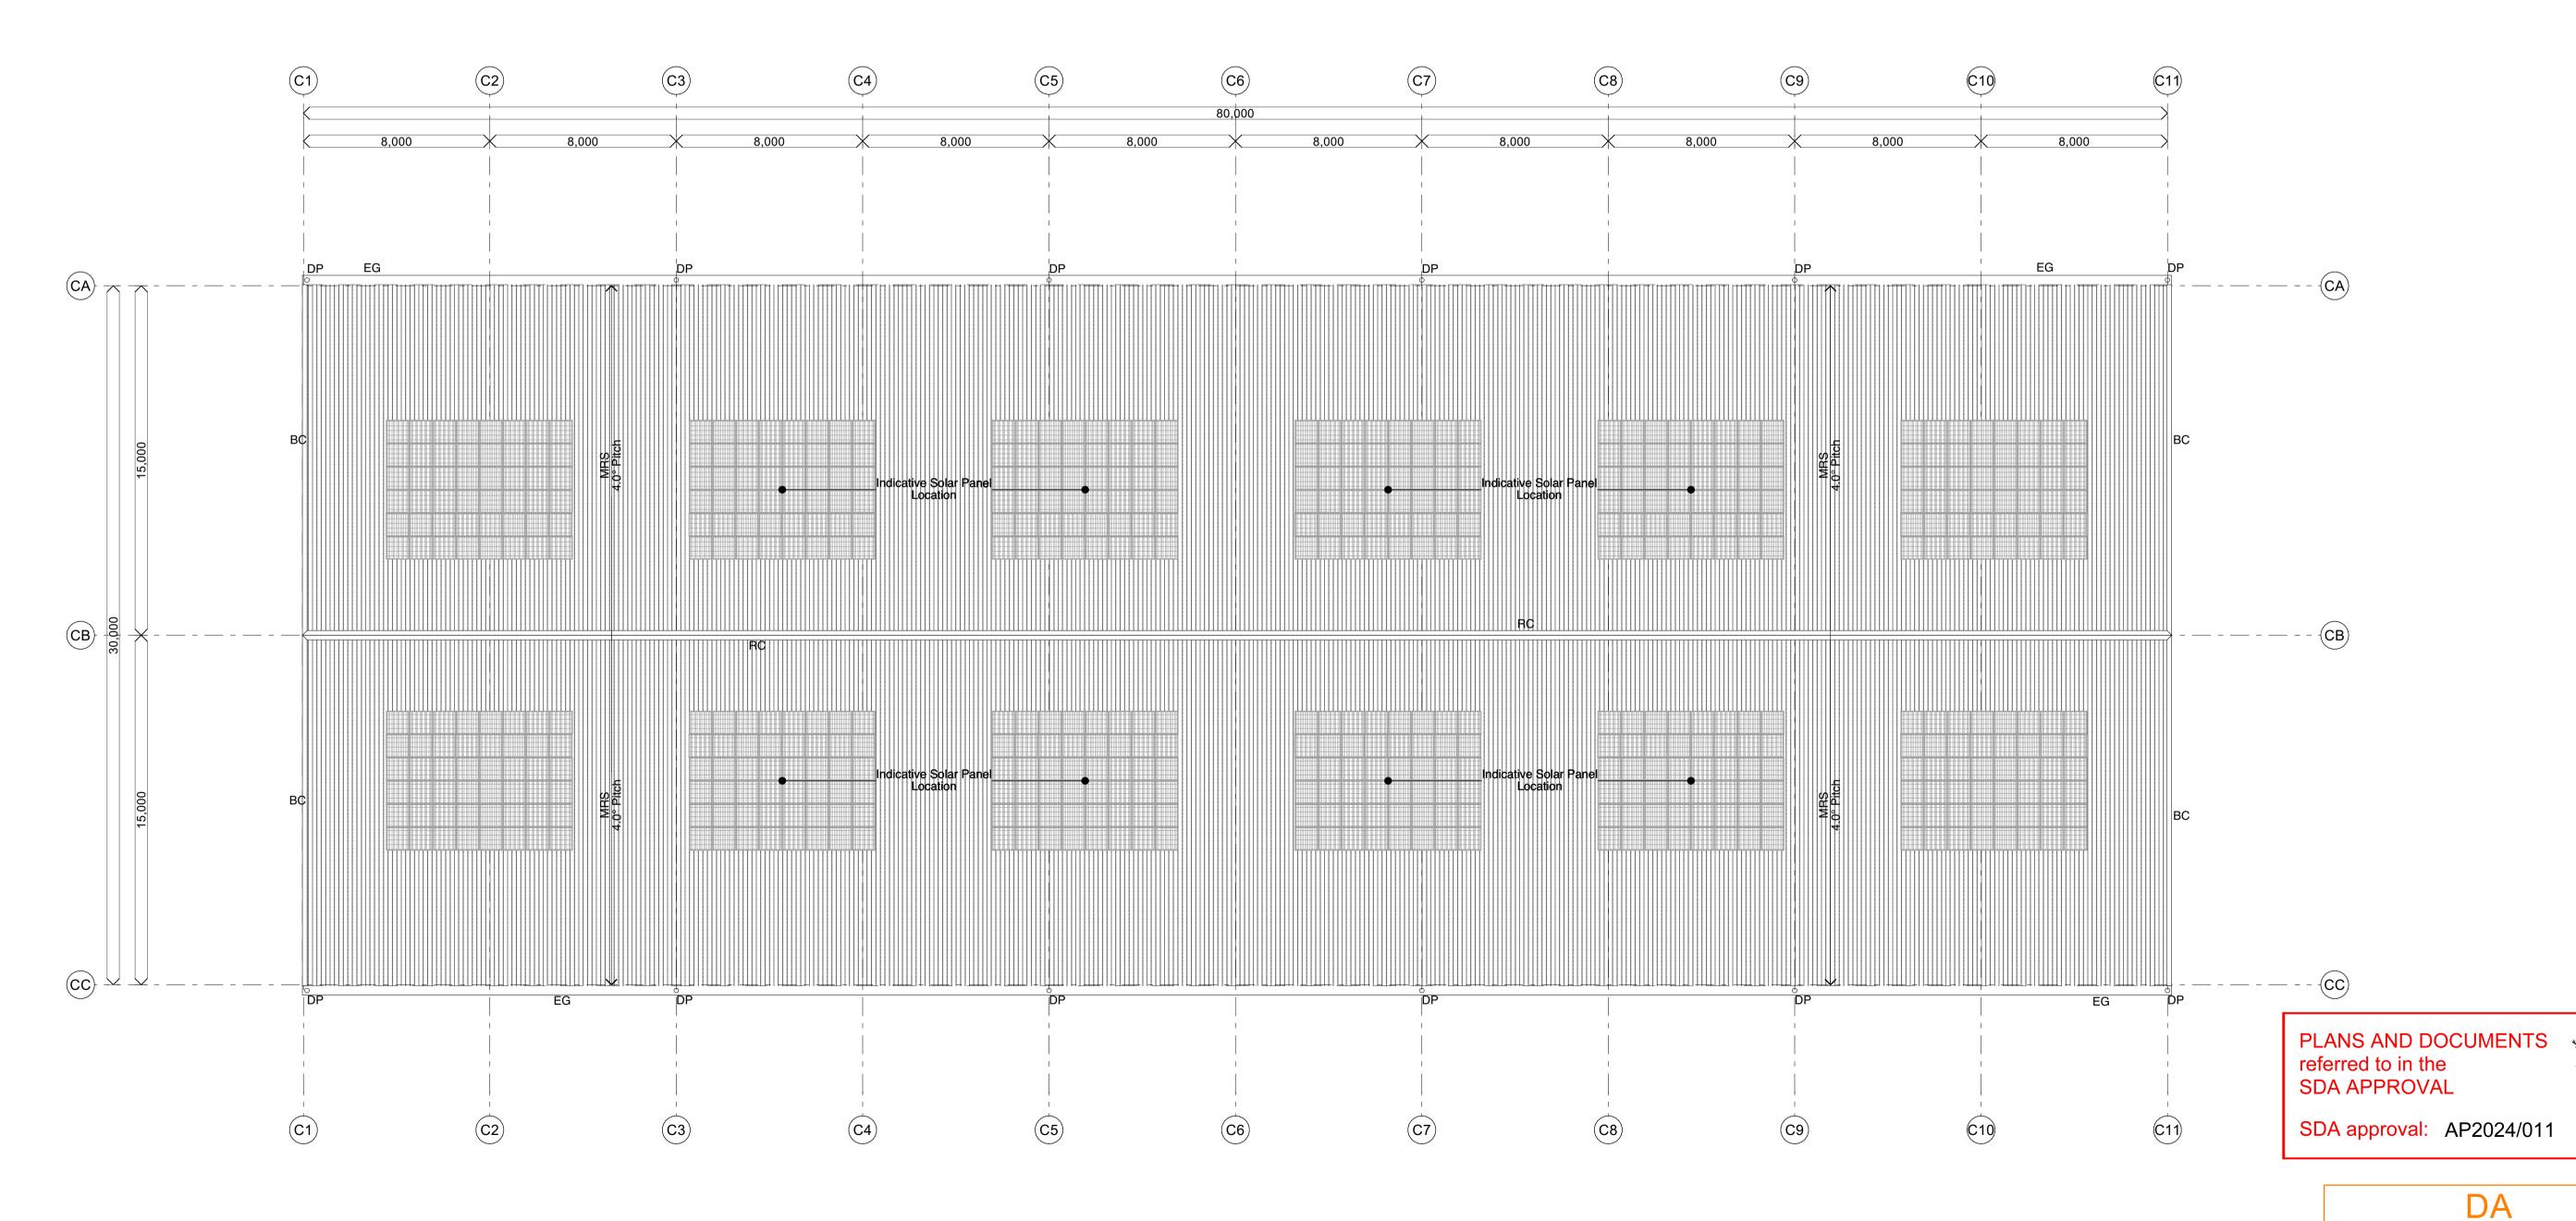
A-DA-04.03

BC Barge Capping
DP Downpipe
EG Eaves Gutter
MRS Metal Roof Sheeting
Colorbond Trimdek
RC Ridge Capping

Roof - FOGO Receival & Sort Shed

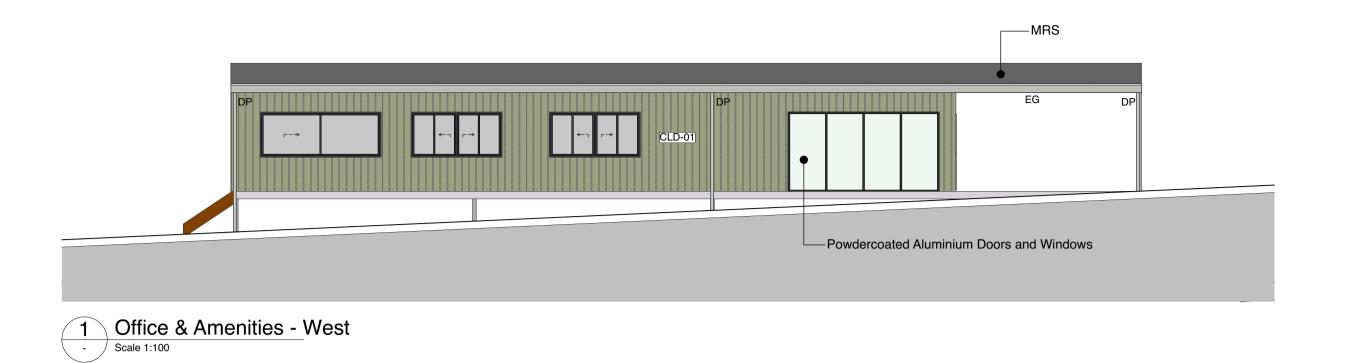
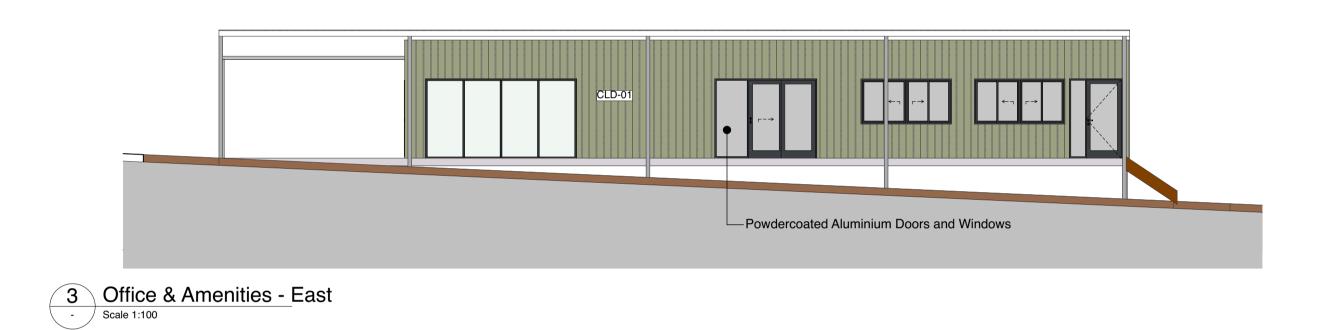
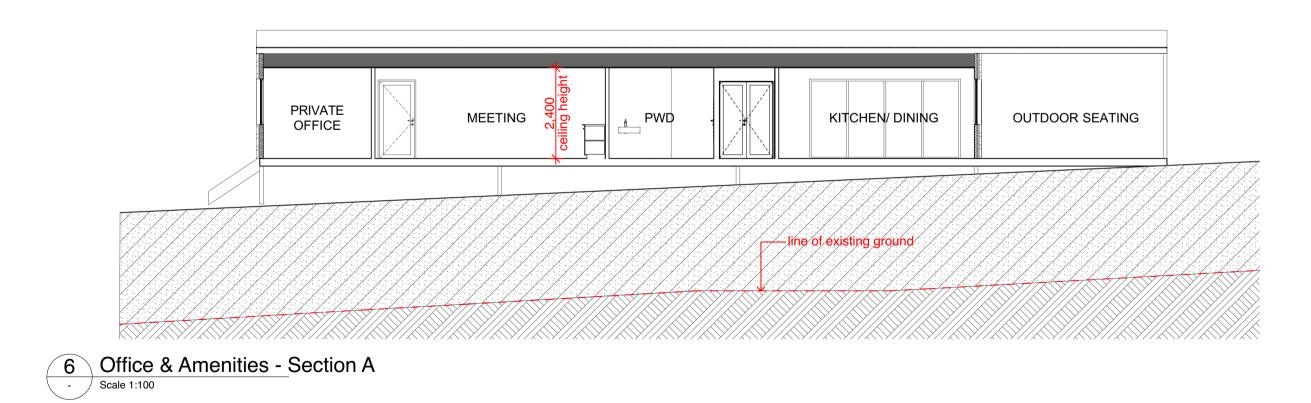
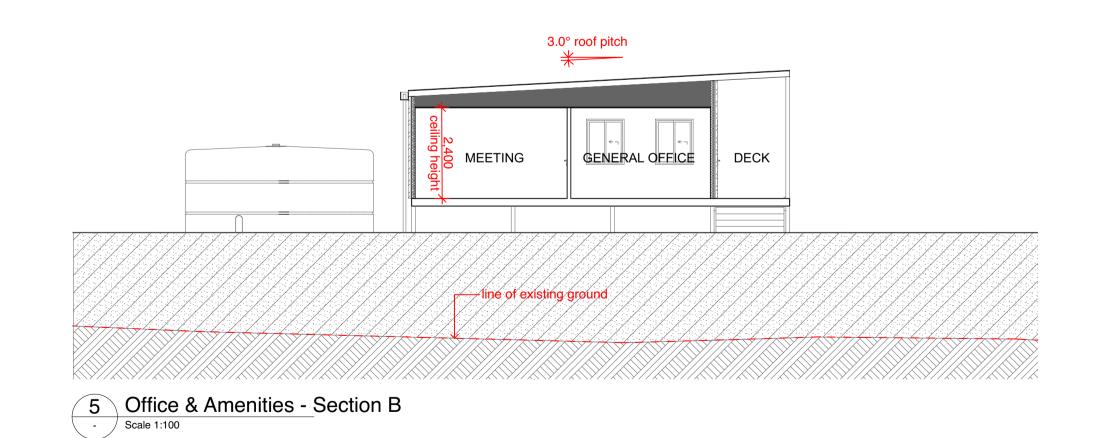
A-DA-09.01

Office & Amenities - South
Scale 1:100

4 Office & Amenities - North
- Scale 1:100

CONC Concrete Tilt Panel Finish: Natural

Elevations & Sections - Office & Amenities

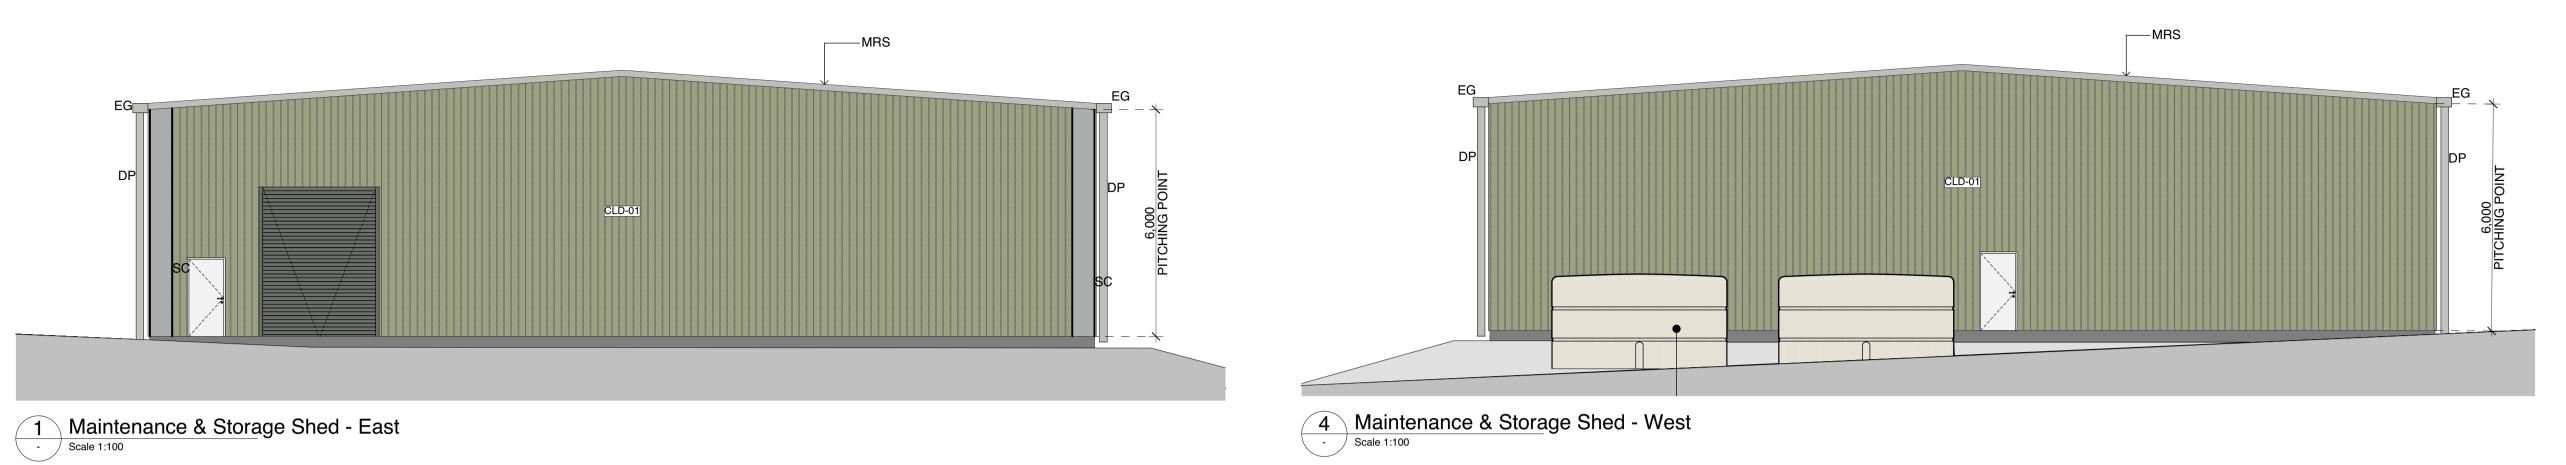
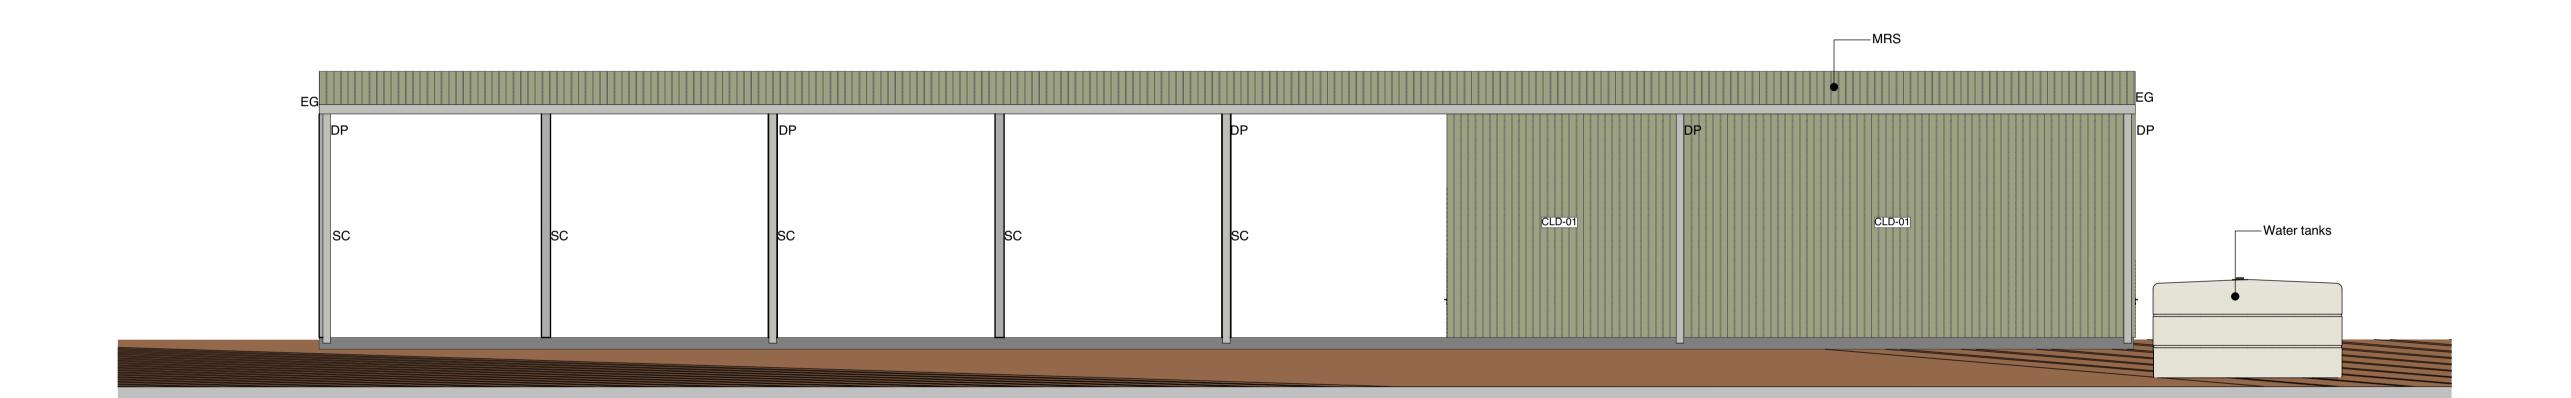
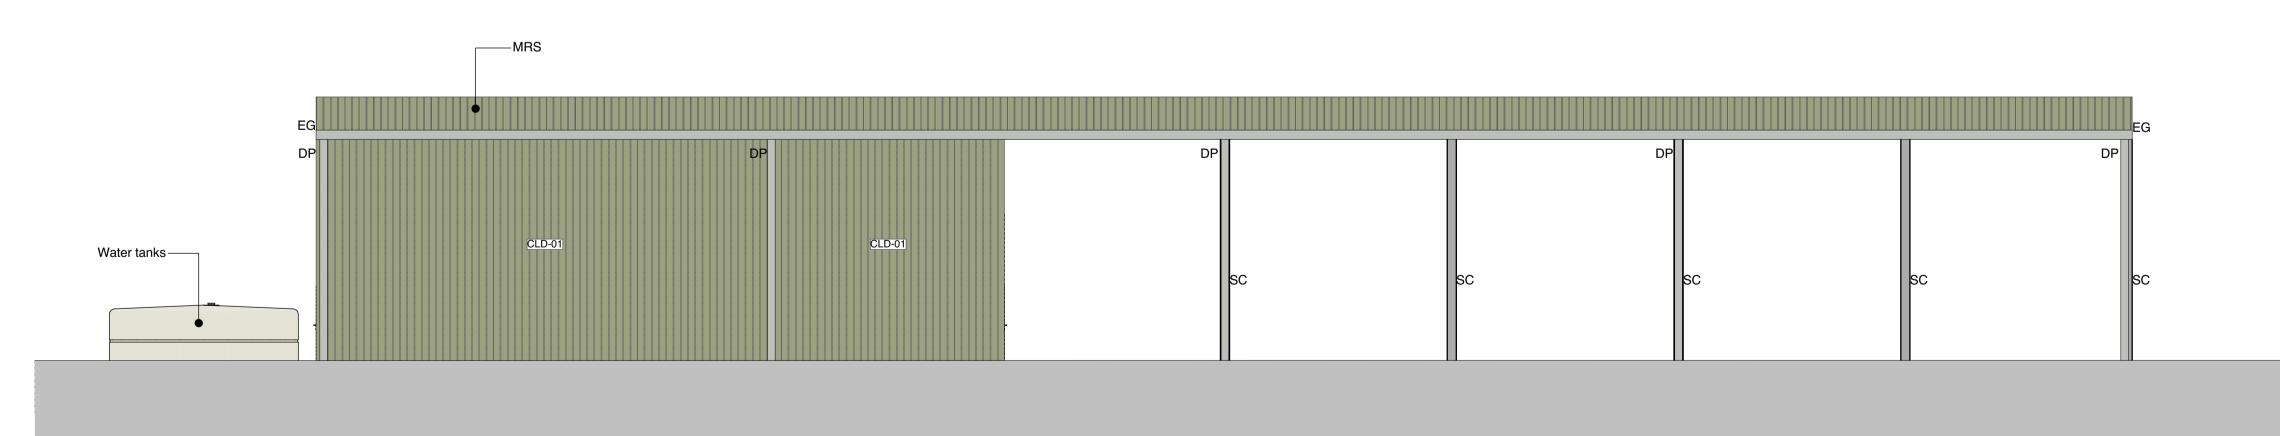
A-DA-09.02

CLD-01 Colorbond Trimdek Colour: Pale Eucalypt

CONC Concrete Tilt Panel Finish: Natural

Maintenance & Storage Shed - South
Scale 1:100

2 Maintenance & Storage Shed - North
- Scale 1:100

Elevations - Maintenance & Storage Shed

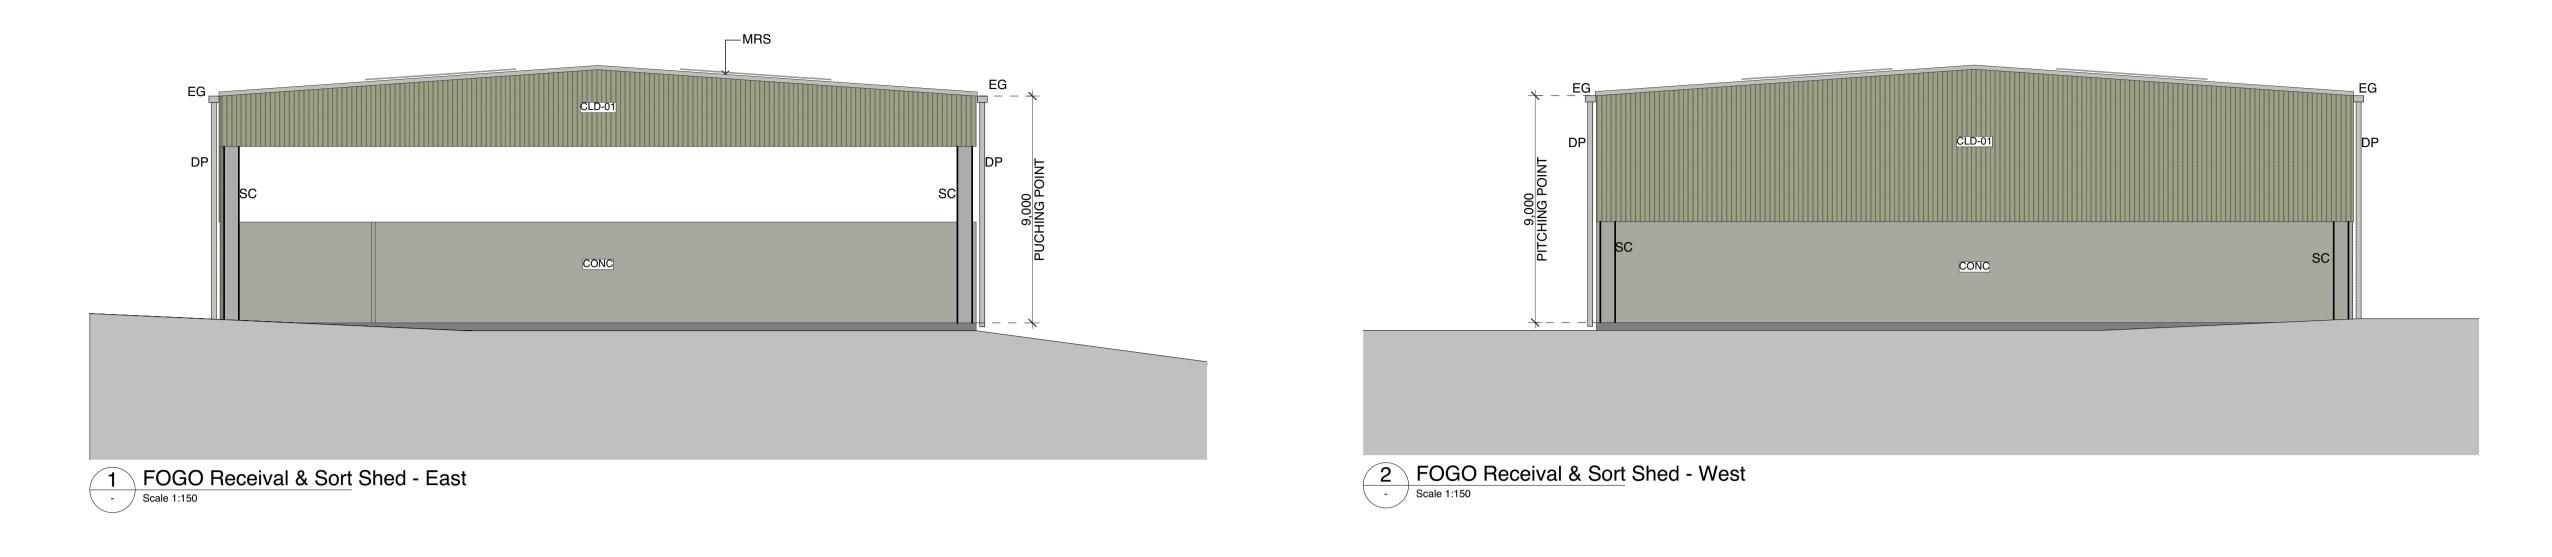
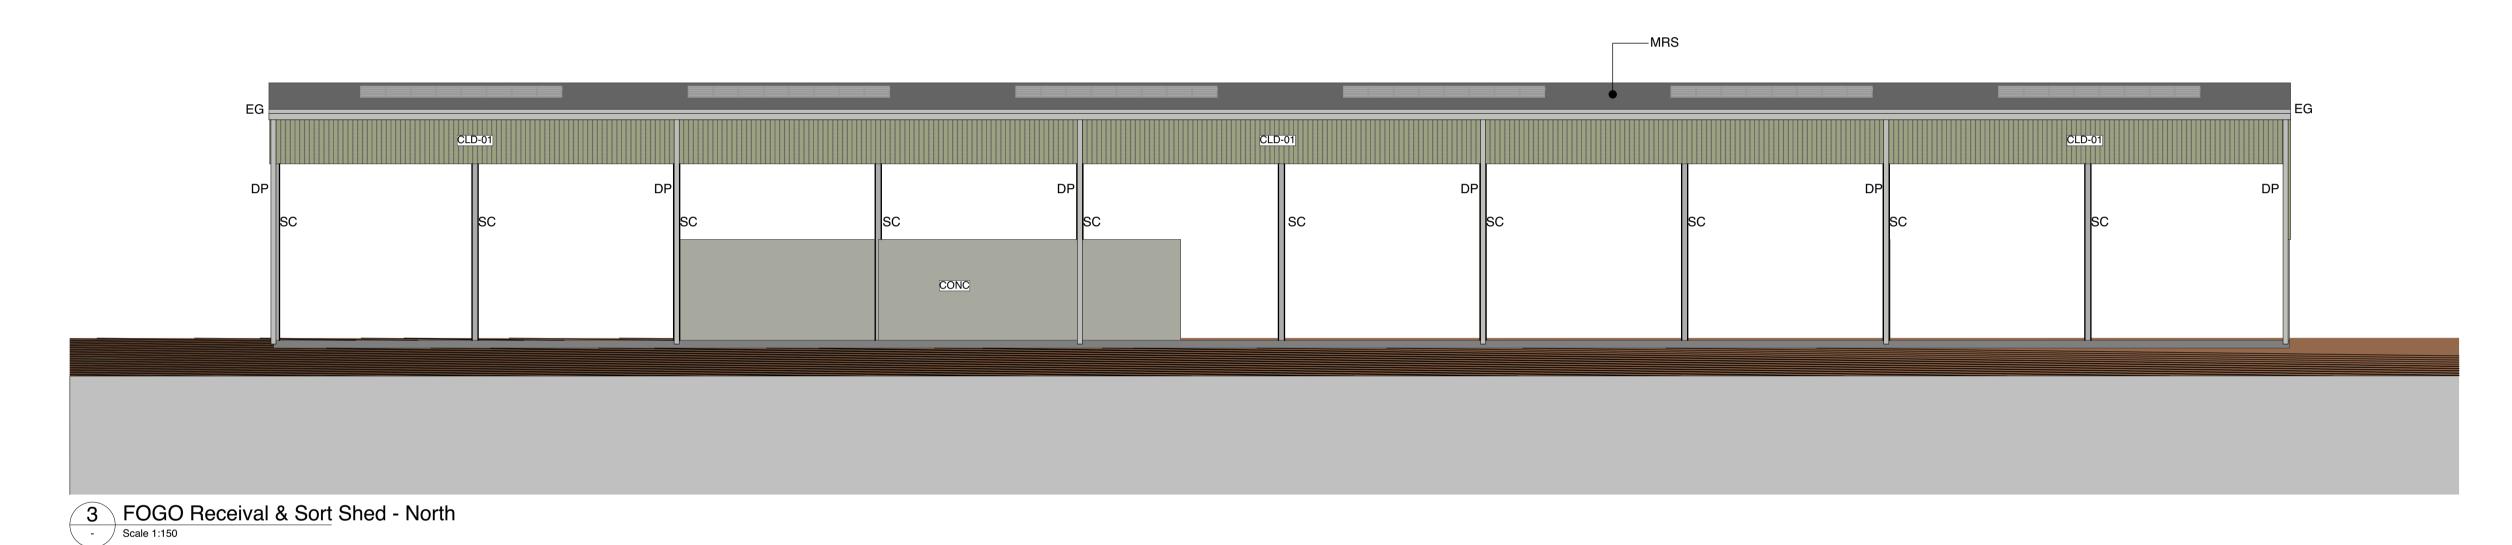
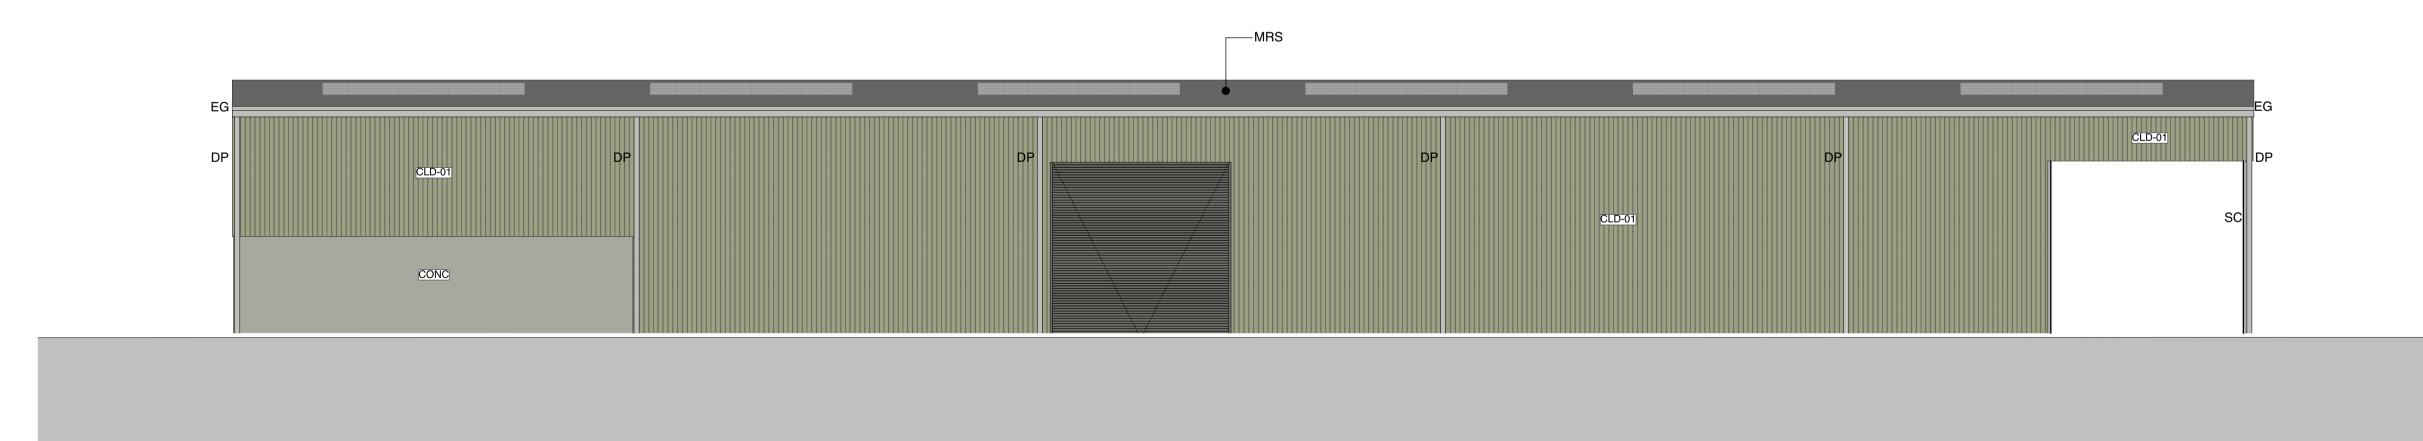
A-DA-09.03

4 FOGO Receival & Sort Shed - South
- Scale 1:150

Elevations - FOGO Receival & Sort Shed

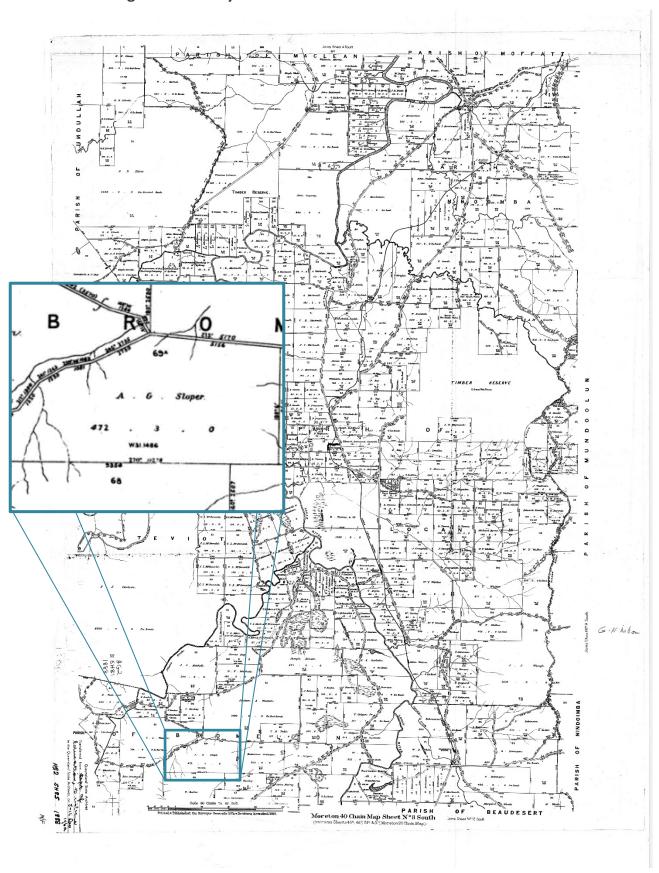
Figure 1 A 1888 map of the Parish of Beaudesert, with inset map of the proposed works area (Surveyor General's Office – Brisbane, Queensland 1888)
