PROPOSED DEVELOPMENT SOILCO PTY LTD BOONAH ROAD, BEAUDESERT

BROMELTON COMPOST MANUFACTURING FACILITY

Project
Bromelton Compost Manufacturing Facility
Lot 4 Mitchell Road Bromelton 4285

Cultural Heritage and Native Title Duty of Care Assessment

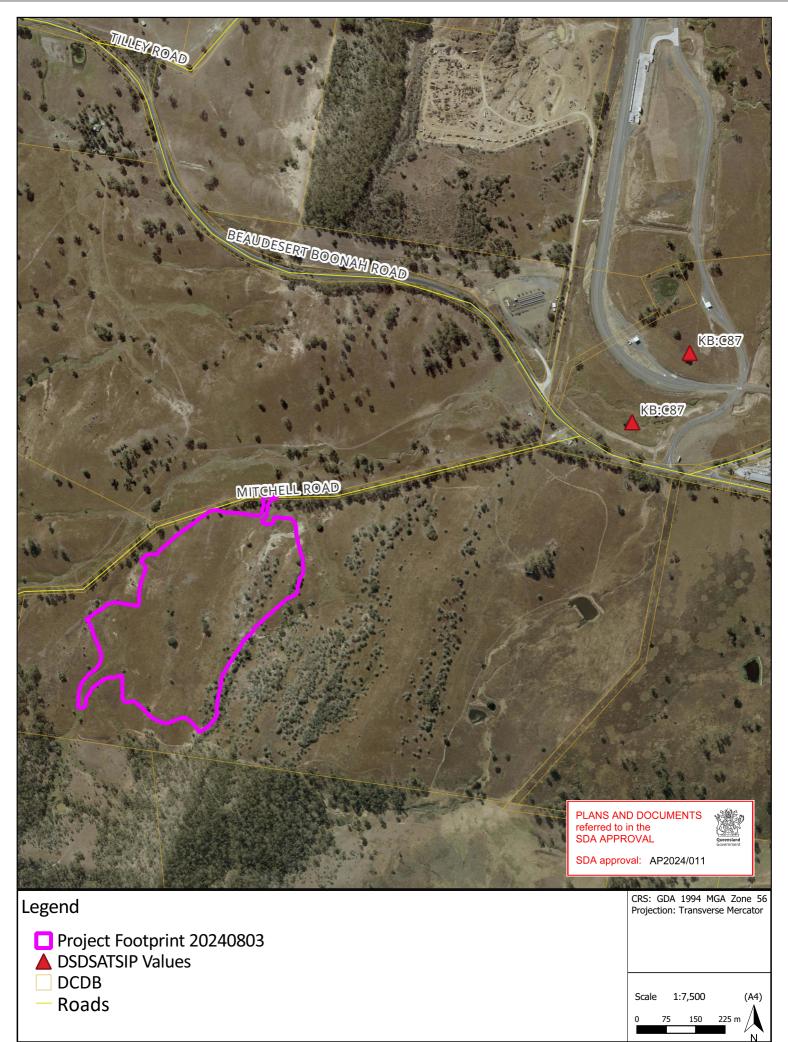
Map 2 DSDSATSIP Indigenous heritage values at or near the proposed Compost Manufacturing Facility, A Bromelton.

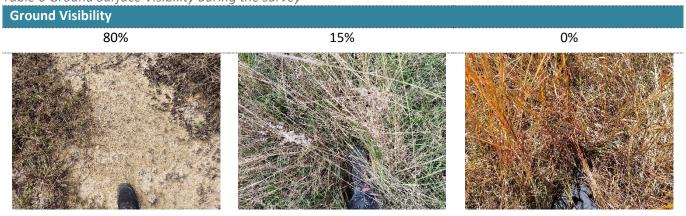
Table 6 Ground Surface Visibility during the survey

GSV at the site was on average 5%. The ground cover consisted of thick grasses and weeds with only a few bare patches allowing the surface to be seen. The survey effort was significantly hampered by these factors, which may result in heritage values remaining undiscovered in the landscape.
