# REPORT OF BOREHOLE: HCAH01

**CLIENT:** SunWater **COORDS:** 657894 m E 7580242 m N 55 MGA94 **SHEET:** 1 OF 1  
**PROJECT:** Connors River Dam and Pipelines **SURFACE RL:** m **DATUM:** AHD **DRILL RIG:** HAND  
**LOCATION:** Harrybrandt Creek **INCLINATION:** -90° **DRILLER:** Golder  
**JOB NO:** 077632049 **HOLE DIA:** 70 mm **HOLE DEPTH:** 1.10 m **LOGGED:** ACF **DATE:** 12/7/09  
**CHECKED:** AB **DATE:** 8/10/09

# REPORT OF TEST PIT: IRTP02

# REPORT OF PHOTOGRAPHS:

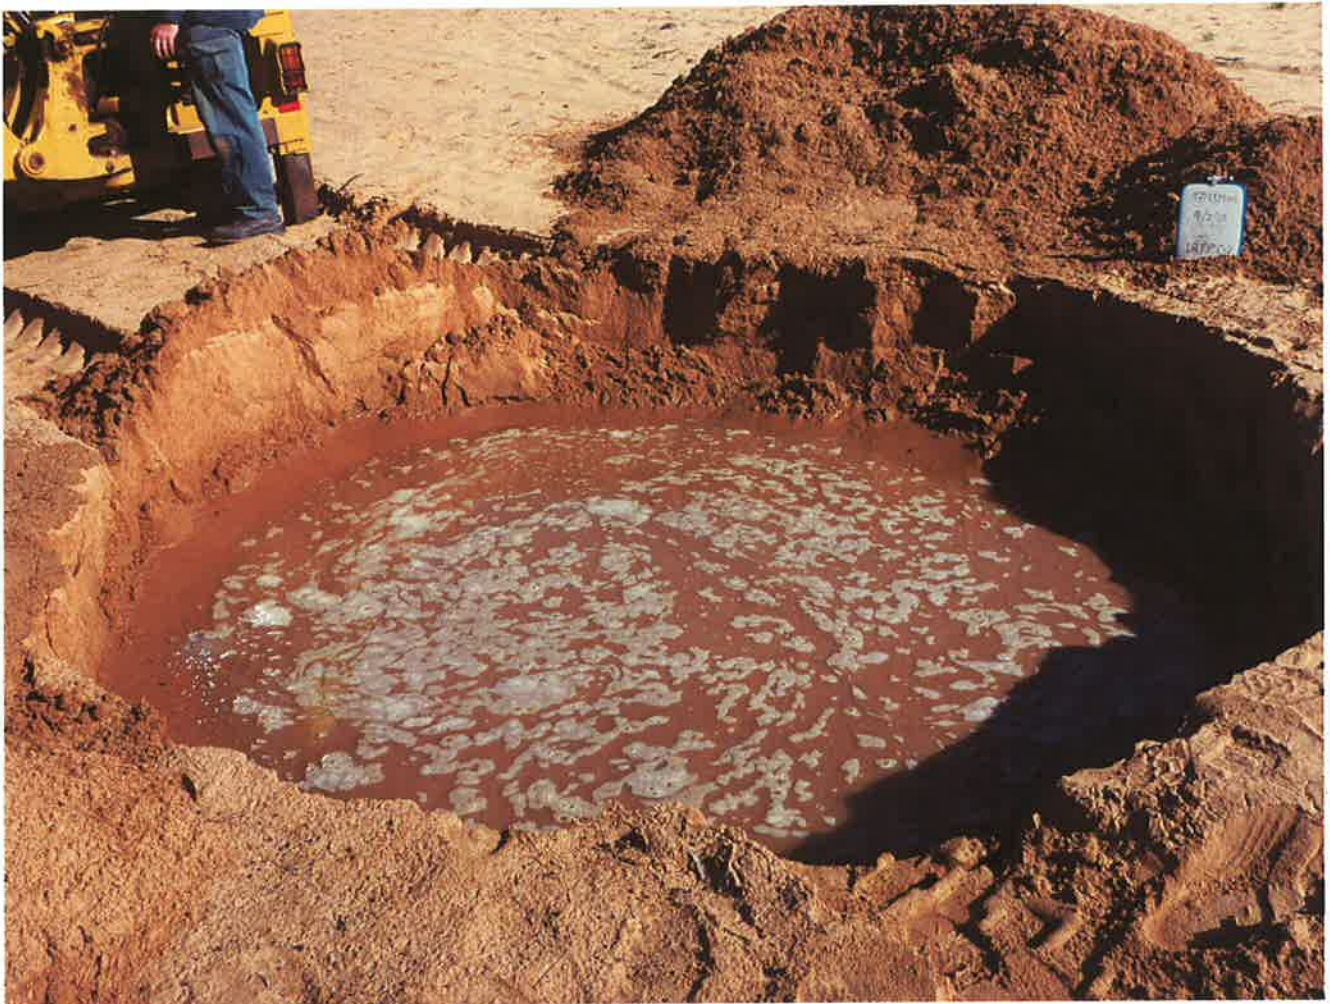
IRTP02

DEPTH RANGE: 0.00 – 1.10m  
MACHINE: Backhoe  
CONTRACTOR: T&M  
LOGGED: ACF DATE: 9/07/09  
CHECKED: AB DATE: 8/10/09

Excavation			Sampling			Field Material Description										
METHOD	EXCAVATION RESISTANCE	WATER	DEPTH (metres)	DEPTH RL	SAMPLE OR FIELD TEST	RECOVERED GRAPHIC LOG	USC Symbol	SOIL / ROCK MATERIAL DESCRIPTION	MOISTURE	CONSISTENCY	DCP TEST (AS1289.6.3.2) Blows per 100 mm					
											0	5	10	15	20	25
BH	L		0.0	0.10	DS 0.00-0.10m	[Yellow dotted pattern]	SP	SAND Medium to coarse, pale grey and pale brown, trace fine angular gravel becoming moist	D							
	M	9/07/09	0.40	0.5	DS 0.60-0.70m			trace fine to coarse angular gravel, rounded cobbles to 0.12m (~5%)	M							
			1.0	1.10				TEST PIT DISCONTINUED @ 1.10 m Test pit discontinued due to caving. Sidewalls caving below 0.5m. Backfilled on completion.	W							
			1.5													
			2.0													
			2.5													
			3.0													
			3.5													
			4.0													
			4.5													
			5.0

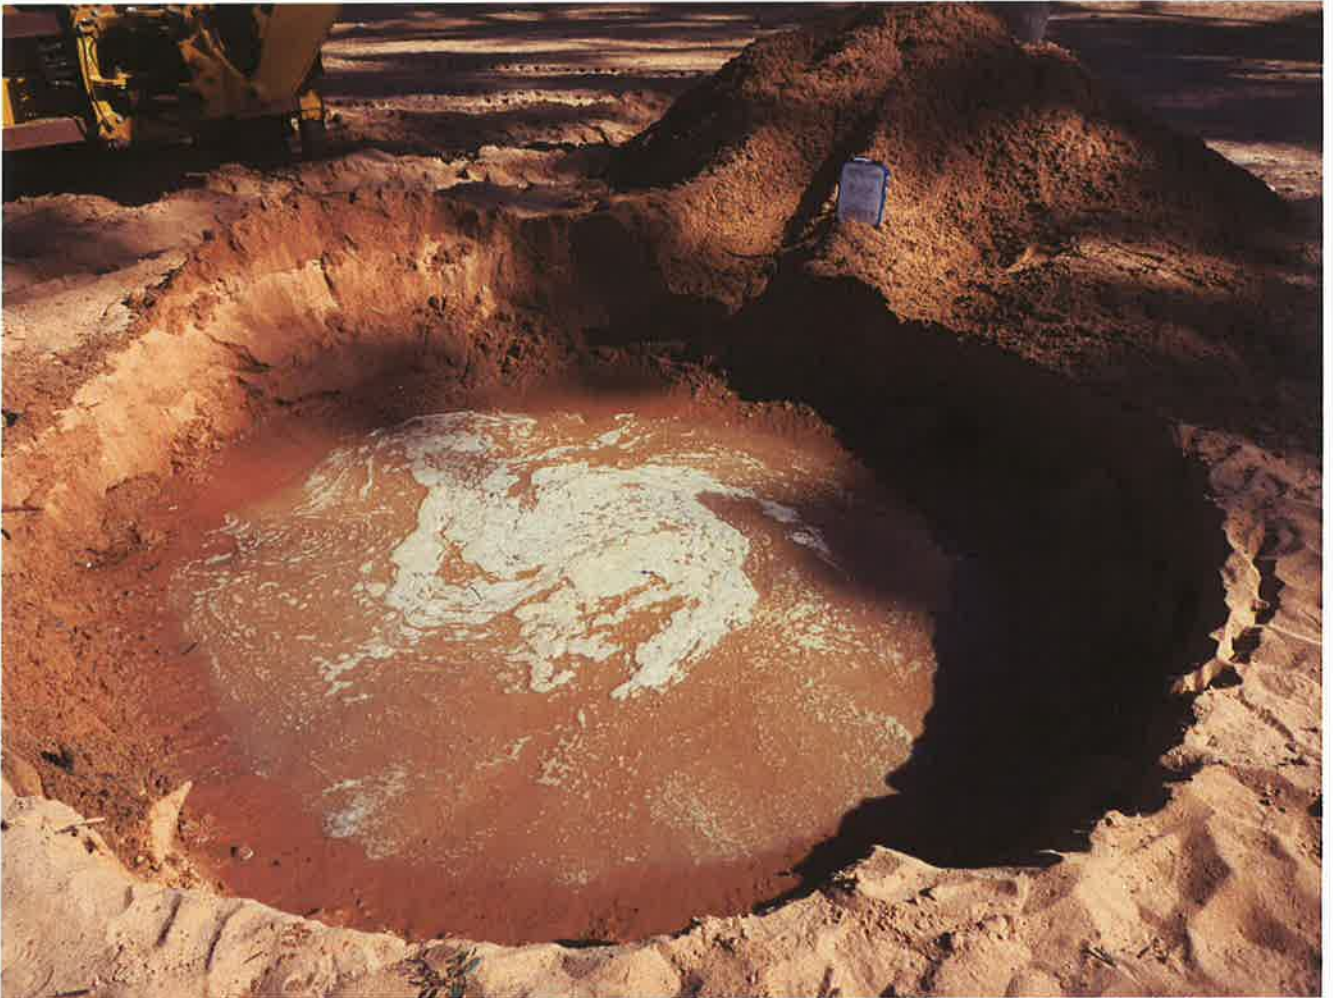
**IRTP03**

DEPTH RANGE: 0.00 – 0.90m  
MACHINE: Backhoe  
CONTRACTOR: T&M  
LOGGED: ACF DATE: 9/07/09  
CHECKED: AB DATE: 8/10/09

Excavation			Sampling		Field Material Description													
METHOD	EXCAVATION RESISTANCE	WATER	DEPTH (metres)	DEPTH RL	SAMPLE OR FIELD TEST	RECOVERED GRAPHIC LOG	USC Symbol	SOIL / ROCK MATERIAL DESCRIPTION	MOISTURE	CONSISTENCY	DENSITY	DCP TEST (AS1289.6.3.2) Blows per 100 mm						
												0	5	10	15	20	25	
BH	L		0.0	0.10	DS 0.00-0.10m		SP	SAND Fine to medium, pale grey and pale brown . becoming moist		D								
	M	80709	0.40	0.50	DS 0.60-0.70m		GP	Sandy GRAVEL Fine angular gravel, pale brown and pale grey, fine to coarse sand, rounded cobbles to 0.11m (~5%)		M	VL

0.90					TEST PIT DISCONTINUED @ 0.90 m Test pit discontinued due to caving. Sidewalls caving below 0.5m. Backfilled on completion.		W								
			1.0

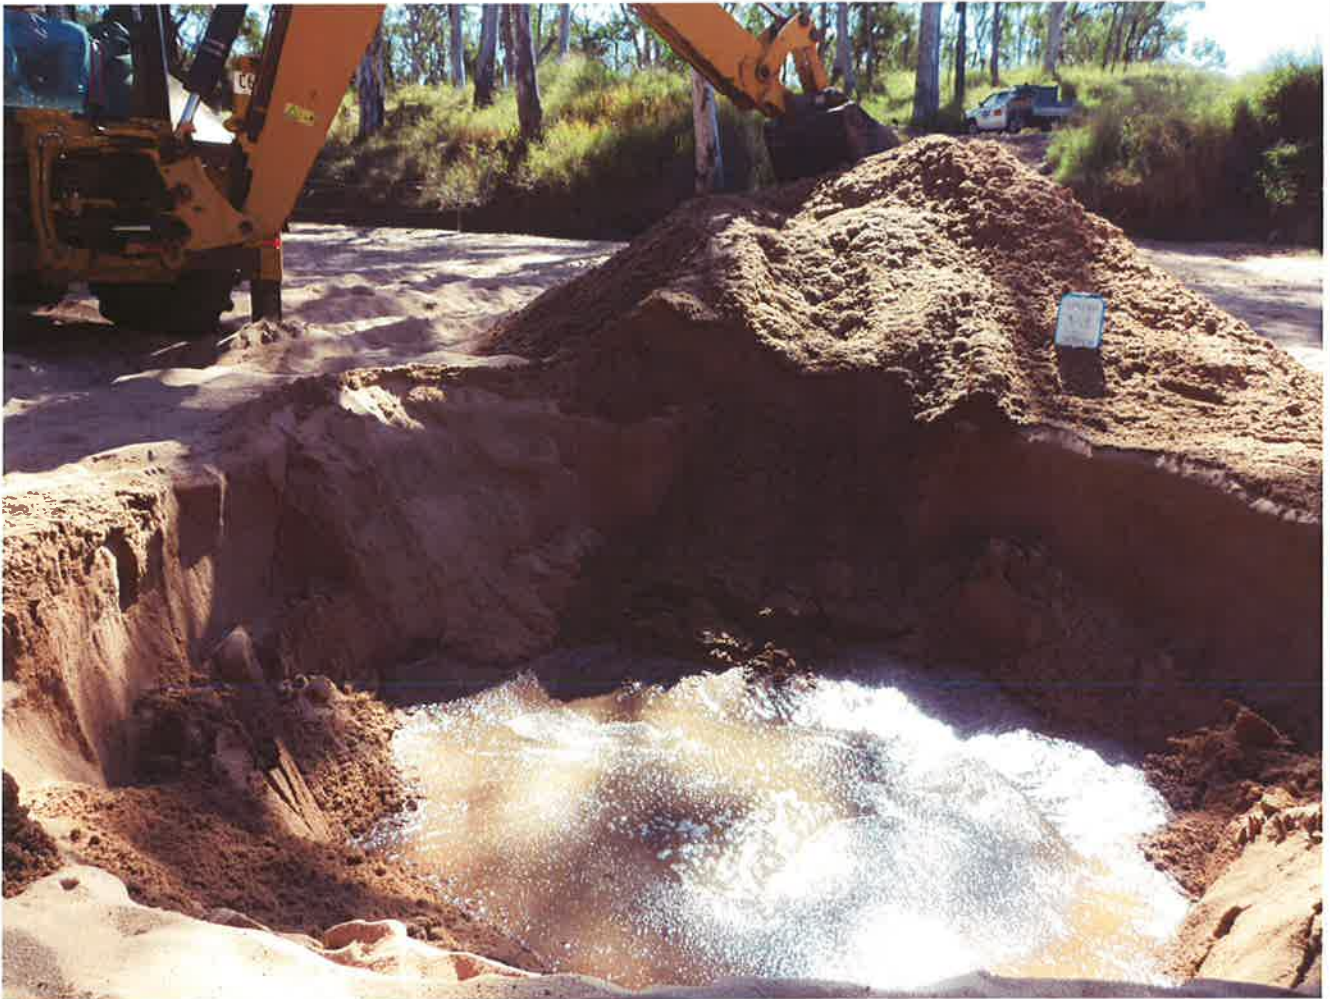
IRTP04

DEPTH RANGE: 0.00 – 1.90m  
MACHINE: Backhoe  
CONTRACTOR: T&M  
LOGGED: ACF DATE: 9/07/09  
CHECKED: AB DATE: 8/10/09

Excavation			Sampling		Field Material Description																												
METHOD	EXCAVATION RESISTANCE	WATER	DEPTH (metres)	DEPTH RL	SAMPLE OR FIELD TEST	RECOVERED GRAPHIC LOG	USC Symbol	SOIL / ROCK MATERIAL DESCRIPTION	MOISTURE CONSISTENCY DENSITY	DCP TEST (AS1289.6.3.2) Blows per 100 mm																							
										0	5	10	15	20	25																		
BH M 910709			0.0	0.10	DS 0.00-0.10m		SP	SAND Medium to coarse, pale brown and pale grey, some fine to medium angular gravel . becoming moist

0.5																														
			0.80																	. becoming wet													
			1.0		DS 1.20-1.30m																												
			1.5

1.70		DS 1.70-1.80m			. becoming grey																									
			1.90					TEST PIT DISCONTINUED @ 1.90 m Test pit discontinued due to caving. Sidewalls caving below 1.4m. Backfilled on completion.

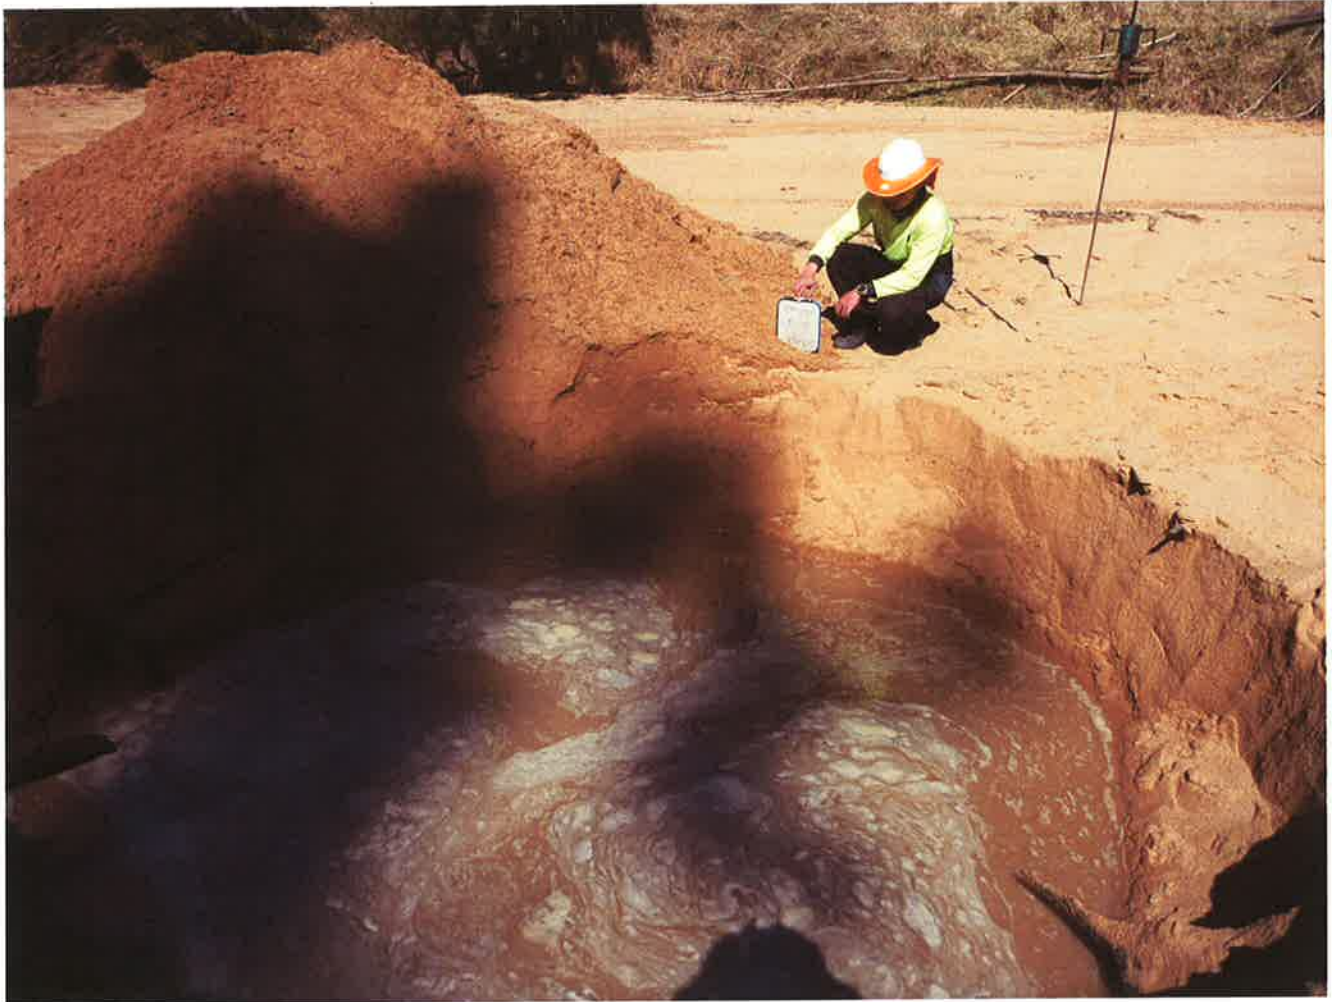
IRTP05

DEPTH RANGE: 0.00 – 2.10m  
MACHINE: Backhoe  
CONTRACTOR: T&M  
LOGGED: ACF DATE: 9/07/09  
CHECKED: AB DATE: 8/10/09

Excavation			Sampling			Field Material Description								
METHOD	EXCAVATION RESISTANCE	DEPTH (metres)	SAMPLE OR FIELD TEST	RECOVERED GRAPHIC LOG	USC Symbol	SOIL / ROCK MATERIAL DESCRIPTION	MOISTURE	CONSISTENCY	DCP TEST (AS1289.6.3.2) Blows per 100 mm					
		DEPTH RL							0	5	10	15	20	25
BH M	L	0.0	DS 0.00-0.10m	[Yellow dotted pattern]	SP	SAND Medium to coarse, pale grey and pale brown, some fine to medium angular gravel becoming moist	D							
		0.70				becoming wet								
		1.70	DS 1.20-1.30m		W									
		2.10	DS 1.70-1.80m	[Brown pattern]	CH	Sandy Silty CLAY Green grey, fine to medium sand	M	VSI						
		2.10	TEST PIT DISCONTINUED @ 2.10 m Test pit discontinued due to caving. Sidewalls caving below 0.7m. Backfilled on completion.											
		2.5												
		3.0												
		3.5												
		4.0												
		4.5												
		5.0

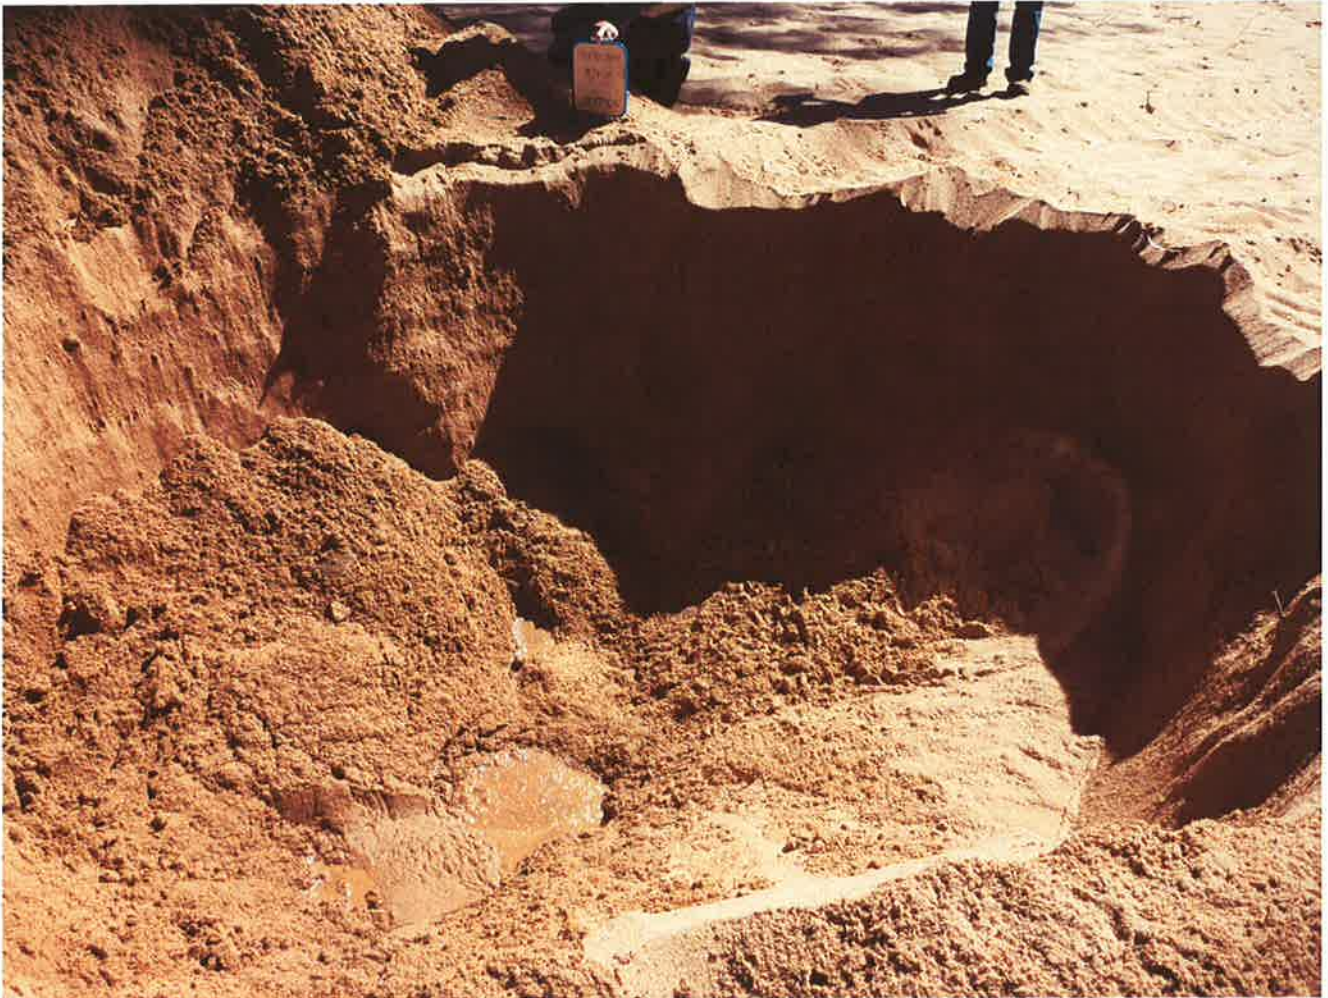
IRTP06

DEPTH RANGE: 0.00 – 1.50m  
MACHINE: Backhoe  
CONTRACTOR: T&M  
LOGGED: ACF DATE: 9/07/09  
CHECKED: AB DATE: 8/10/09

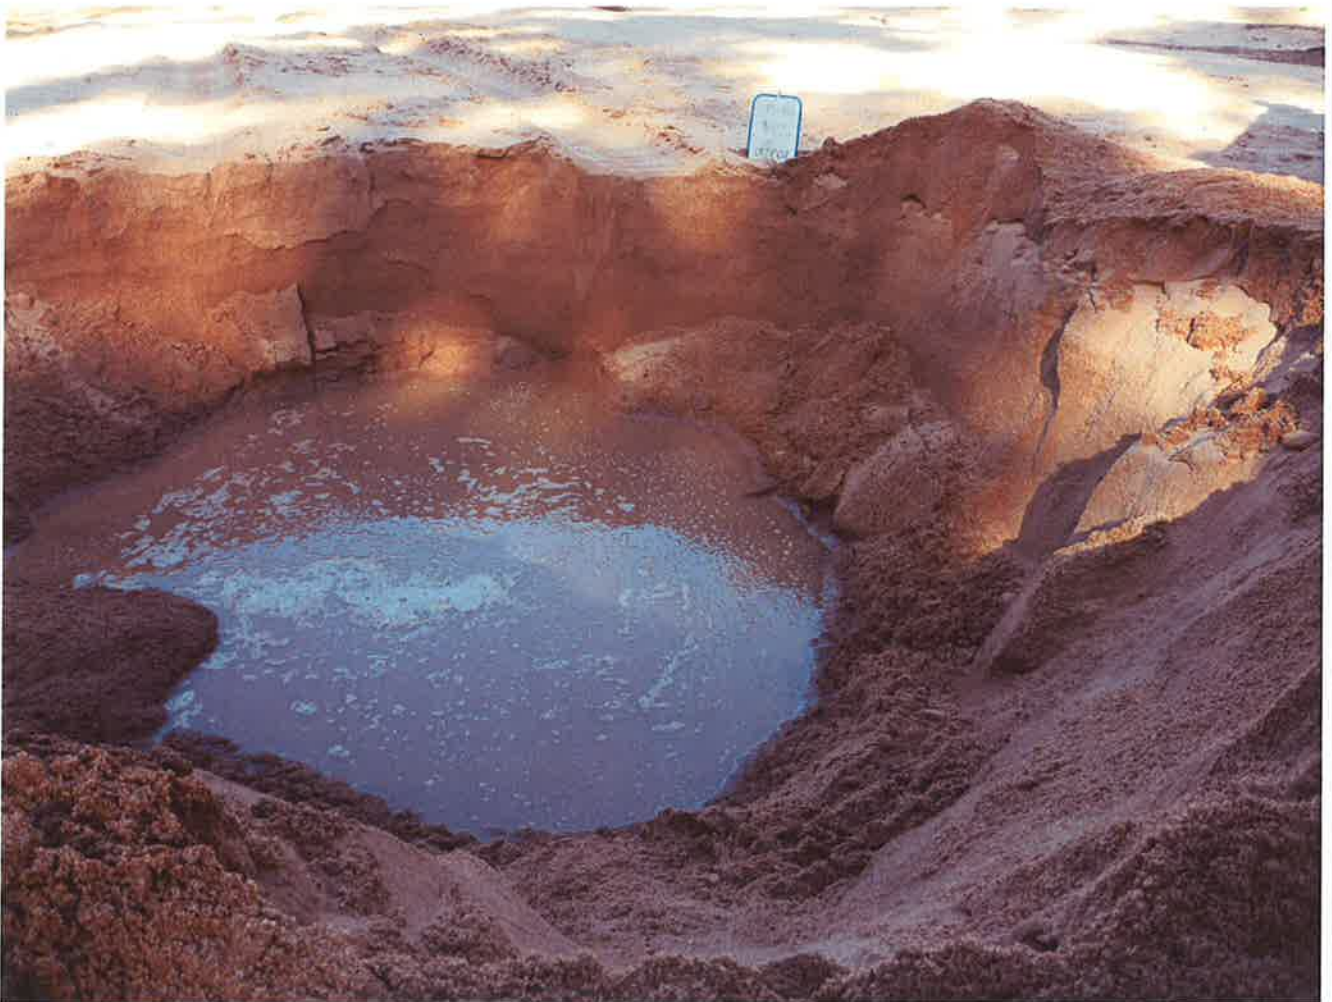
DEPTH RANGE: 0.00 – 1.90m  
MACHINE: Backhoe  
CONTRACTOR: T&M  
LOGGED: ACF DATE: 9/07/09  
CHECKED: AB DATE: 8/10/09

Excavation			Sampling			Field Material Description													
METHOD	EXCAVATION RESISTANCE	WATER	DEPTH (metres)	DEPTH RL	SAMPLE OR FIELD TEST	RECOVERED	GRAPHIC LOG	USC Symbol	SOIL / ROCK MATERIAL DESCRIPTION	MOISTURE	CONSISTENCY	DENSITY	DCP TEST (AS1289.6.3.2) Blows per 100 mm						
													0	5	10	15	20	25	
BH	L	M	0.0	0.10	DS 0.00-0.10m			SP	SAND Medium to coarse, pale brown and pale grey . becoming moist, some fine angular gravel	D									
			0.5		DS 0.80-0.90m			M											
			1.0	1.20					. becoming wet	VL									
			1.5							W									
			1.90						TEST PIT DISCONTINUED @ 1.90 m Test pit discontinued due to caving. Sidewalls caving below 1.1m. Backfilled on completion.										
			2.0																
			2.5																
			3.0																
			3.5																
			4.0																
			4.5																
			5.0

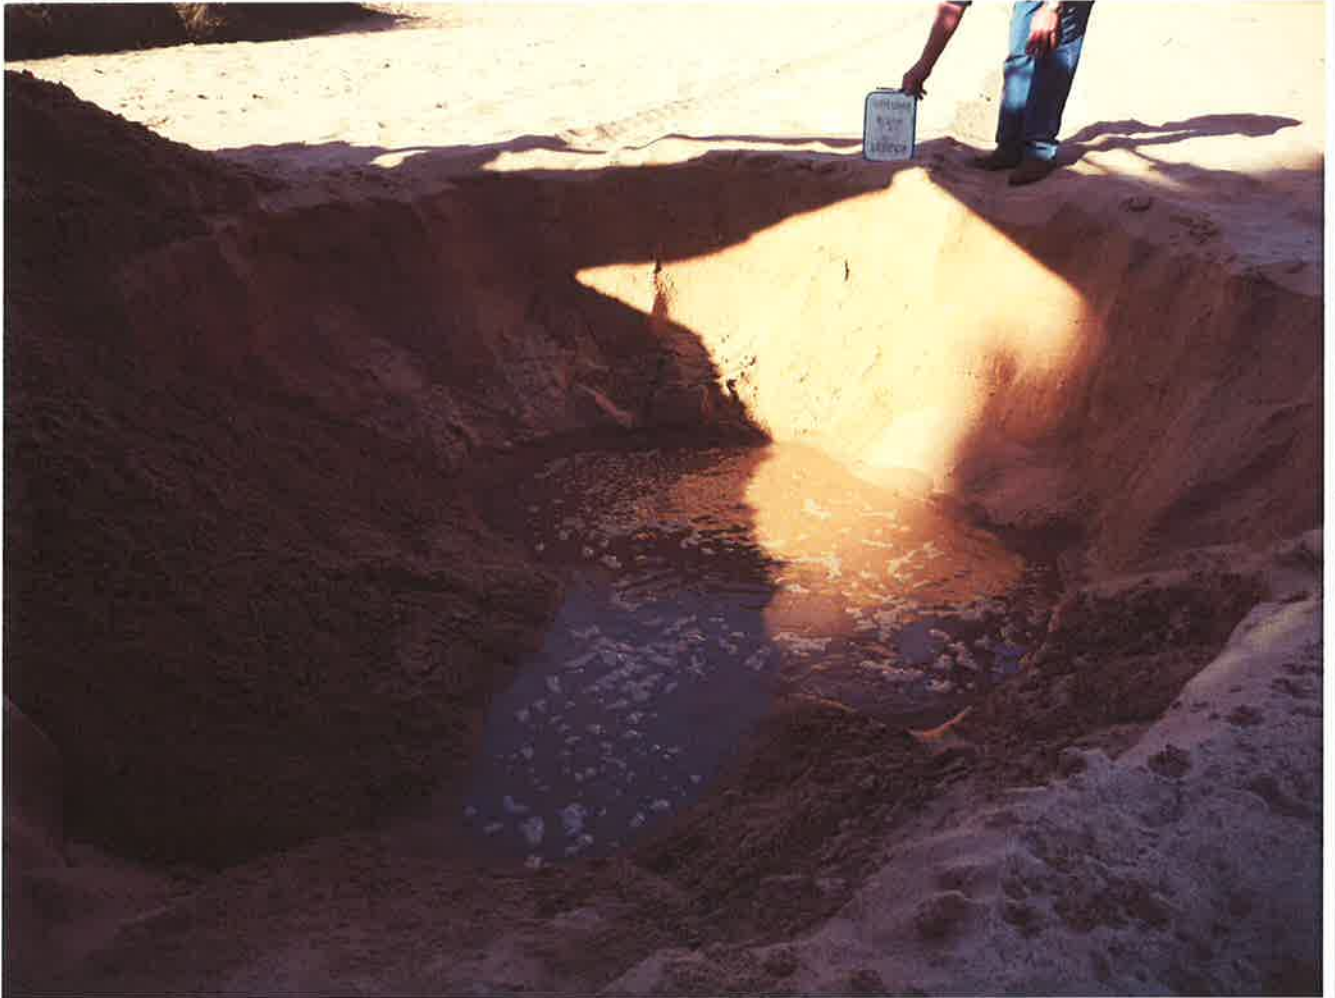
DEPTH RANGE: 0.00 – 2.10m  
MACHINE: Backhoe  
CONTRACTOR: T&M  
LOGGED: ACF DATE: 9/07/09  
CHECKED: AB DATE: 8/10/09

Excavation			Sampling			Field Material Description											
METHOD	EXCAVATION RESISTANCE	WATER	DEPTH (metres)	DEPTH RL	SAMPLE OR FIELD TEST	RECOVERED GRAPHIC LOG	USC Symbol	SOIL / ROCK MATERIAL DESCRIPTION	MOISTURE	CONSISTENCY	DENSITY	DCP TEST (AS1289.6.3.2) Blows per 100 mm					
												0	5	10	15	20	25
BH	L	M	0.0	0.10	DS 0.00-0.10m		SP	SAND Medium to coarse, pale grey and pale brown, trace fine angular gravel becoming moist	D	M	VL

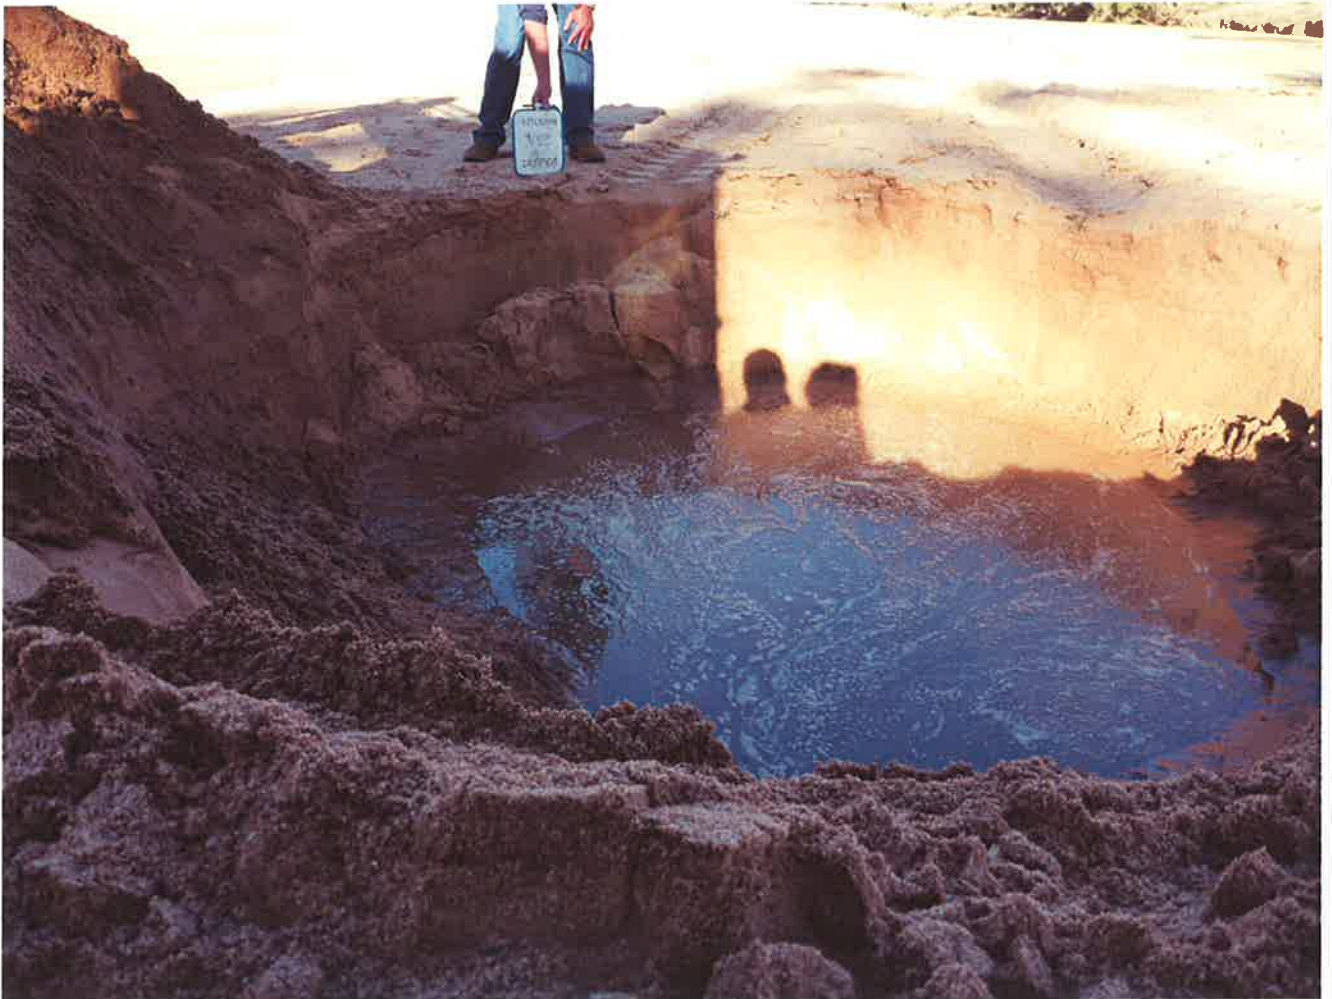
DEPTH RANGE: 0.00 – 2.10m  
MACHINE: Backhoe  
CONTRACTOR: T&M  
LOGGED: ACF DATE: 9/07/09  
CHECKED: AB DATE: 8/10/09

Excavation			Sampling		Field Material Description														
METHOD	EXCAVATION RESISTANCE	WATER	DEPTH (metres)	DEPTH RL	SAMPLE OR FIELD TEST	RECOVERED GRAPHIC LOG	USC Symbol	SOIL / ROCK MATERIAL DESCRIPTION	MOISTURE	CONSISTENCY	DENSITY	DCP TEST (AS1289.6.3.2) Blows per 100 mm							
												0	5	10	15	20	25		
BH	L	M	0.0	0.10	DS 0.00-0.10m		SP	SAND Medium to coarse, pale grey and pale brown, trace fine angular gravel becoming moist											
			0.5	0.60				becoming wet, some fine to medium angular gravel											
			1.0		DS 1.30-1.40m														
			1.5																
			2.0	2.10															
			2.5					TEST PIT DISCONTINUED @ 2.10 m Test pit discontinued due to caving. Sidewalls caving below 0.5m. Backfilled on completion.											
			3.0																
			3.5																
			4.0																
			4.5																
			5.0

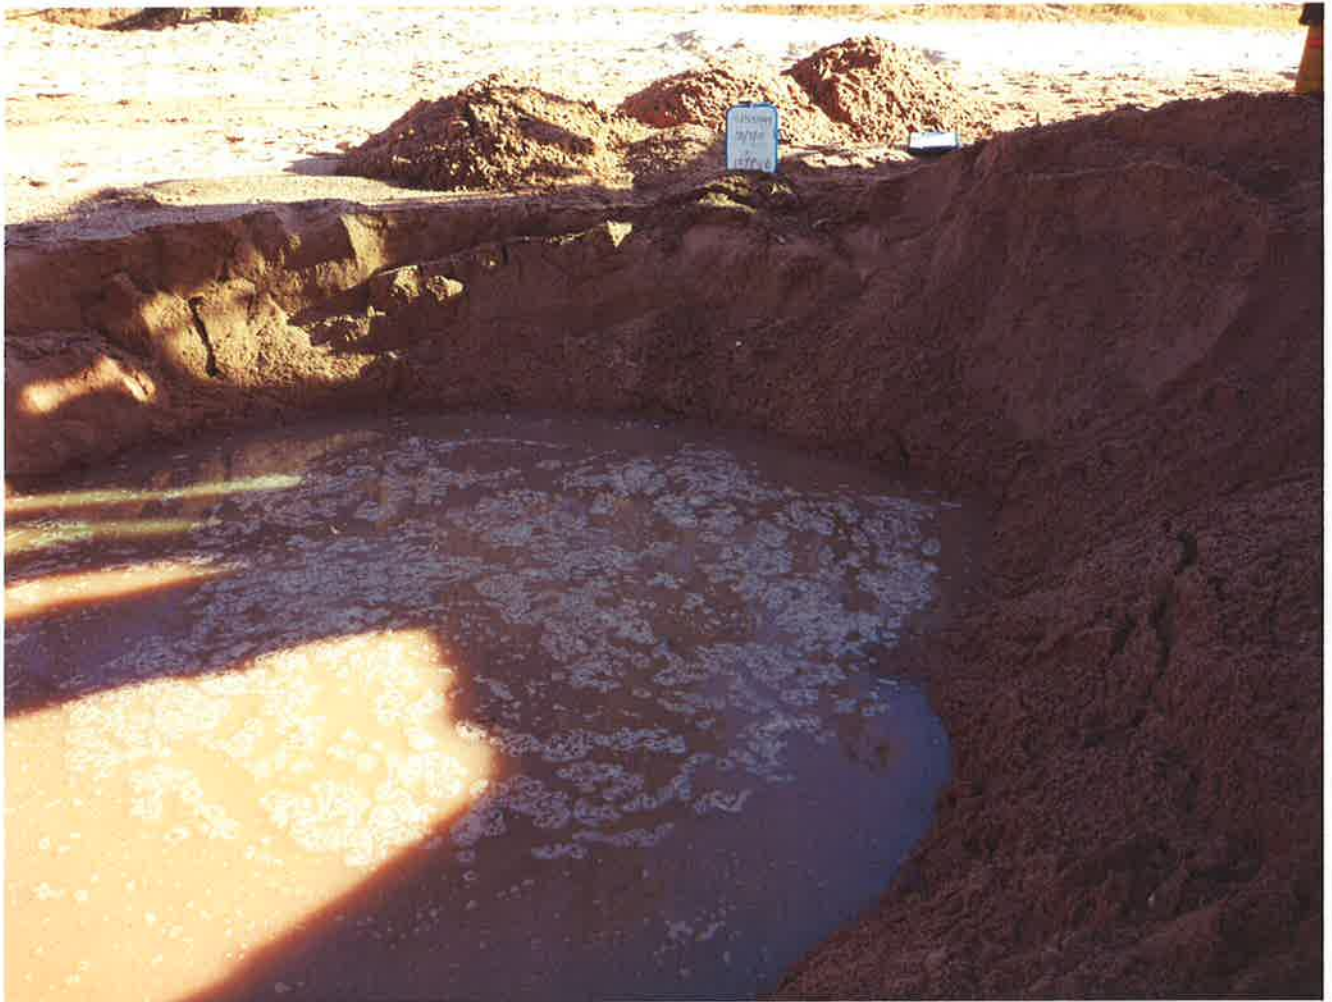
DEPTH RANGE: 0.00 – 2.10m  
MACHINE: Backhoe  
CONTRACTOR: T&M  
LOGGED: ACF DATE: 10/07/09  
CHECKED: AB DATE: 8/10/09

Excavation			Sampling		Field Material Description						
METHOD	EXCAVATION RESISTANCE	WATER	DEPTH (metres)	DEPTH RL	SAMPLE OR FIELD TEST	RECOVERED GRAPHIC LOG	USC Symbol	SOIL / ROCK MATERIAL DESCRIPTION	MOISTURE CONSISTENCY DENSITY	DCP TEST (AS1289.6.3.2) Blows per 100 mm	
										0 5 10 15 20 25	
BH	L	M	0.0	0.10	DS 0.00-0.10m	[Yellow dotted pattern]	SP	SAND Medium to coarse, pale grey and pale brown, trace fine angular gravel becoming moist	D		
			0.5								
			0.90				SP	Gravelly SAND (95%) and COBBLES (5%) Gravelly SAND: medium to coarse, pale grey and pale brown, fine gravel COBBLES: rounded and subangular	VL		
			2.0	2.10	DS 1.90-2.00m				W		
			2.5					TEST PIT DISCONTINUED @ 2.10 m Test pit discontinued due to caving. Sidewalls caving below 0.8m. Backfilled on completion.			15/50mm
			3.0								
			3.5								
			4.0								
			4.5								
			5.0

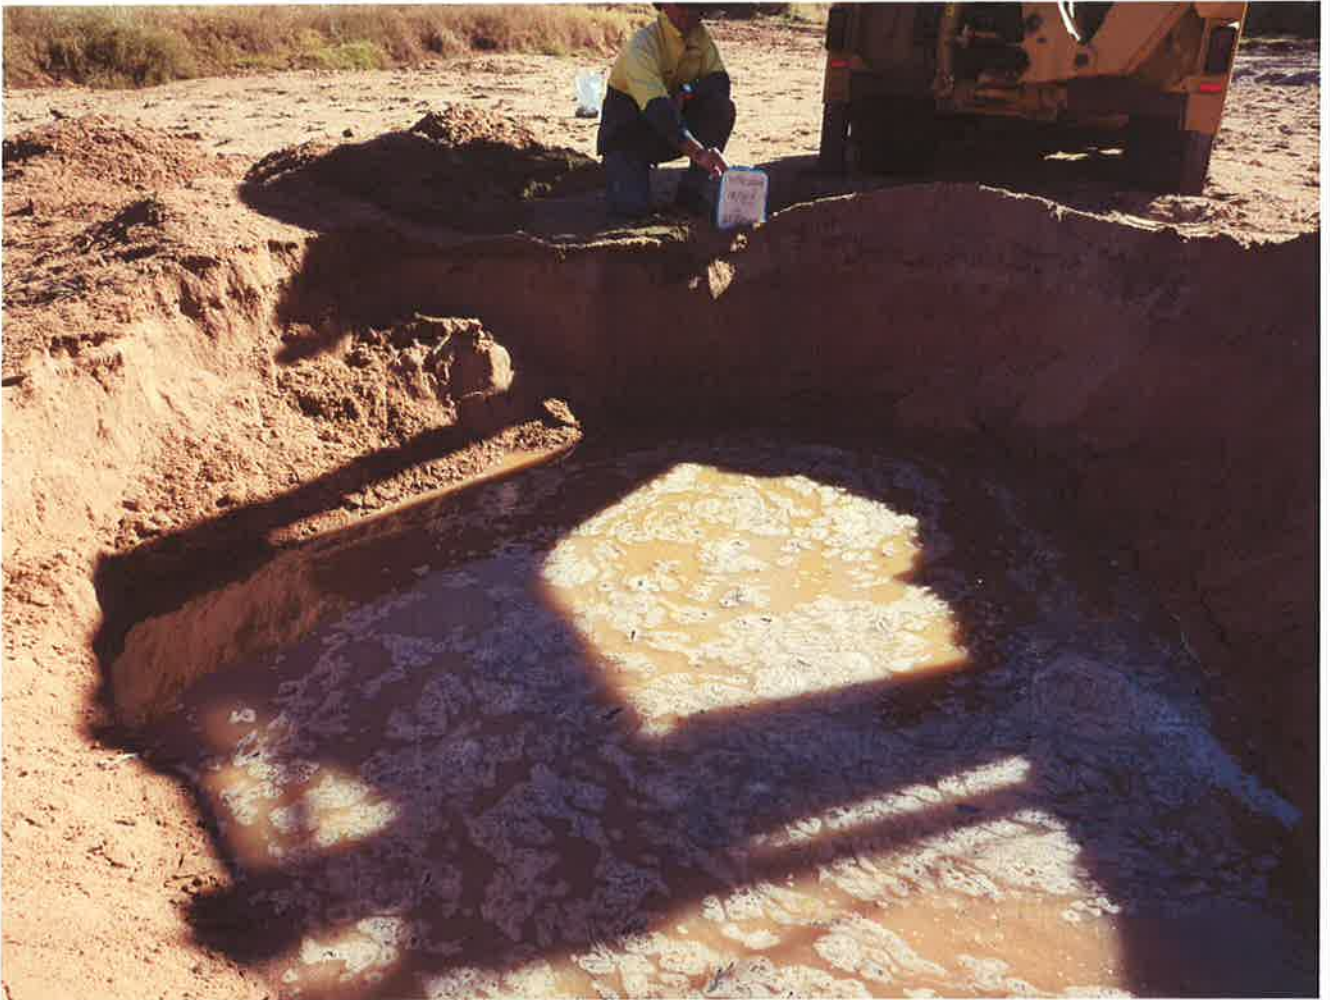
DEPTH RANGE: 0.00 – 2.00m  
MACHINE: Backhoe  
CONTRACTOR: T&M  
LOGGED: ACF DATE: 10/07/09  
CHECKED: AB DATE: 8/10/09

Excavation		Sampling		Field Material Description																
METHOD	EXCAVATION RESISTANCE	WATER	DEPTH (metres)	DEPTH RL	SAMPLE OR FIELD TEST	RECOVERED GRAPHIC LOG	USC Symbol	SOIL / ROCK MATERIAL DESCRIPTION	MOISTURE	CONSISTENCY	DCP TEST (AS1289.6.3.2) Blows per 100 mm									
											0	5	10	15	20	25				
BH M	10/07/09		0.0	0.10	DS 0.00-0.10m		SP	SAND Medium to coarse, pale grey and pale brown, trace fine to medium angular gravel becoming moist, cobbles to 0.11m (~5%)	D

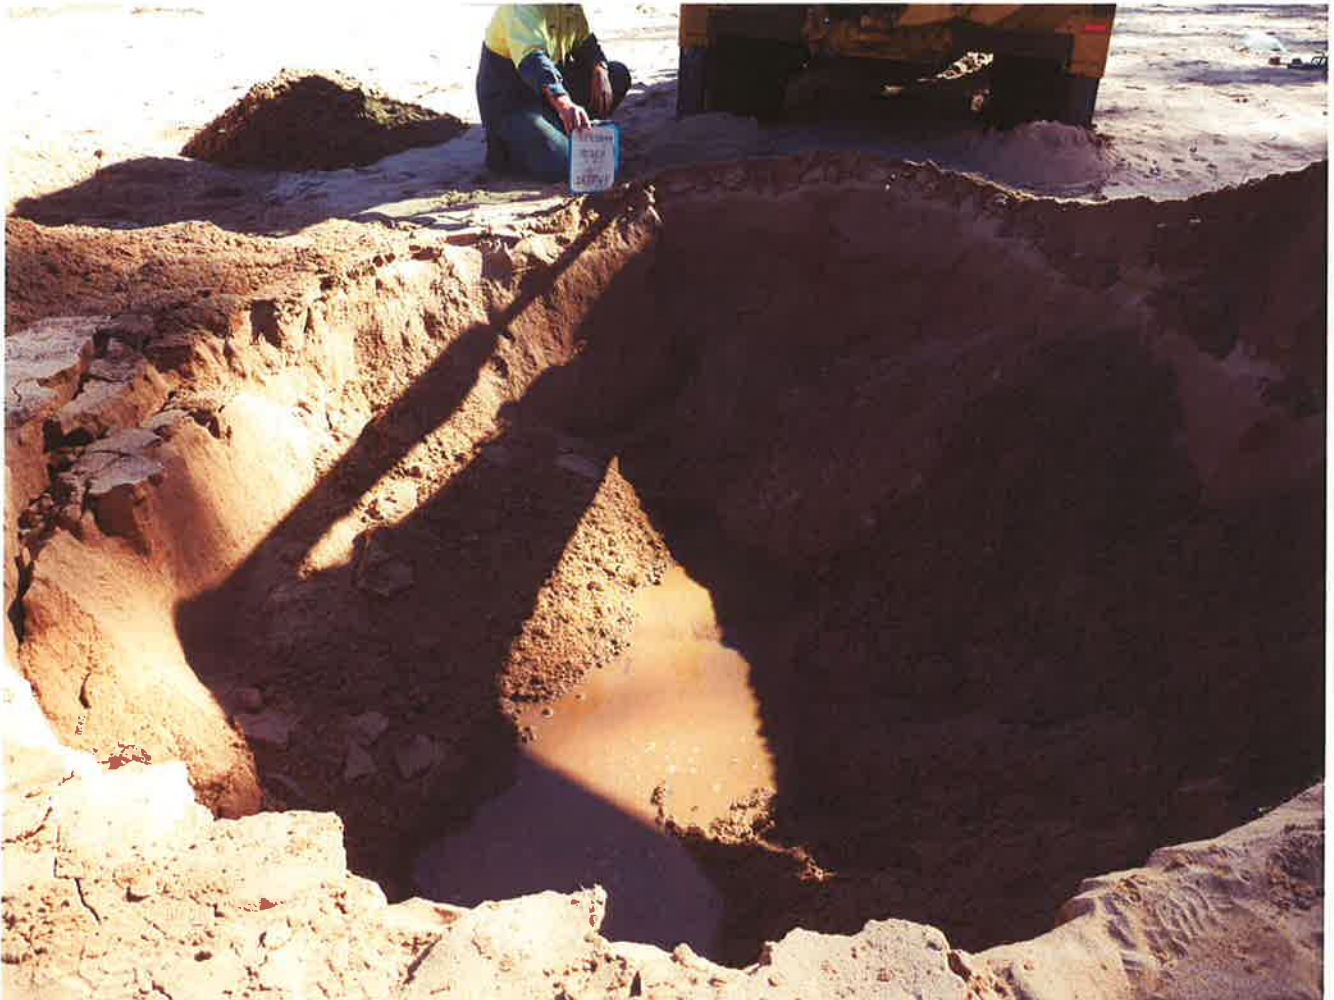
DEPTH RANGE: 0.00 – 2.10m  
MACHINE: Backhoe  
CONTRACTOR: T&M  
LOGGED: ACF DATE: 10/7/09  
CHECKED: AB DATE: 8/10/09

Excavation			Sampling		Field Material Description														
METHOD	EXCAVATION RESISTANCE	WATER	DEPTH (metres)	DEPTH RL	SAMPLE OR FIELD TEST	RECOVERED GRAPHIC LOG	USC Symbol	SOIL / ROCK MATERIAL DESCRIPTION	MOISTURE	CONSISTENCY	DENSITY	DCP TEST (AS1289.6.3.2) Blows per 100 mm							
												0	5	10	15	20	25		
BH	L	1007/06	0.0	0.10	DS 0.00-0.10m	[Yellow dotted pattern]	SP	SAND Medium to coarse, pale grey and pale brown becoming moist	D

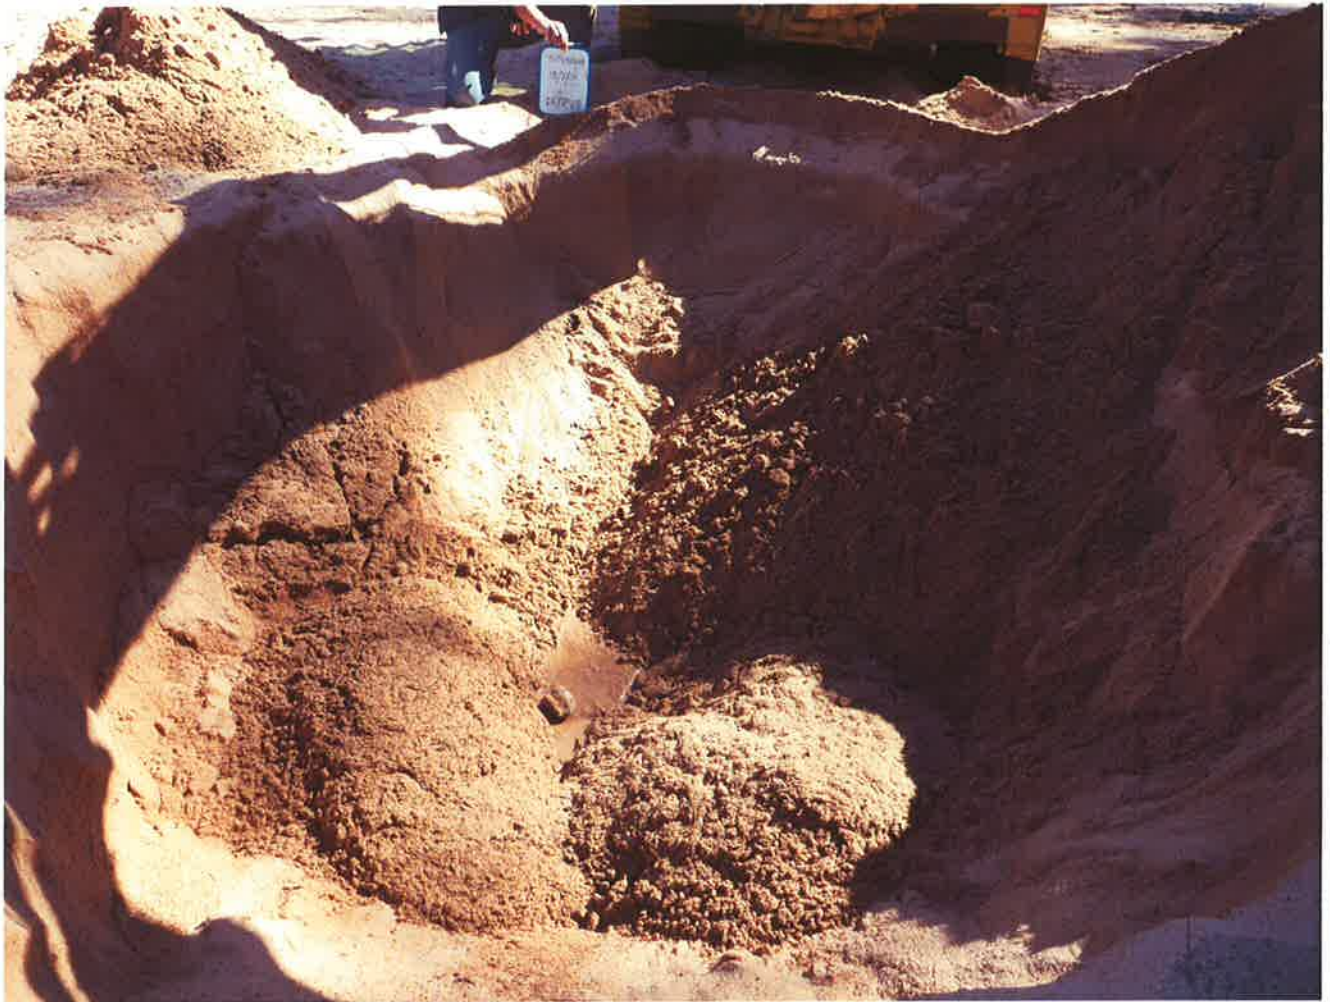
DEPTH RANGE: 0.00 – 2.10m  
MACHINE: Backhoe  
CONTRACTOR: T&M  
LOGGED: ACF DATE: 10/7/09  
CHECKED: AB DATE: 8/10/09

Excavation		Sampling		Field Material Description														
METHOD	EXCAVATION RESISTANCE	WATER	DEPTH (metres)	DEPTH RL	SAMPLE OR FIELD TEST	RECOVERED GRAPHIC LOG	USC Symbol	SOIL / ROCK MATERIAL DESCRIPTION	MOISTURE	CONSISTENCY	DCP TEST (AS1289.6.3.2) Blows per 100 mm							
											0	5	10	15	20	25		
BH	L	M	0.0	0.10	DS 0.00-0.10m	[Yellow dotted pattern]	SP	SAND Medium to coarse, pale grey and pale brown, trace fine gravel becoming moist	D	M	VL	[DCP Test Data]	[DCP Test Data]	[DCP Test Data]	[DCP Test Data]	[DCP Test Data]	[DCP Test Data]

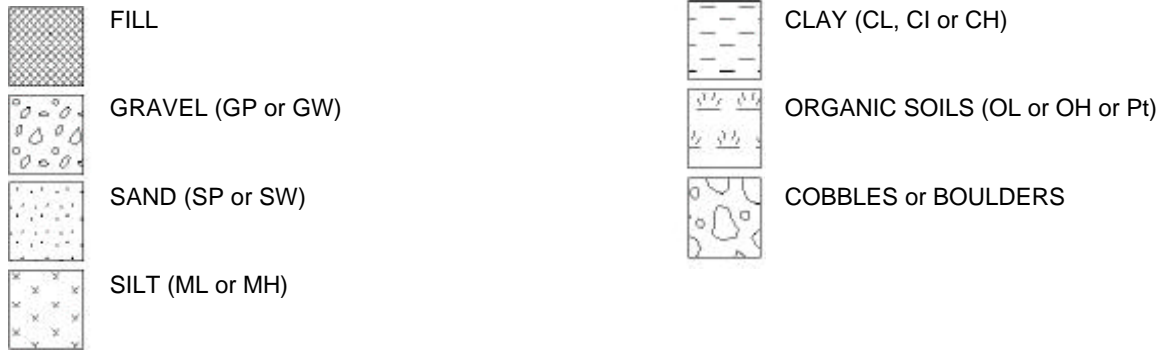
# METHOD OF SOIL DESCRIPTION USED ON BOREHOLE AND TEST PIT REPORTS

Combinations of these basic symbols may be used to indicate mixed materials such as sandy clay.
