INLAND
RAIL

Non-Indigenous Cultural Heritage Technical Report

HELIDON TO CALVERT ENVIRONMENTAL IMPACT STATEMENT

Document Number:
2-0001-330-EAP-10-RP-0218

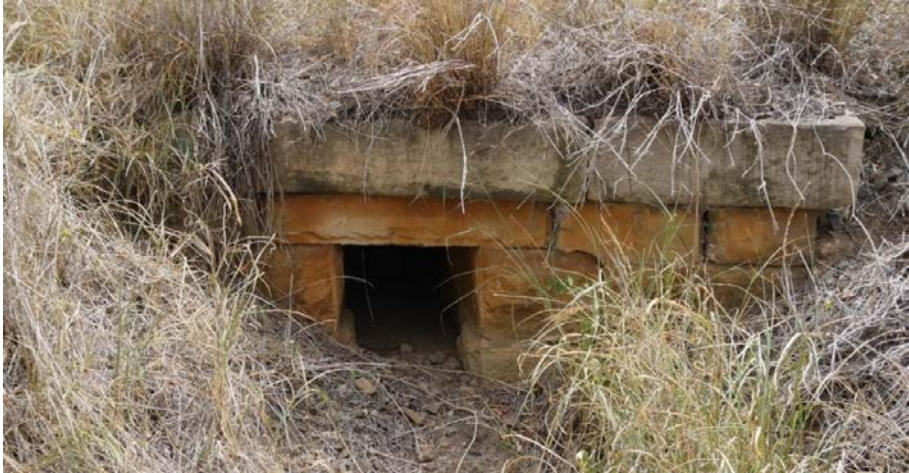
Photograph 6.1 Sandstone culvert (H2C-19-H01)

Key elements		
Culvert	Easting (GDA94 Z56)	Northing (GDA94 Z56)
The headwall of the culvert consists of four courses of dressed sandstone blocks, with the top course acting as a lintel, and measures approximately 1 m x 2 m. The culvert itself is two courses high and the opening measures approximately 0.6 m x 0.6 m.	411818mE	6953854mN

Most culverts from this period are believed to have been removed during the 1920s regrading works (Buchanan Architects 2002). The QR Heritage Study (Buchanan Architects 2002) notes some other remaining sandstone culverts further along the line to the west, but does not include that at H2C-19-H01, suggesting that it has not previously been identified.

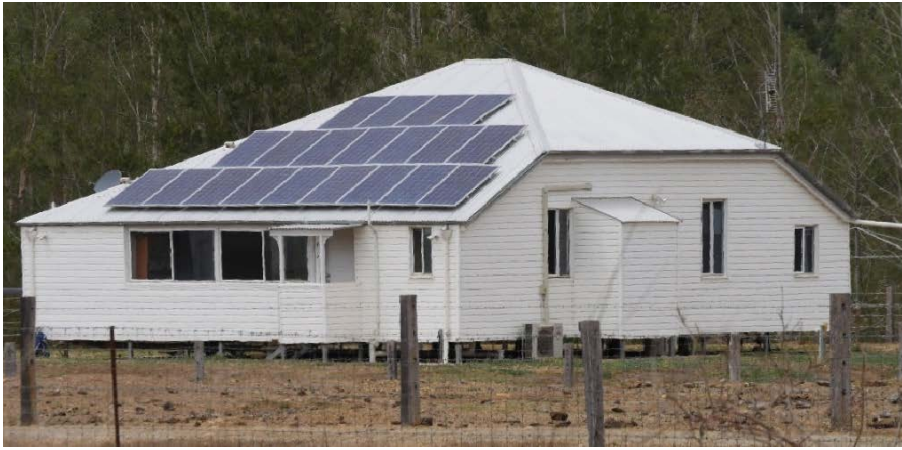
Photograph 6.2 House (H2C-19-H02)

Key elements		
House	Easting (GDA94 Z56)	Northing (GDA94 Z56)
The house is a weatherboard-clad early 20 th century bungalow with an L-shaped verandah (Rechner 1998). The corrugated iron hipped roof is gabled on the western façade and extends over an enclosed verandah on the northern and eastern sides. A stove alcove projects from the western façade. The roof cladding and all visible windows appear to be new.	419333mE	6952275mN

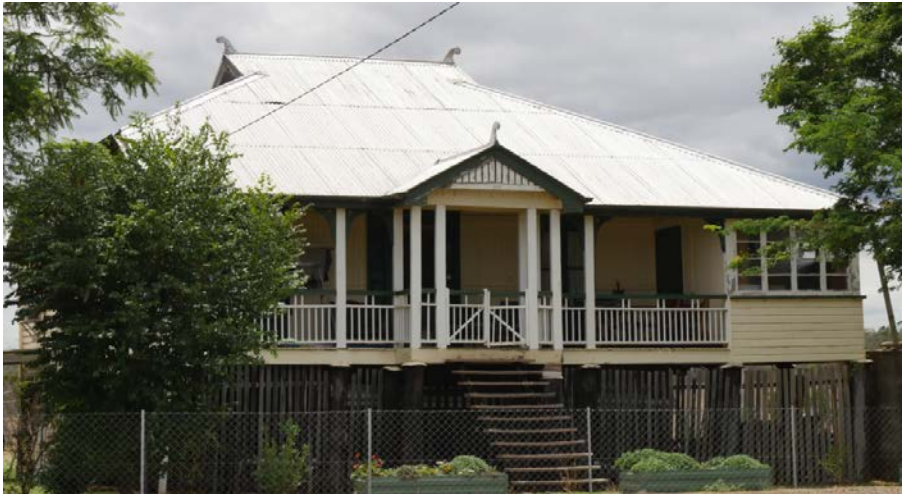
Photograph 6.3 House (H2C-19-H03)

Description		
Location of structures shown on 1933 aerial photograph. Comprises a house and old timber shed on Smithfield Road (Lot 29/CA314), Gatton. The site could not be accessed but was visually inspected from a nearby public area.		
Listings		
None		
Current imagery	Historical imagery (1933 MAP20902746)	
Key elements		
House	Easting (GDA94 Z56)	Northing (GDA94 Z56)
The house is a weatherboard-clad early 20 th century bungalow with an L-shaped verandah (Rechner 1998), and features a corrugated iron, gabled hipped roof. The entrance is marked by a pediment with a screened gable, and the ridge and gable ends are decorated with scroll finials. The interior verandah wall is single skinned, with exposed stud work, and the majority of windows appear to be original two-paned sashes, with original convex tin sunhoods remaining on the western façade. A portion of the front and side verandahs have been enclosed and feature mid-20 th century casement windows.	427853mE	6952736mN

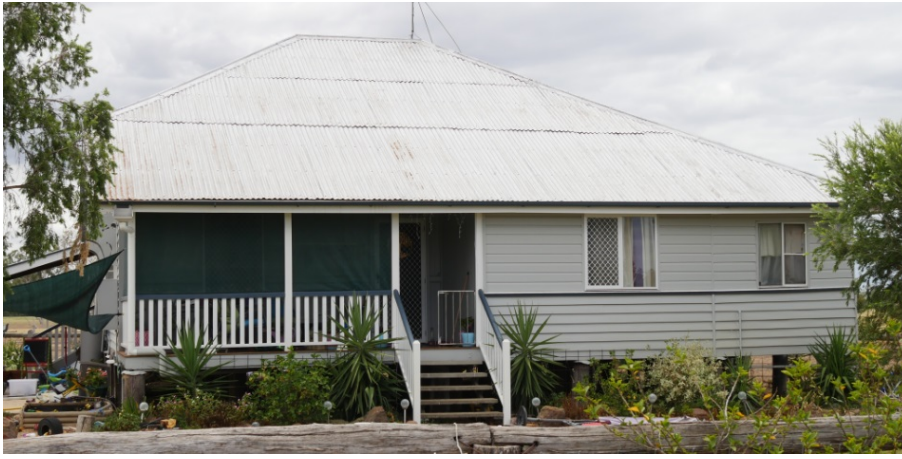
Photograph 6.4 House (H2C-19-H04)

Description		
<p>Location of structures shown on 1933 aerial photograph. Comprises a house and a large corrugated iron shed at the corner of Smithfield Road and Raymont Road (Lot 30/CA314), Gatton. The site could not be accessed but was visually inspected from a nearby public area.</p>		
Listings		
None		
Current imagery	Historical imagery (1933 MAP20902746)	
Key elements		
House	Easting (GDA94 Z56)	Northing (GDA94 Z56)
<p>The house is a weatherboard clad early 20th century bungalow with an L-shaped verandah (Rechner 1998). The corrugated iron, short ridge hipped roof is gabled on the western façade and extends over a chamferboard enclosed verandah on the southern and eastern sides. The interior verandah wall is single skinned, with exposed stud work, and the majority of windows appear to be original two paned sashes, with original convex tin sunhoods remaining on the western façade. A portion of the front and side verandah has been enclosed and features late-20th century sliding windows.</p>	428224mE	6954252mN

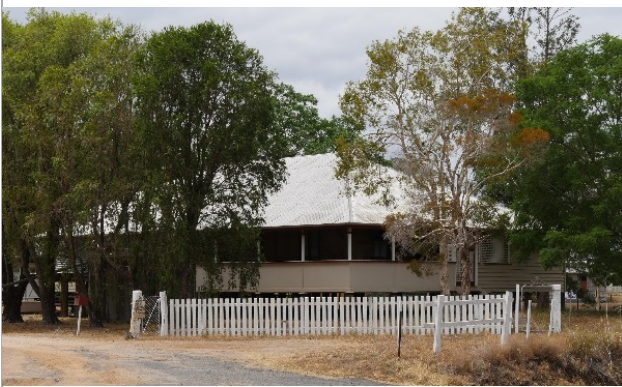
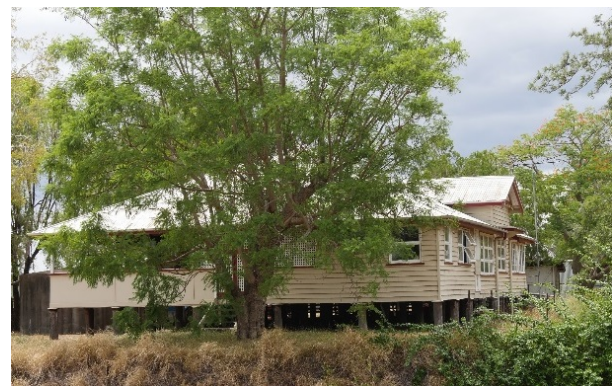
Photograph 6.5 House (H2C-19-H05)

Description		
<p>Location of structures shown on 1933 aerial photograph. Comprises a house and a number of outbuildings on a high bank overlooking Lockyer Creek at the intersection of Smithfield Road and Burgess Road (Lot 34/CA314), Gatton. The site could not be accessed but was visually inspected from a nearby public area.</p>		
Listings		
None		
Current imagery	Historical imagery (1933 MAP209010475)	
Key elements		
House	Easting (GDA94 Z56)	Northing (GDA94 Z56)
<p>The house is a weatherboard clad early 20th century bungalow (Rechner 1998), with a corrugated iron, long ridge hipped roof. The encircling verandah has been enclosed on the eastern and southern sides, and a half-timbered gable added to the centre of the southern elevation, likely during the inter-war period. Windows on the enclosed verandah are a mixture of early 20th century casements, and late-20th century awnings.</p> <p>The interior verandah wall is single skinned, with exposed stud work, and the majority of windows appear to be original two paned sashes and French doors.</p>	446962mE	6939765mN

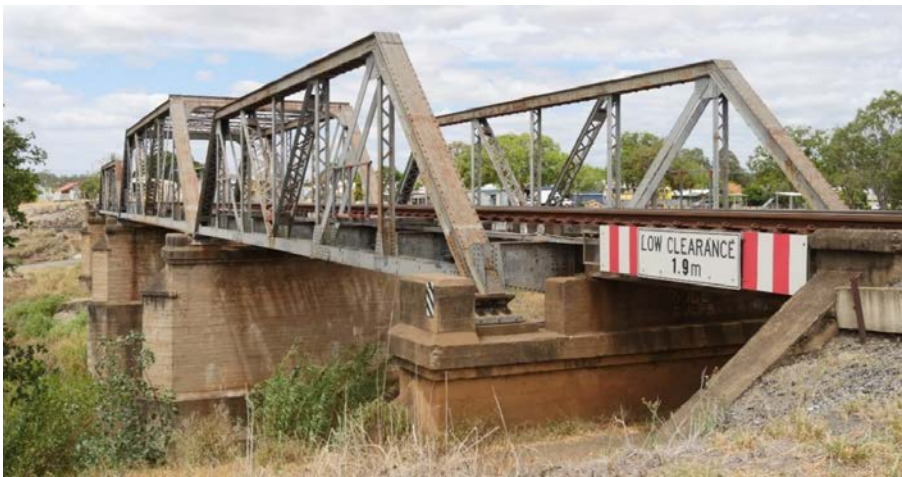
Photograph 6.6 Lockyer Creek Bridge (H2C-19-H06)

Description		
An early 20 th century truss rail bridge on the Main Line, spanning Lockyer Creek on the western side of Gatton. The site could not be accessed but was visually inspected from a nearby public area.		
Listings		
QR Heritage Asset Register (non-statutory)		
Current imagery	Historical imagery (1933 MAP209010475)	
Key elements		
Bridge	Easting (GDA94 Z56)	Northing (GDA94 Z56)
<p>The Gatton to Helidon section of the Main Line was completed in 1866, and included a timber bridge over the Lockyer Creek, which ran just west of the Gatton Railway Station. By the end of the 19th century, however, the timber structure was no longer sufficient to meet demands for heavier loads and larger, more powerful locomotives. As a part of an extensive series of upgrades, the original bridge was replaced by the current steel and concrete structure (Kerr 1966: Vol 2).</p> <p>The bridge is a Pratt 4-panel riveted steel truss structure with concrete piers and abutments, and a single straight double track. It is described as a ‘through and half through’ design, meaning that the girders in some sections are high enough for cross bracing (the ‘through’), and other sections are not (the ‘half through’) (Buchanan Architects 2002; DES 2016b). It is understood to be the oldest remaining bridge of its type on the Main Line, and possibly more widely on the QR network, and is recommended for conservation in the QR Heritage Study (Buchanan Architects 2002).</p>	428468mE	6952134mN

Criterion	Assessment	Threshold
A – historical	The Lockyer Creek Bridge is important in demonstrating the evolution of the railway network in QLD. Constructed in 1909 to replace the original timber structure, the Lockyer Creek Bridge was part of a program to upgrade the 1860s Main Line for heavier freight and larger locomotives. As such, it is understood to be one of the oldest remaining bridges of its type – a Pratt truss – on the Main Line, and potentially the QR network as a whole.	<input type="checkbox"/> Not met <input checked="" type="checkbox"/> Local <input type="checkbox"/> State
B – rarity	The design of the bridge – a through and half through Pratt truss – appears to be unusual, but there is insufficient information about bridges on the QR network to determine its rarity.	<input checked="" type="checkbox"/> Not met <input type="checkbox"/> Local <input type="checkbox"/> State
C – research	The bridge is considered unlikely to contribute new or important information.	<input checked="" type="checkbox"/> Not met <input type="checkbox"/> Local <input type="checkbox"/> State

D – representativeness	Not enough information is available about the condition of the bridge or of other examples on the QR network to determine representativeness.	<input checked="" type="checkbox"/> Not met <input type="checkbox"/> Local <input type="checkbox"/> State
E – aesthetic	The bridge occupies a prominent location on the north western side of the Gatton CBD and, along with adjacent Gatton Railway Station, creates a significant historical railway landscape.	<input type="checkbox"/> Not met <input checked="" type="checkbox"/> Local <input type="checkbox"/> State
F – creative/technical	The bridge has no known creative or technical values.	<input checked="" type="checkbox"/> Not met <input type="checkbox"/> Local <input type="checkbox"/> State
G – social	The bridge has no known social significance.	<input checked="" type="checkbox"/> Not met <input type="checkbox"/> Local <input type="checkbox"/> State

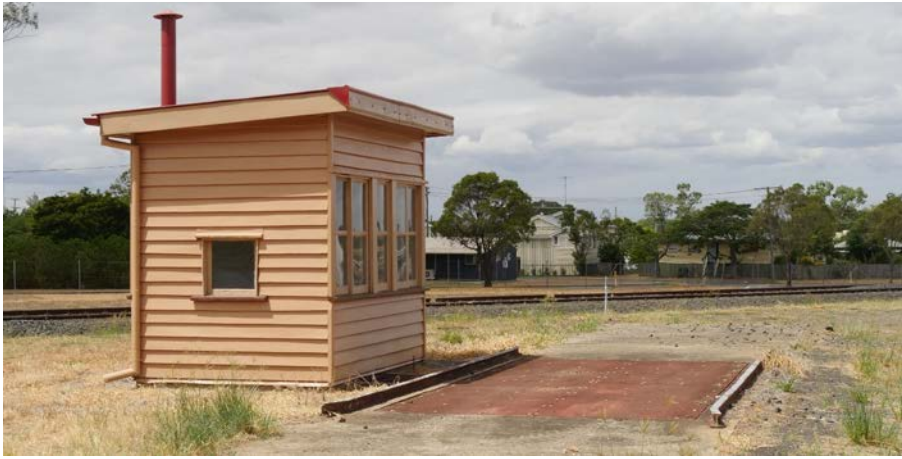
Photograph 6.7 Weighbridge (H2C-19-H07)

Description		
<p>The Gatton Railway Station opened in 1866 as a part of the Main Line and is located on Lots 381 and 382 SP121744. The present station buildings date to the 20th century, and include a passenger station, platform shelter, footbridge and weighbridge (Buchanan Architects 2002).</p>		
Listings		
<p>QR Heritage Asset Register (non-statutory) LVRC LHR (excluding weighbridge)</p>		
Current imagery	Historical imagery (1933 MAP209010475)	
Key elements		
Weighbridge	Easting (GDA94 Z56)	Northing (GDA94 Z56)
<p>The weighbridge is believed to date to the mid-20th century and consists of a standard 21 tonne capacity cart weighbridge and a small timber weatherboard structure with a skillion roof and sliding timber windows. The building was found to be of significance in the QR heritage study, and was recommended for conservation (Buchanan Architects 2002).</p>	428719mE	6951881mN

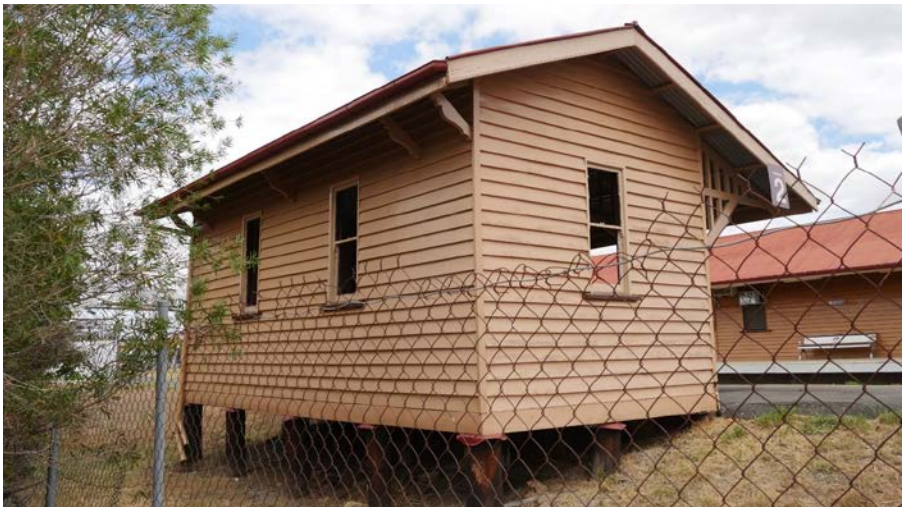
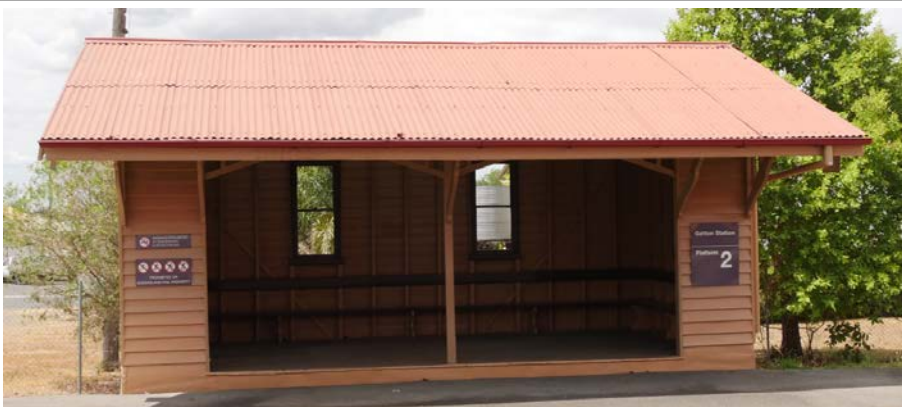
Platform shelter	Easting (GDA94 Z56)	Northing (GDA94 Z56)
<p>The timber platform shelter is believed to have been built c.1914 (Buchanan Architects 2002), and measures approximately 7 m x 8 m. The structure is clad in weatherboards with a corrugated iron gabled roof which extends on the platform side to provide shelter to waiting passengers. This front awning is supported on ladder frame brackets with rare decorative struts (refer also H2C-19-H35). The shape of these struts is replicated on the eaves brackets at the rear of the building. The narrow, single pane sash windows are unglazed, but the interior of the shelter retains its original timber benches. The building was found to be of significance in the QR heritage study and was recommended for conservation (Buchanan Architects 2002).</p>	428677mE	6951966mN

Photograph 6.8 Platform shelter (rear) (H2C-19-H07)

Photograph 6.9 Platform shelter (front) (H2C-19-H07)

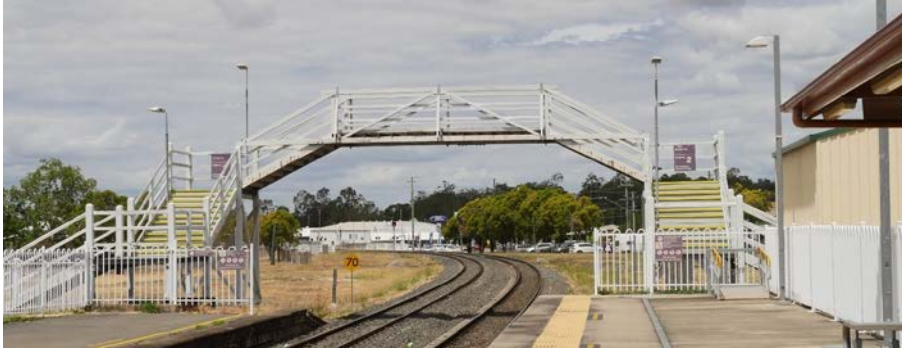
Photograph 6.10 Footbridge (H2C-19-H07)

Footbridge	Easting (GDA94 Z56)	Northing (GDA94 Z56)
<p>The footbridge is also believed to have been constructed c.1914 and consists of a standard timber frame overhead bridge with bituminous felt laid over the timber treads, deck and landings. It is understood to be the only example of its type remaining unaltered on the Main Line and was recommended for conservation in the QR heritage study (Buchanan Architects 2002).</p>	428706mE	6951925mN

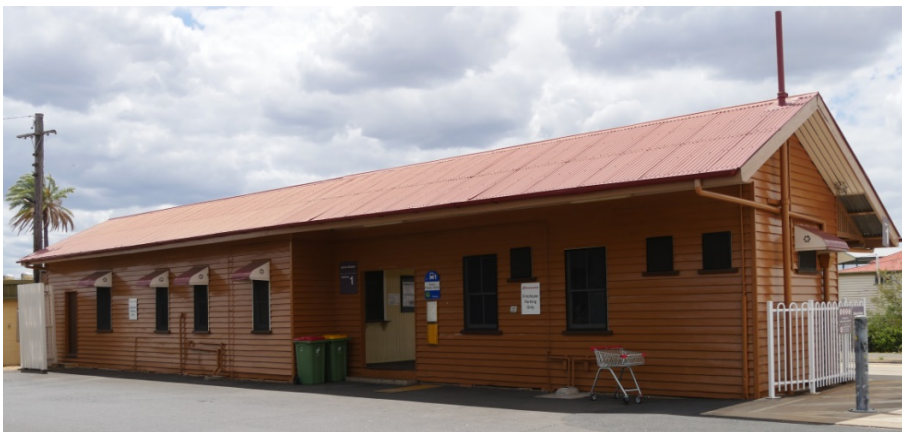
Photograph 6.11 Passenger station (front) (H2C-19-H07)

Passenger station	Easting (GDA94 Z56)	Northing (GDA94 Z56)
<p>The passenger station is also thought to date to 1914, although there is some potential for elements of an earlier, 1899 building to be retained within the later structure (Buchanan Architects 2002). The station building is of standard design with a station master's office, parcel shed, open waiting area, store and toilets. The timber structure is clad in weatherboards and features a corrugated iron gable roof which, like the platform shelter, extends on the platform side to create an awning. The awning is supported by ladder brackets with plain struts rather than the decorative examples found on the platform shelter. Windows appear to be original two pane sash, and original tin bullnose sunhoods remain on the eastern and southern elevations. External doors are original four panel timber, and a number of other original timber elements remain, such as benches. The building was found to be of significance in the QR heritage study and was recommended for conservation (Buchanan Architects 2002).</p>	428670mE	6951937mN

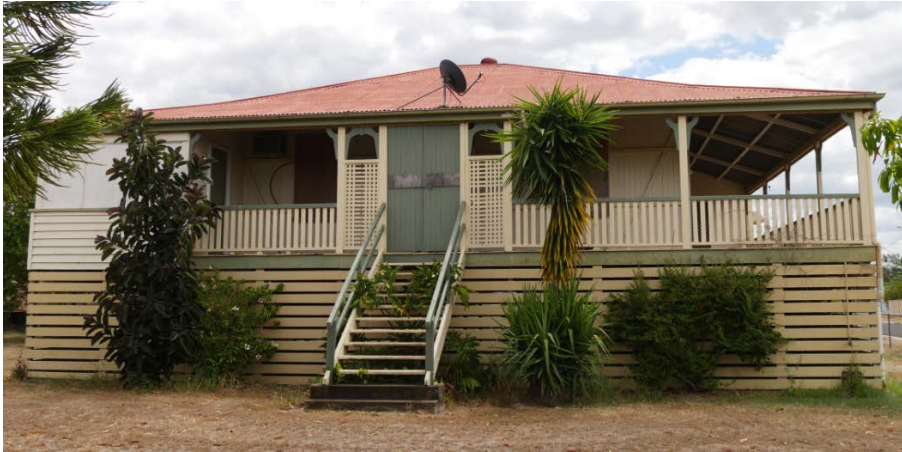
Photograph 6.14 Gatton Station Master's Residence (H2C-19-H08)

Key elements		
House	Easting (GDA94 Z56)	Northing (GDA94 Z56)
<p>Timber, weatherboard clad bungalow with corrugated iron broken-back hipped roof and a verandah on three sides. The verandah features decorative, art nouveau style brackets, and the interior wall is single skinned, with exposed stud work. The verandah has been enclosed on the southern side. Visible windows are a mixture of modern sliding aluminium and timber casements.</p> <p>The house appears to be of the same design as the now-demolished 1915 Grandchester Station Master's Residence and is assumed to date to a similar period (Buchanan Architects 2002).</p>	428703mE	6951966mN

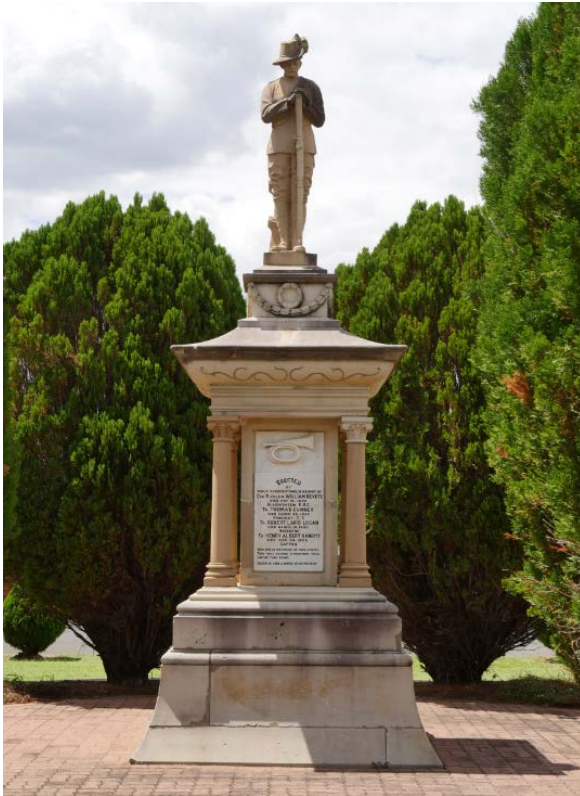
Photograph 6.15 Boer War Memorial (H2C-19-H09)

Key elements		
Memorial	Easting (GDA94 Z56)	Northing (GDA94 Z56)
Memorial is located on a paved mall with low brick garden beds and plantings of various species of cypress (<i>Cupressus sp.</i>) on either side. The memorial itself consists of a Helidon sandstone plinth surmounted by a 'digger' statue, with marble plaques on each side.	428651mE	6951914mN

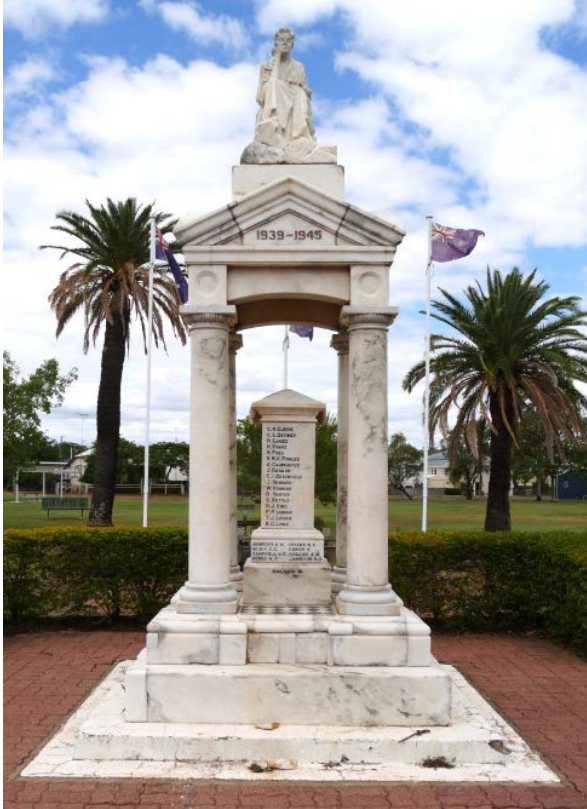
Photograph 6.16 Weeping Mother Memorial (H2C-19-H10)

Key elements		
Memorial	Easting (GDA94 Z56)	Northing (GDA94 Z56)
The memorial is located on a paved mall with a low hedge to the rear. Memorials to a number of other conflicts have been placed around the mall. The memorial itself is constructed from marble and includes a low plinth and a four-columned mausoleum structure surmounted by a statue of a woman.	428789mE	6951999mN

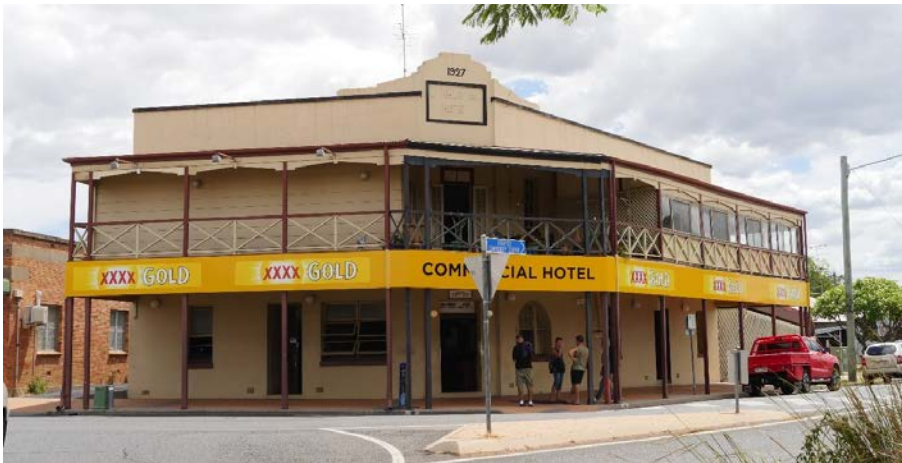
Photograph 6.17 Commercial Hotel (H2C-19-H11)

Key elements		
Hotel	Easting (GDA94 Z56)	Northing (GDA94 Z56)
Two-storey brick building with a simple, art deco style parapet wall bearing the name and establishment date of the hotel. The hotel is surrounded by a skillion-roofed verandah on three sides, one of which has been partly enclosed, and the interior verandah wall features original six-paned sash windows and French doors. The lower storey retains several original sash windows, as well as a bank of later awning windows.	428651mE	6951869mN

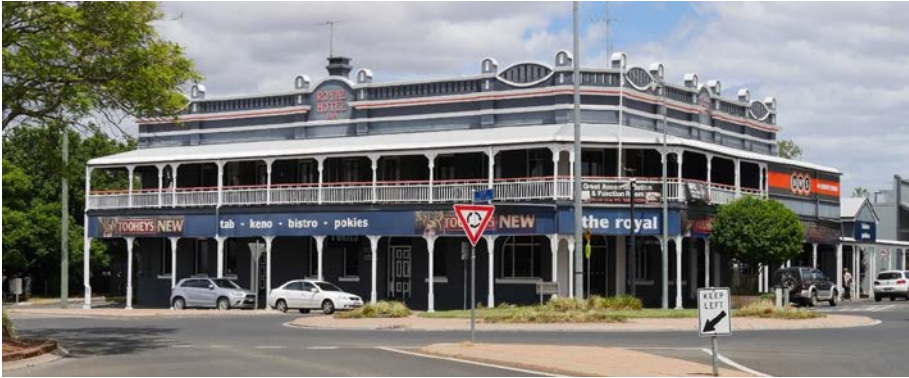
<p>Photograph 6.18 Royal Hotel (H2C-19-H12)</p>

Key elements		
Hotel	Easting (GDA94 Z56)	Northing (GDA94 Z56)
Two-storey brick building with a decorative parapet wall bearing the name and establishment date of the hotel. The hotel is surrounded by a skillion-roofed verandah on three sides, one of which has been partly enclosed, and the interior verandah wall appears to retain original sash windows and French doors. All of the glazing on the lower storey appears to be new, but original fenestration remains, including large, decorative arch windows and chamfered sills. The lower storey also retains original six-panel timber doors and fan lights.	428686mE	6951815mN

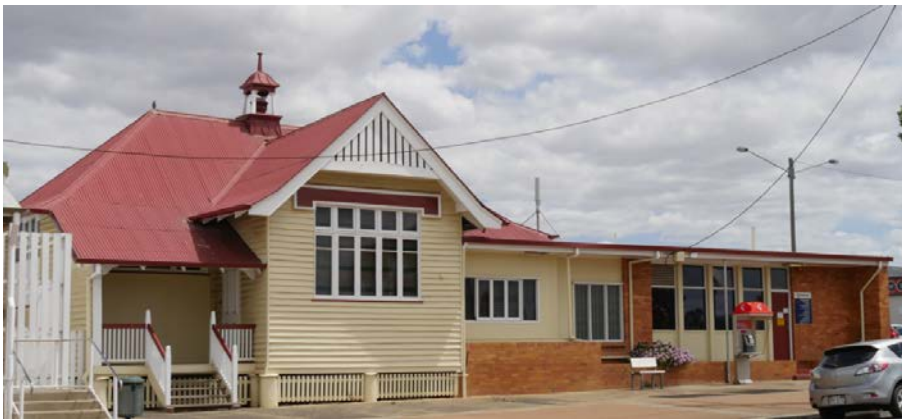
Photograph 6.19 Post and Telegraph Office (H2C-19-H13)

Key elements		
Post and Telegraph Office	Easting (GDA94 Z56)	Northing (GDA94 Z56)
<p>The first Gatton post office opened in 1865, before being relocated to the new Gatton Station with the opening of the Main Line in 1866. The Station Master continued to act as postmaster and telegraphist until 1908, when a standalone office and adjacent staff quarters were constructed to plans drawn up by the State Public Works Department (Queensland Times, Ipswich Herald and General Advertiser 22 October 1907:3) (refer Photograph 6.20). A small telephone exchange was installed in the building that same year, later expanding into a brick extension added in the mid-20th century (Talbot 2014) (refer Photograph 6.19). The staff quarters were demolished in the late 20th century.</p> <p>Much of the original Federation Arts and Crafts style weatherboard post and telegraph office is retained in the eastern portion of the current building (refer Photograph 6.21). The structure features a complex, prominent roof with hipped, gabled and broken-back elements, exposed rafter ends and a decorative bell-tower style ventilator. The front gable is screened with wide barge boards. Windows appear to be the original narrow casements and, on the gable end, are surmounted by a plaque that formerly bore the name of the office. The post office counter, located on a small porch on the eastern side of the building, has been boarded up, but it is possible that original elements remain.</p> <p>The unsympathetic brick extension appears to have been added to the western porch of the original building, and elements of the original roof line remain.</p>	428760mE	6951797mN

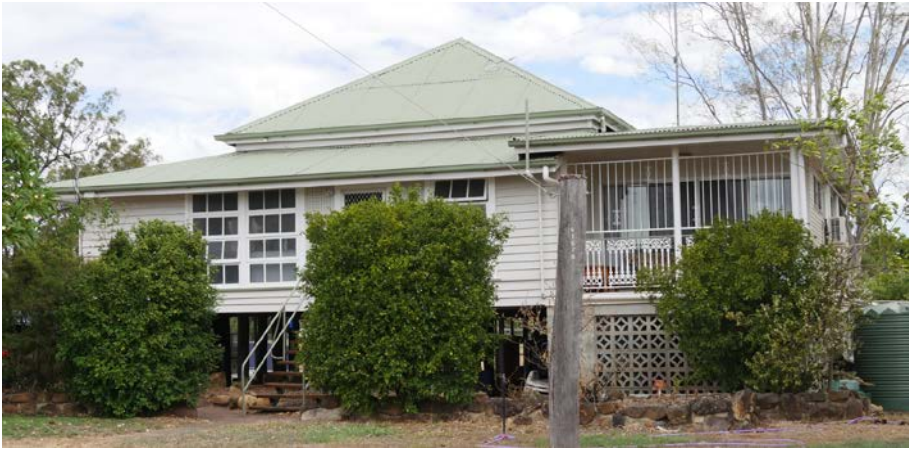
Photograph 6.22 House (H2C-19-H14)

Key elements		
House	Easting (GDA94 Z56)	Northing (GDA94 Z56)
The house is a weatherboard clad colonial with a corrugated iron, pyramid hipped roof and stepped verandah (Rechner 1998). The building has undergone a number of alterations, including the enclosure of the verandahs, and the addition of a chamferboard extension on the northern façade.	476468mE	6922125mN

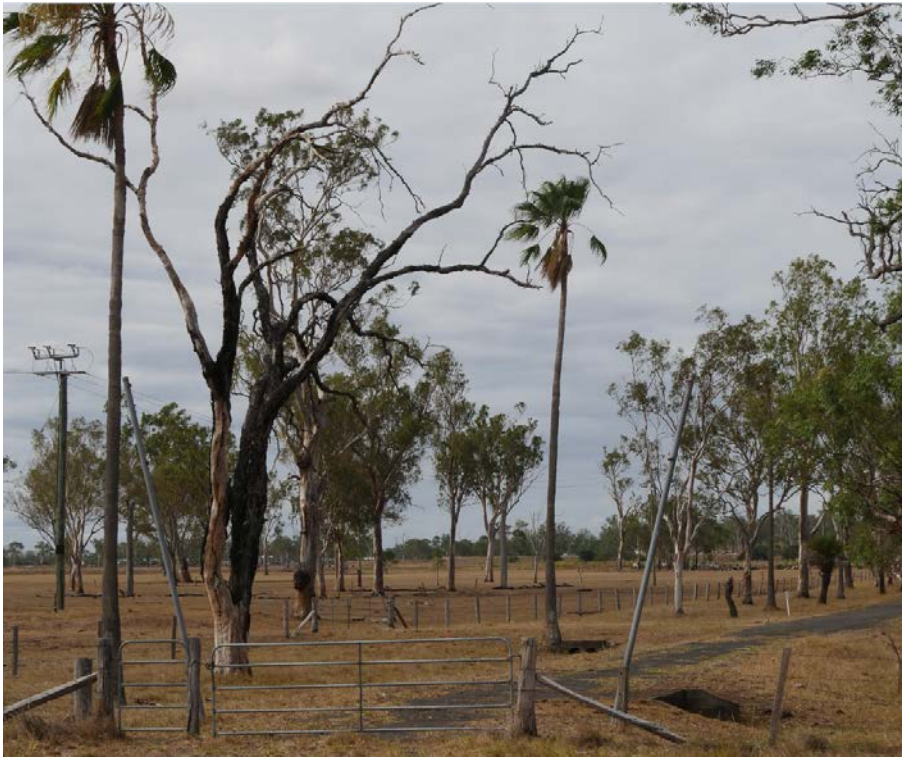
Original Entrance	Easting (GDA94 Z56)	Northing (GDA94 Z56)
<p>The UQ (Gatton) was established in 1897 as the QLD Agricultural College (DES 2016d). At this time, the most efficient way to travel to and from the site was via the Main Line, and a siding was added to the railway adjacent to the southern boundary of the college (refer below). A road was constructed from the siding to the main college buildings to the north, and this became the institution’s main entrance. The road was weatherproofed in the early 20th century, and Canary Island Date Palms (<i>Phoenix canariensis</i>), the signature planting of the campus, were established either side. In the 1910s an avenue of eucalypts was added to the roadside and, by the end of the 1920s, the entrance was marked by a picket fence, gate and sign (refer Photograph 6.23). Shortly thereafter, the main entrance to the college was shifted to the north, linking to the Warrego Highway, although the original entrance continued to be used to access the siding (DES 2016d).</p> <p>Little evidence remains of the original entrance aside from the road itself, and the adjacent avenues of palms and eucalypts (refer Photograph 6.24). A number of the original plantings have been lost, and the gaps infilled with the current signature plantings of UQ: jacarandas (<i>Jacaranda mimosifolia</i>) and leopard trees (<i>Libidibia ferrea</i>).</p>	433602mE	6950291mN

Photograph 6.24 Original entrance to University of Queensland (Gatton) (H2C-19-H15)

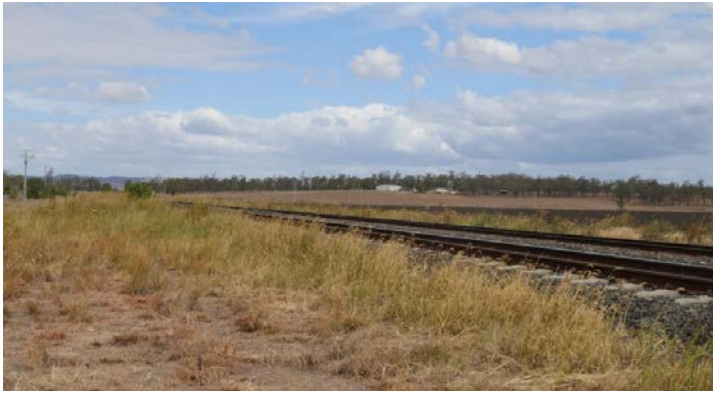
Photograph 6.26 Lawes Rail Siding
(H2C-19-H15)

Lawes Siding	Easting (GDA94 Z56)	Northing (GDA94 Z56)
<p>The college siding was established on the Main Line in 1897, the same year the institution was opened. In 1935, it was renamed Lawes Siding, in honour of Sir John Bennett Lawes, an agricultural education philanthropist (DES 2016d). Historical photographs from around this time suggest that a small platform (refer Photograph 6.25) and shelter had been constructed at the siding. It is unclear when the siding closed, but the platform building had been removed by the mid-1990s (Cash 2015).</p> <p>Little evidence of the siding now remains aside from some sturdy timber stumps that may relate to the platform, or adjacent fencing (refer Photograph 6.26 and Photograph 6.27).</p>	433593mE	6950273mN

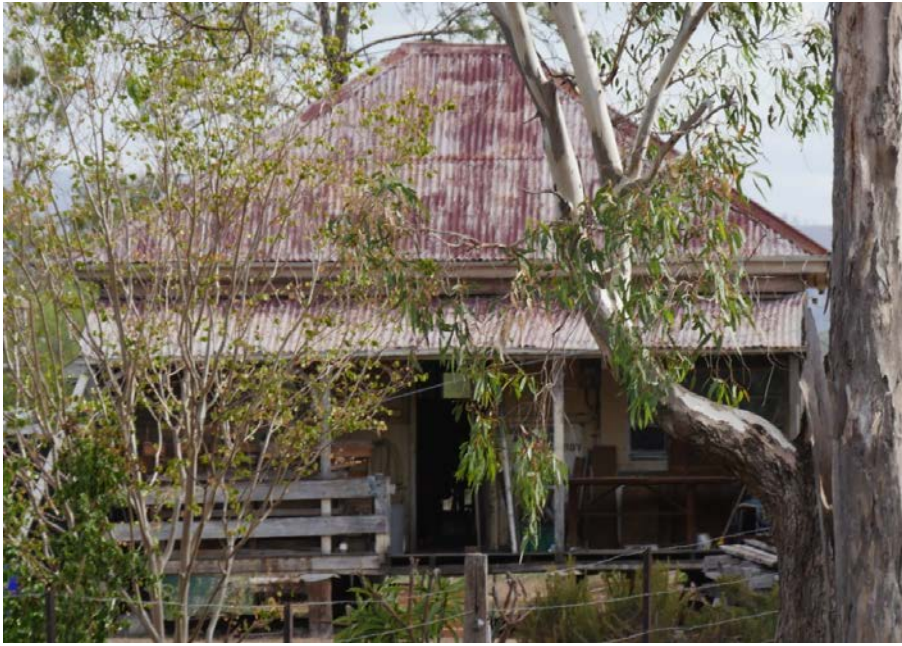
Photograph 6.28 Cottage (H2C-19-H16)

Description		
<p>Location of a structure shown on 1933 aerial photograph. Comprises a cottage and a number of outbuildings on Dotd Road, Lawes (Lot 35/RP7798). A modern house is located to the north of the original dwelling. The site could not be accessed but was visually inspected from a nearby public area.</p>		
Listings		
None		
Current imagery	Historical imagery (1933 MAP210311344)	
Key elements		
House	Easting (GDA94 Z56)	Northing (GDA94 Z56)
<p>The house is a weatherboard clad colonial cottage with a corrugated iron, short-ridged hipped roof and stepped, convex roofed verandah (Rechner 1998). The interior verandah wall is single skinned, with exposed stud work, and the windows appear to be original sashes, with original bullnose tin sunhoods remaining on the eastern façade. The building appears to have undergone very few alterations but is in poor condition.</p>	435357mE	6948971mN

D – representativeness	The house appears to be in poor condition and to have undergone numerous alterations, and so is unlikely to be a good example of type.	<input checked="" type="checkbox"/> Not met <input type="checkbox"/> Local <input type="checkbox"/> State
E – aesthetic	The homestead complex is not considered to be of aesthetic value.	<input checked="" type="checkbox"/> Not met <input type="checkbox"/> Local <input type="checkbox"/> State
F – creative/technical	The homestead complex has no known creative or technical values.	<input checked="" type="checkbox"/> Not met <input type="checkbox"/> Local <input type="checkbox"/> State
G – social	The homestead complex has no known social significance.	<input checked="" type="checkbox"/> Not met <input type="checkbox"/> Local <input type="checkbox"/> State
H – associational	The homestead complex has no known special association with the life or work of a particular person, group or organisation of historical importance.	<input checked="" type="checkbox"/> Not met <input type="checkbox"/> Local <input type="checkbox"/> State

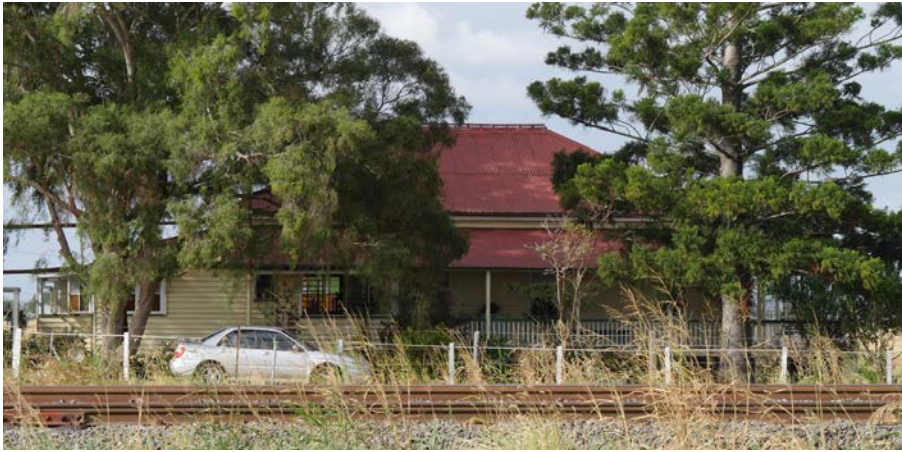
Photograph 6.29 House (H2C-19-H17)

Description		
<p>Location of a structure shown on 1933 aerial photograph. Comprises a house and a number of outbuildings on Greyfriars Road, Lawes (Lot 2/RP114066). The site could not be accessed but was visually inspected from a nearby public area.</p>		
Listings		
None		
Current imagery	Historical imagery (1933 MAP210311344)	
Key elements		
House	Easting (GDA94 Z56)	Northing (GDA94 Z56)
<p>The house is a weatherboard clad colonial dwelling with a corrugated iron, long-ridged hipped roof and a stepped, convex roofed verandah on all sides (National Trust of Queensland 1976; Rechner 1998). The western façade of the building features a pediment over the entrance, and the roof of the main building has ridge decorations. The interior verandah wall is single skinned, with exposed stud work, and the windows appear to be original two paned sashes, some with multi-colour glazing, and French doors. The eastern verandahs have been enclosed, possibly incorporating a separate kitchen wing, but the building otherwise appears to have undergone very few alterations.</p>	435556mE	6949045mN

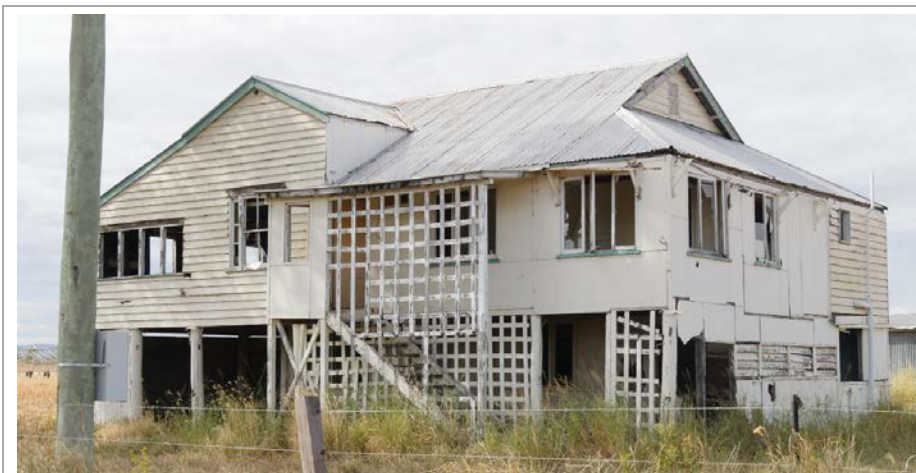
Photograph 6.30 House (H2C-19-H18)

Key elements		
House	Easting (GDA94 Z56)	Northing (GDA94 Z56)
The house is a weatherboard clad dwelling with a corrugated iron, long-ridged gambrel roof and transverse gable (Rechner 1998). The structure has undergone a number of alterations and is in poor condition, making the style difficult to date. However, the gambrel roof and transverse gable suggest the early 20 th century (National Trust of Queensland 1976).	436176mE	6948545mN

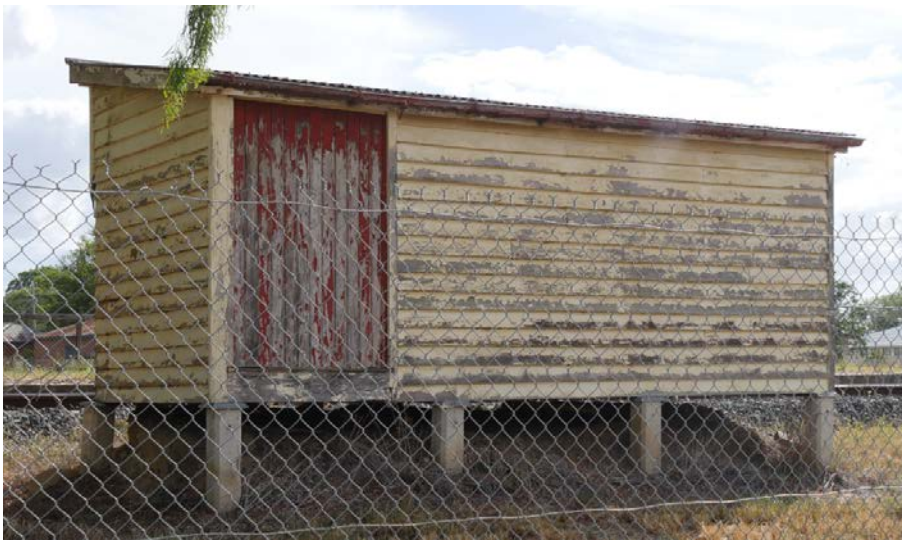
Photograph 6.31 Goods Shed (H2C-19-H19)

Description		
<p>The Forest Hill Railway Station opened in 1866 as a part of the Main Line and is located on Lot 22/SP131010. The location of the passenger station is listed on the LVRC LHR, but all buildings have been removed. The only remaining element of the station appears to be a mid-20th century goods shed.</p>		
Listings		
<p>QR Heritage Asset Register (non-statutory) (significant buildings now removed) LVRC LHR (all protected buildings now removed)</p>		
Current imagery	Historical imagery (1933 MAP209810979)	
Key elements		
Goods shed	Easting (GDA94 Z56)	Northing (GDA94 Z56)
<p>The goods shed is believed to date to the mid-20th century and consists of a small timber weatherboard structure with a skillion roof and wooden doors. The structure is described in the QR Heritage Study as a 'modest example of a goods shed' and was assessed to be of low significance (Buchanan Architects 2002). It is not located in the LVRC LHR curtilage for the Forest Hill Railway Station.</p>	436425mE	6948297mN

The 'Forest Hill Railway Station' is identified as a heritage place in the LVRC LHR and the QR Heritage Study (Buchanan Architects 2002), and as making a contribution to the townscape in the Brisbane Valley Townscape Study (National Trust of Queensland 1976). It should be noted, however, that the elements to which these listing applied, including the station building and footbridge, have since been removed. The following assessment of significance is supplied for the extant site.

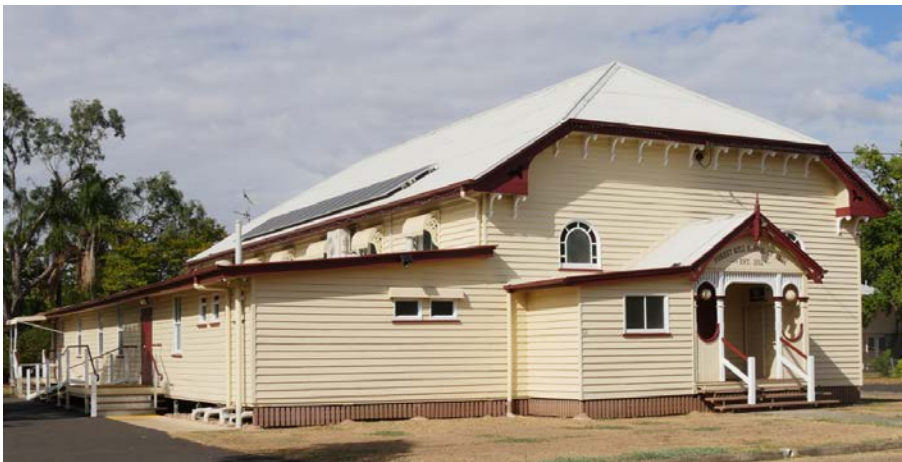
Photograph 6.33 Forest Hill School of Arts (H2C-19-H20)

The weatherboard clad timber building is highly decorative, combining elements of Federation Arts and Crafts with elements of the Carpenter Gothic style usually restricted to ecclesiastic buildings (Apperly, Irving, & Reynolds 1994) (refer Photograph 6.33). The corrugated iron roof features hipped gables with ornamental eaves brackets, and a wide barge board with gothic foil motifs. The front windows are fixed arches with multi-coloured panes, and the side windows appear to be a mixture of awnings and sash, with convex tin sunhoods. The front porch features a gabled pediment with Art Nouveau style filigree bargeboard, and spandrels ornamented with a circular motif. The hall appears to retain most of its original features, and although the eastern side of the porch and the main building have been extended, the new work is generally sympathetic.

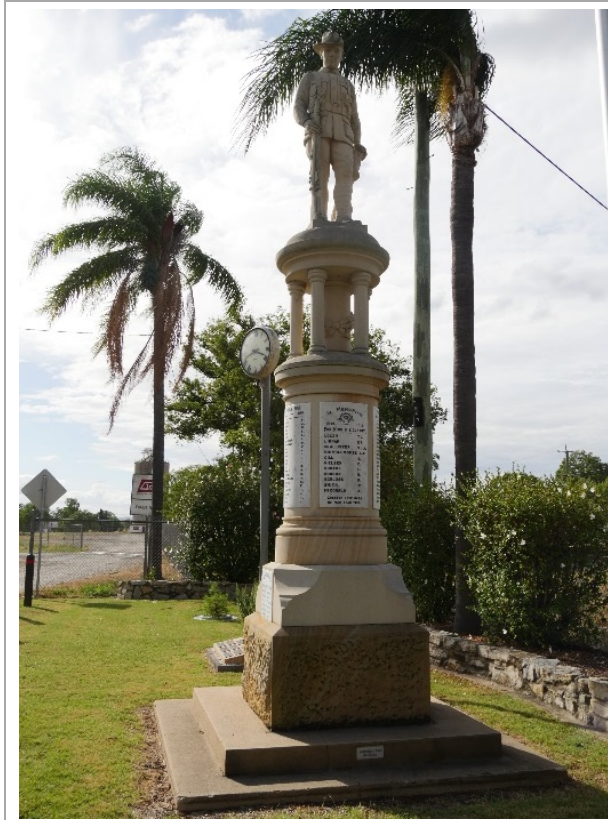
Photograph 6.34 Forest Hill War Memorial (H2C-19-H21)

Key elements		
Memorial	Easting (GDA94 Z56)	Northing (GDA94 Z56)
Memorial is located in a grassed area with nearby plantings of rosemary and other commemorative plaques. The memorial itself consists of a sandstone plinth surmounted by a 'digger' statue, with marble plaques on each side.	436527mE	6948191mN

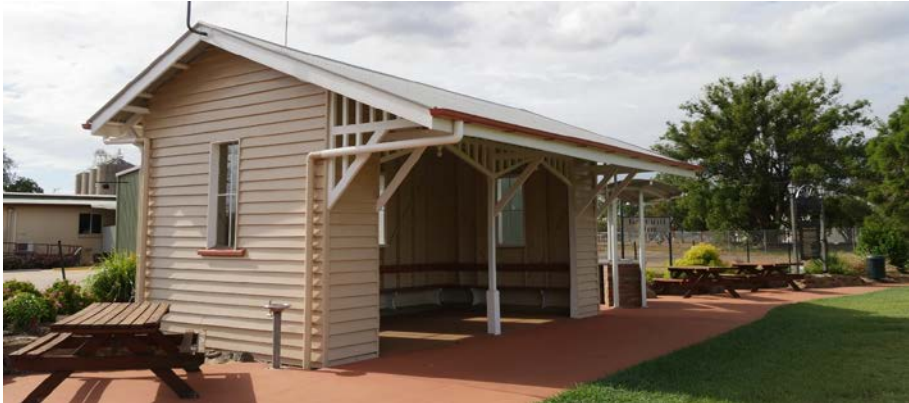
<p>Photograph 6.35 Platform shelter (H2C-19-H22)</p>

Key elements		
Platform shelter	Easting (GDA94 Z56)	Northing (GDA94 Z56)
<p>The timber platform shelter is clad in weatherboards with a corrugated iron gabled roof which extends on the front to provide shelter to waiting passengers (Photograph 6.35). This front awning is supported on plain ladder frame brackets (c.f. H2C-19-H07). The original sash windows have been replaced by fixed windows, but the interior of the shelter retains its original timber benches. The design of the shelter is consistent with those built on the Main Line c.1915.</p> <p>It seems most likely that this shelter was relocated from the adjacent Forest Hill Railway Station, where an identical building was documented in 2002 (refer Photograph 6.36 and Photograph 6.37). The QR heritage study found the building to be of low significance and recommended that it be relocated within the railway station, or moved to another QR site (Buchanan Architects 2002).</p>	436494mE	6948160mN

The 'Railway Platform Building' appears to be that identified in the QR Heritage Study at the adjacent Forest Hill Railway Station (Buchanan Architects 2002). The building was assessed as being of low significance, but was recommended for conservation, with the option for relocation within QR property. The following assessment against criteria draws on the information provided in the QR Heritage Study.

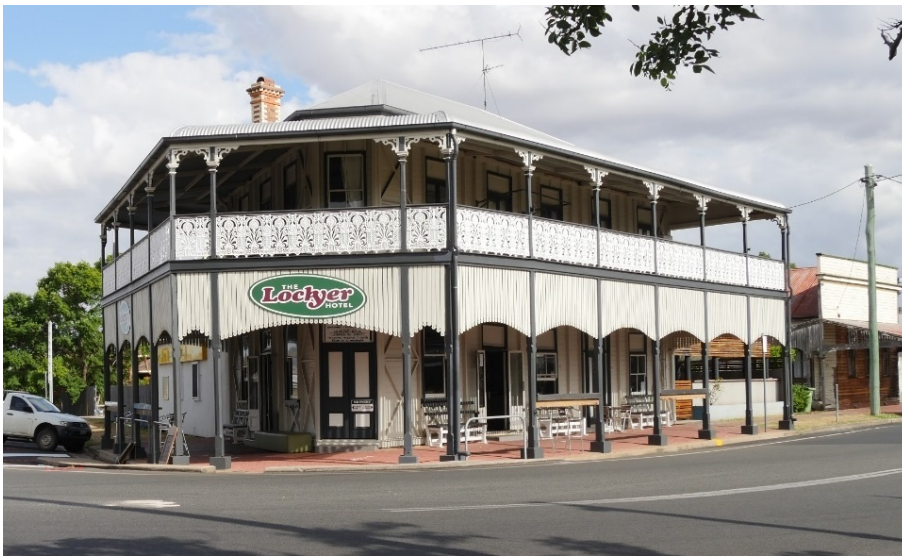
Photograph 6.38 Lockyer Hotel (H2C-19-H23)

Key elements		
Hotel	Easting (GDA94 Z56)	Northing (GDA94 Z56)
Two-storey timber building with corrugated iron hipped roof and a stepped, convex roofed verandah on three sides. The exterior walls of the hotel are single skinned, with exposed stud work, and the windows appear to be original, double hung sash, several of which retain decorative, art nouveau style timber sills. Modern extensions have been added to the western and southern sides of the building.	436536mE	6948143mN

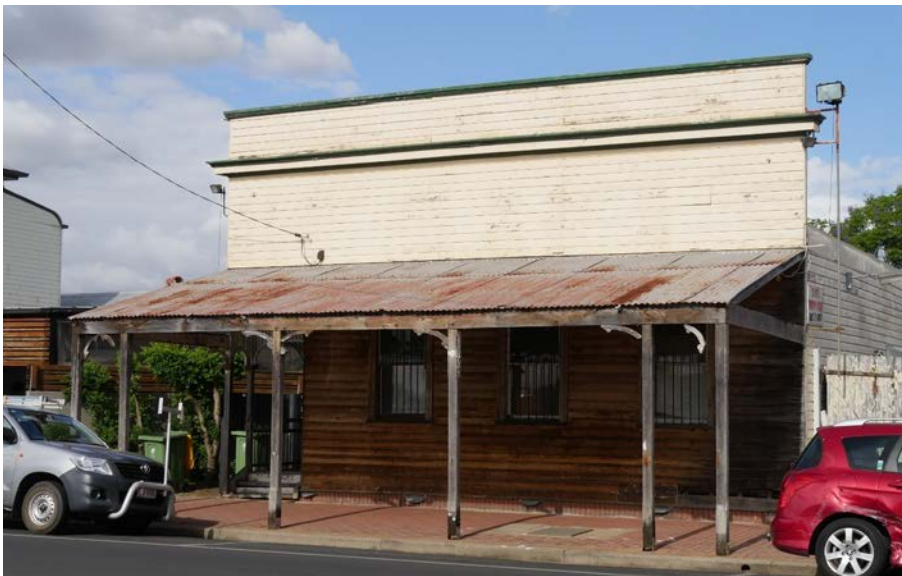
Photograph 6.39 National Bank (former) (H2C-19-H24)

H2C-19-H24	National Bank (former)	Dust from construction and operation may speed dilapidation. Building in poor condition and maybe more susceptible to impact.	Low
H2C-19-H25	Forest Hill Hotel	Dust from construction and operation may speed dilapidation. However, elements most likely impacted – such as the roofing iron – are non-original.	Low
H2C-19-H28	Homestead Complex	Dust from construction and operation may speed dilapidation. Rear building appears in poor condition and maybe more susceptible to impact.	Low
H2C-19-H29	Homestead Complex	Dust from construction and operation may speed dilapidation.	Negligible
H2C-19-H31	House	Dust from construction and operation may speed dilapidation. Building in poor condition and maybe more susceptible to impact. Archaeological deposits unlikely to be impacted.	Low

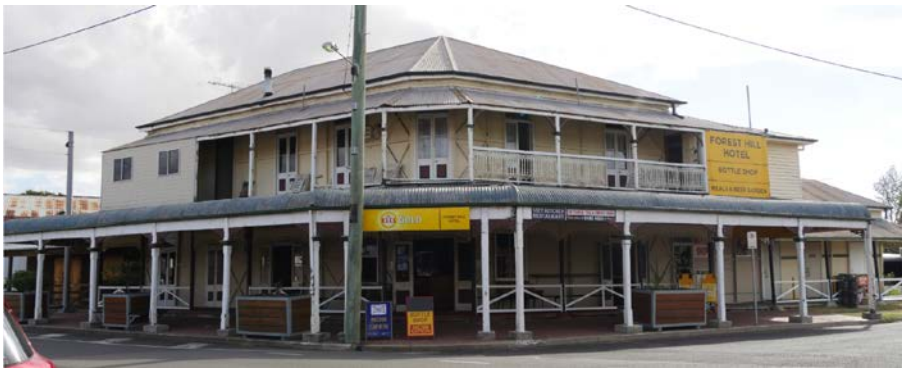
Photograph 6.40 Forest Hill Hotel (H2C-19-H25)

Description		
Two-storey timber hotel constructed in 1898 on William Street, Forest Hill (Lot 1/RP7805).		
Listings		
SHR (SHR#600652) LVRC LHR		
Current imagery	Historical imagery (1933 MAP209810979)	
Key elements		
Hotel	Easting (GDA94 Z56)	Northing (GDA94 Z56)
Two-storey timber building with corrugated iron hipped roof and a stepped, skillion roofed verandah on three sides, some of which have been partly enclosed. The exterior walls of the hotel are single skinned, with exposed stud work. Both storeys of the building are accessed predominately through French doors, and there are very few windows on the front façade. A number of weatherboard clad extensions have been constructed to the rear of the building, and a large, bullnose awning has been added, extending from the base of the first-floor verandah to shelter the footpath.	436497mE	6948110mN

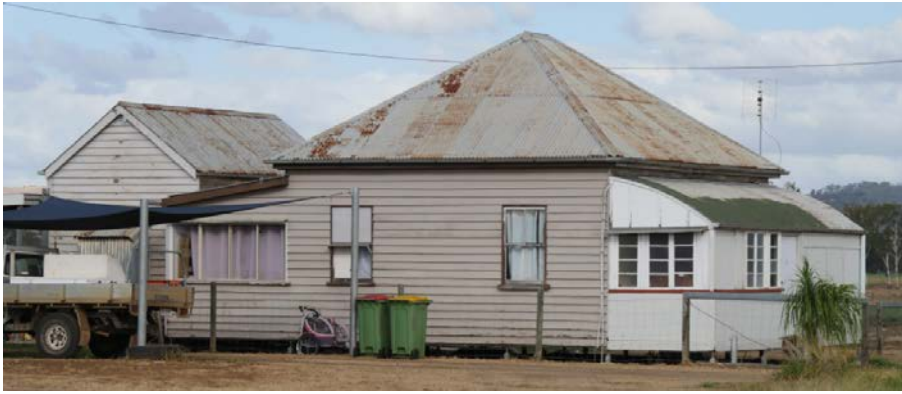
Photograph 6.41 Cottage (H2C-19-H26)

Description		
Location of structures shown on 1933 aerial photograph. Comprises a cottage and a number of outbuildings on Hall Road, Forest Hill (Lot 1/RP25631). The site could not be accessed but was visually inspected from a nearby public area.		
Listings		
None		
Current imagery	Historical imagery (1933 MAP209810979)	
Key elements		
Cottage	Easting (GDA94 Z56)	Northing (GDA94 Z56)
The house is a weatherboard clad colonial cottage with a corrugated iron, short ridge hipped roof (Rechner 1998). There is a stepped, convex roofed verandah on the front, and stepped skillion roofed verandah at the rear, both of which have been enclosed. A small gabled timber structure with a corrugated iron stove alcove is located to the rear, most likely a separate kitchen wing. Some original two paned sash windows remain.	437264mE	6947695mN

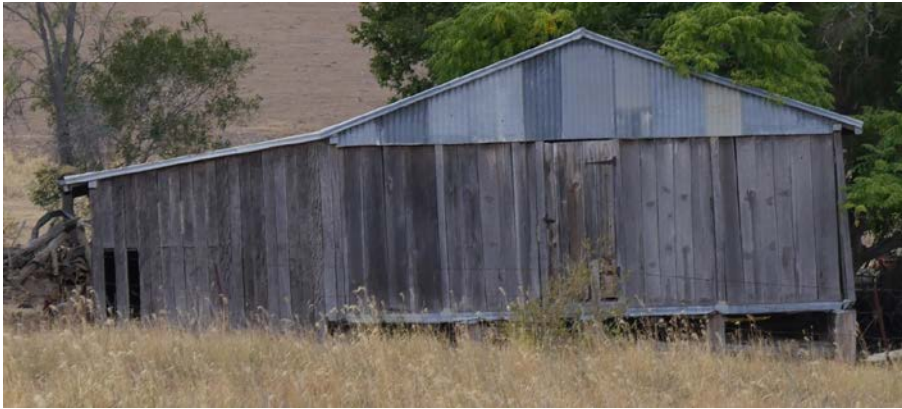
Photograph 6.44 Outbuilding with timber slabs (H2C-19-H28)

Photograph 6.43 Houses (H2C-19-H28)		
Outbuildings	Easting (GDA94 Z56)	Northing (GDA94 Z56)
There are a number of outbuildings around the property, most of which are built of milled timber and corrugated iron. However, one building has been partly constructed with salvaged timber slabs (refer Photograph 6.44), suggesting the potential for earlier structures on the site.	441974mE	6944492mN
