INLAND
RAIL

Non-Indigenous Cultural Heritage Technical Report

HELIDON TO CALVERT ENVIRONMENTAL IMPACT STATEMENT

Document Number:
2-0001-330-EAP-10-RP-0218

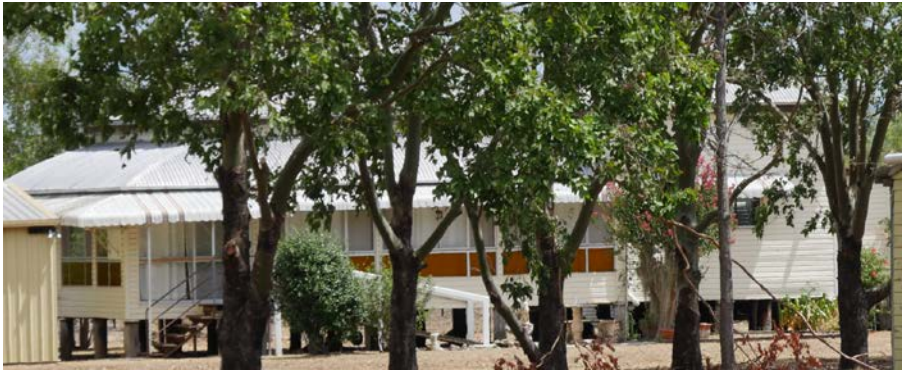
Photograph 6.45 House (H2C-19-H29)

Description		
Location of structures shown on 1933 aerial photograph. Comprises a house and a number of outbuildings on Luck Road, Laidley (Lot 2/RP209381). The site could not be accessed but was visually inspected from a nearby public area.		
Listings		
None		
Current imagery	Historical imagery (1933 MAP209811000)	
Key elements		
House	Easting (GDA94 Z56)	Northing (GDA94 Z56)
The house appears to be a late colonial dwelling with a short ridge hipped roof, stepped convex verandah, and what was originally a separate rear kitchen. However, the building also appears to have undergone many modifications and, given the limitations of the inspection, it was not possible to identify the extent of original fabric or layout.	441675mE	6944163mN

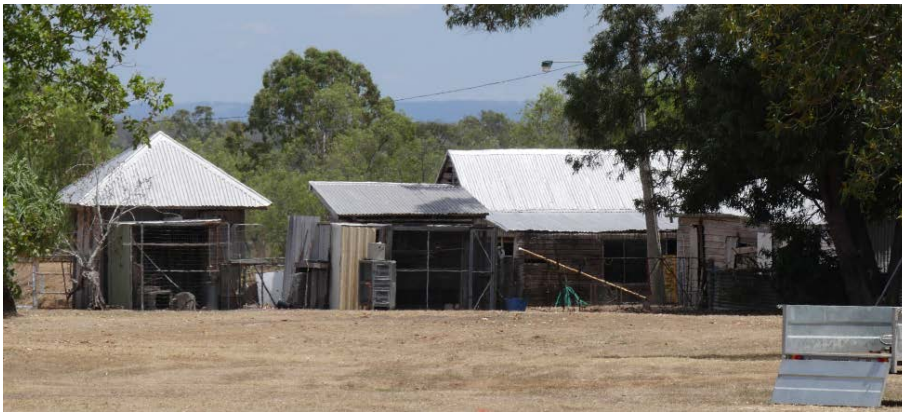
Outbuildings	Easting (GDA94 Z56)	Northing (GDA94 Z56)
<p>There are a number of outbuildings around the property, most of which are generic in design and suitable for a number of purposes. However, one distinctive building was noted: a small, square, hipped roof structure that was most likely a creamery, and used as a part of the dairying process to separate milk products prior to transport.</p>	441659mE	6944186mN

Photograph 6.46 Creamery and other outbuildings (H2C-19-H29)

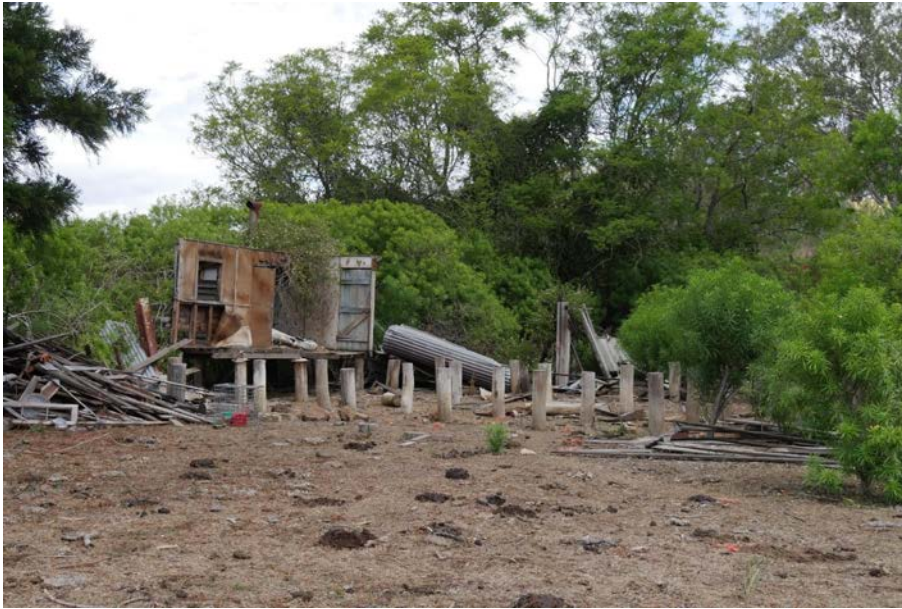
Photograph 6.47 House ruin (H2C-19-H30)

Criterion	Assessment	Threshold
A – historical	The ruinous condition of the house makes the building style difficult to identify, but it's simple hipped construction with separate rear kitchen suggests it may date to the colonial period, demonstrating the earliest eras of settlement in the region.	<input type="checkbox"/> Not met <input checked="" type="checkbox"/> Local <input type="checkbox"/> State
B – rarity	The house has no known rarity values.	<input checked="" type="checkbox"/> Not met <input type="checkbox"/> Local <input type="checkbox"/> State
C – research	There is some potential for archaeological remains related to mid-late 19 th century domestic life to be preserved in, under and around the residence.	<input type="checkbox"/> Not met <input checked="" type="checkbox"/> Local <input type="checkbox"/> State
D – representativeness	The house is in a state of dilapidation and is unlikely to be a good representation of its type.	<input checked="" type="checkbox"/> Not met <input type="checkbox"/> Local <input type="checkbox"/> State

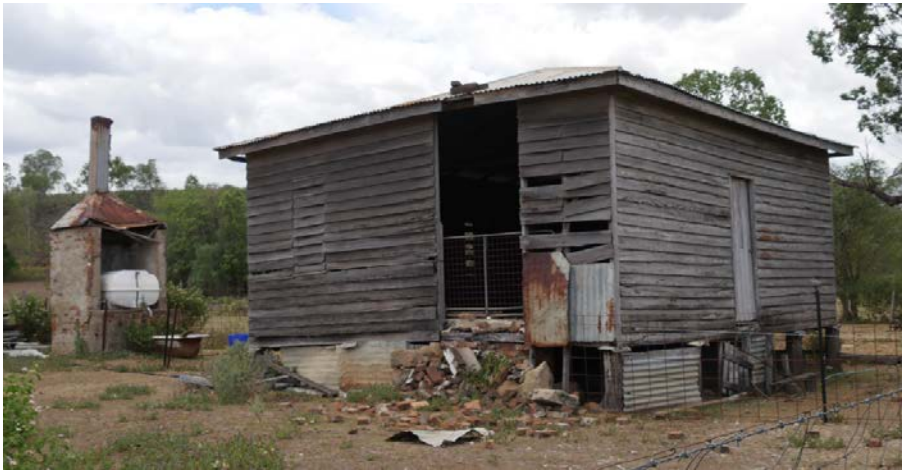
Photograph 6.48 House (H2C-19-H31)

Key elements		
House	Easting (GDA94 Z56)	Northing (GDA94 Z56)
<p>The house is a square, weatherboard structure with a pyramid hipped roof. There is a collapsed brick fire place and a boarded-up window on the western façade. The southern façade features a door and the remnants of a set of stairs, and the northern façade appears to contain at least one further door and window. To the rear of the house is another brick fireplace with a corrugated iron chimney.</p> <p>The main structure is in a state of advanced dilapidation, which makes it difficult to determine its nature or extent. However, given the simple hipped roof construction, and the presence of a second fireplace, which suggests a separate kitchen wing, it is likely that this was a colonial cottage (c.f. H2C-19-H26).</p>	446083mE	6940186mN

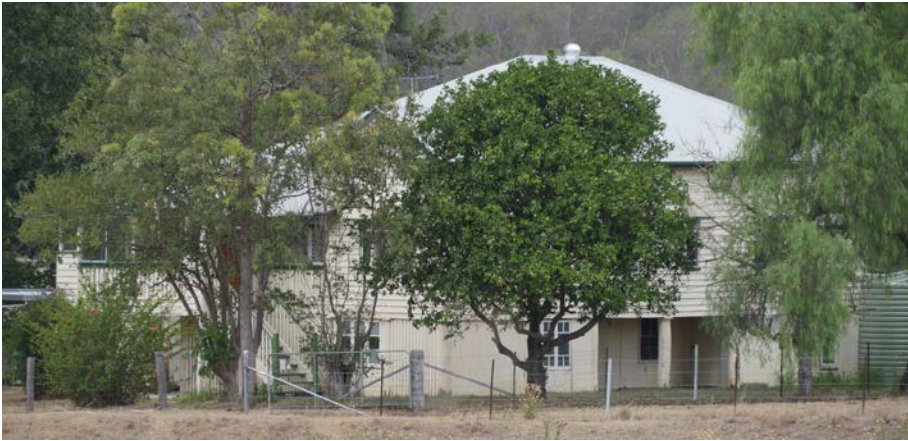
Key elements		
House	Easting (GDA94 Z56)	Northing (GDA94 Z56)
The house appears to be an interwar period multi-gable dwelling, clad in weatherboards with corrugated iron roofing (Rechner 1998). Windows appear to be casements, and some tin sunhoods remain.	446111mE	6939954mN

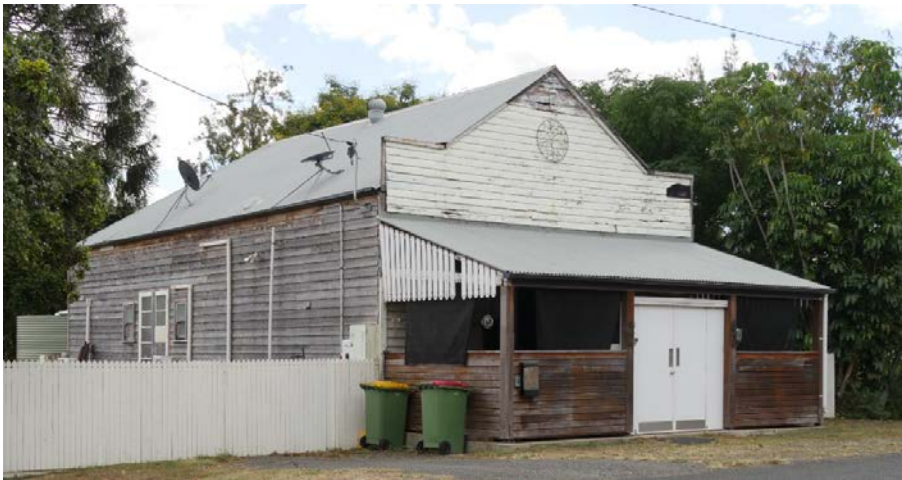
Photograph 6.51 Store (H2C-19-H33)

Key elements		
Store	Easting (GDA94 Z56)	Northing (GDA94 Z56)
<p>The former store was identified as an 'Item of Interest' in the Expanded Ipswich Heritage Study (Buchanan Architects 1996) and, along with a now-demolished house, as a 'pleasant group of buildings' in the Brisbane Valley Townscape Study (National Trust of Queensland 1976).</p> <p>The timber building is clad in weatherboard with a corrugated iron roof that is hipped at the rear and gabled at the front. The gable end is covered by a partly stepped parapet wall and a wide, skillion roofed corrugated iron awning. Some small sash windows remain on the southern façade.</p>	446936mE	6939999mN

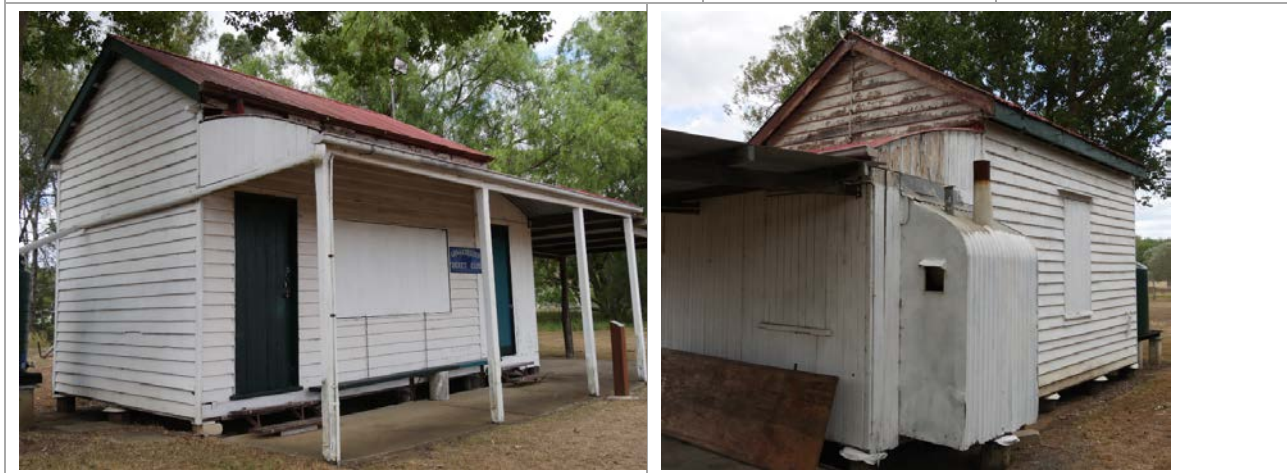
Photograph 6.53 Crew Quarters (former) (H2C-19-H35)

Crew quarters	Easting (GDA94 Z56)	Northing (GDA94 Z56)
<p>A small, rectangular, weatherboard-clad timber building on low stumps with a gabled, corrugated iron roof. There is a convex stepped verandah on the northern and eastern sides, the former of which has been enclosed, and a corrugated iron stove alcove installed. A boarded-over window is located on the western façade, and on the east is an original timber door, along with a large, shuttered opening that may be a later alteration (refer Photograph 6.53).</p> <p>This building is consistent with the style of small, gabled structures that first appear at the adjacent Grandchester Railway Station in 1884 (refer Photograph 6.54). By 1915, a second building of this type had been built beside the first, and a third can be seen in the distance (refer Photograph 6.55). The purpose of these buildings is unknown, but the presence of chimneys in the 1915 photograph suggests that they may be a type of crew quarters. This possibility is supported by historical documents that indicate accommodations for drivers and firemen were built at Grandchester in 1888 (Kerr 1966).</p>	447155mE	6940010mN

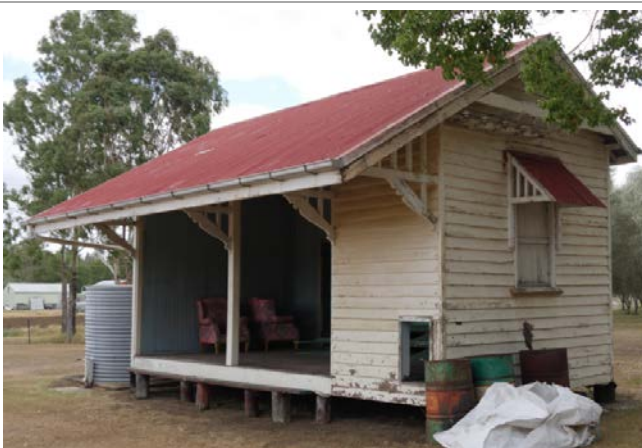
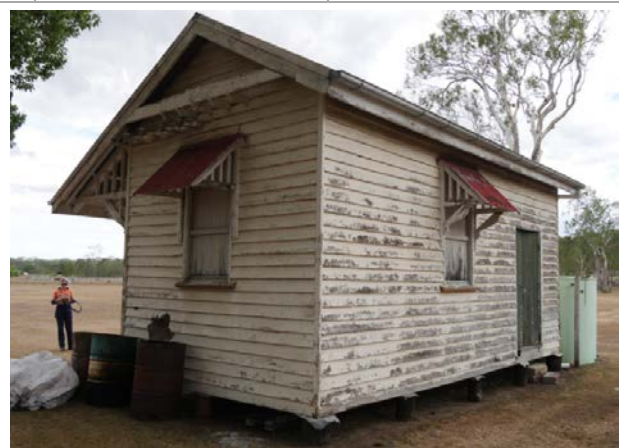
Photograph 6.56 Goods Shed (former) (H2C-19-H35)

The date and function of the building are unknown, but the decorative elements are consistent with the standard designs used by QR in the 1910s (c.f. H2C-19-H07) (Buchanan Architects 2002). The large double doors of the structure suggest that it may have been used as a goods shed, while the small insulators may indicate a connection to the telegraphic system. Historical documents indicate that a goods shed, and a telegraph office was present at Grandchester from 1916, both of which have since been removed (Kerr 1966).

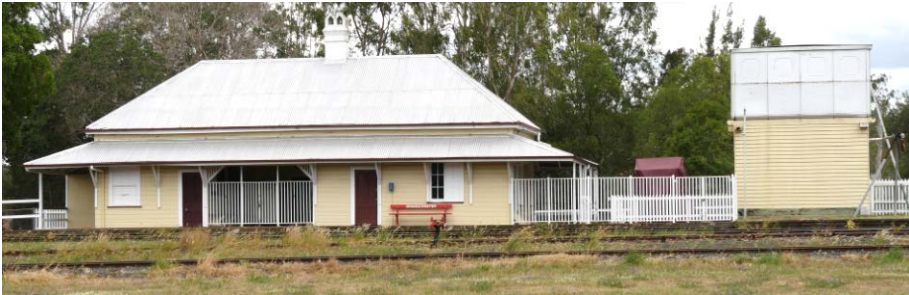
Photograph 6.57 Grandchester Railway Station (H2C-19-H36)

Key elements		
Station building, goods shed and water tank	Easting (GDA94 Z56)	Northing (GDA94 Z56)
<p>The station building is clad in weatherboards with a corrugated iron hipped roof and a skillion verandah extending around the entire structure. There is a prominent brick chimney stack with arched cowls. The 1875 weatherboard goods shed is located immediately west of the station building, and acts as a stand for the water tank brought to the site from Laidley in 1876 (Buchanan Architects 2002).</p> <p>Several other buildings constructed in the 19th and 20th centuries have since been removed, including the animal yards (1885), second goods shed (1885), timber loading crane (1886), engine driver and fireman's quarters (1888) (refer H2C-19-35), station master's residence (1915) and telegraph (1916) (Kerr 1966).</p>	447336mE	6940059mN

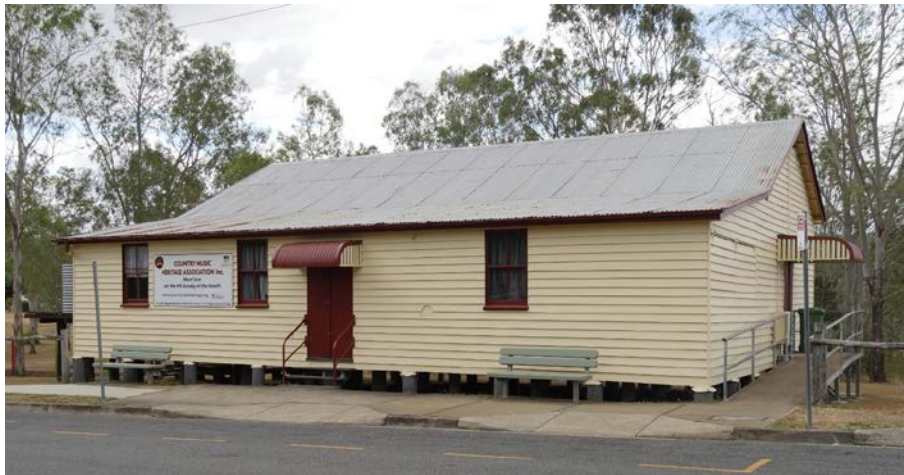
Photograph 6.58 Grandchester Community Hall (H2C-19-H37)

Key elements		
Hall	Easting (GDA94 Z56)	Northing (GDA94 Z56)
<p>Analysis of aerial photograph suggests the hall was constructed between 1948 (SVY04305025) and 1951 (QAP0155004). Simple weatherboard clad hall with a corrugated iron gabled roof that extends into a skillion roof at the front of the building.</p> <p>The building was noted as an 'old timber hall' in the Brisbane Valley Townscape Study (National Trust of Queensland 1976) and was identified as being of local heritage significance in the Expanded Ipswich Heritage Study. It is listed on the Ipswich LHR.</p>	447245mE	6939762mN

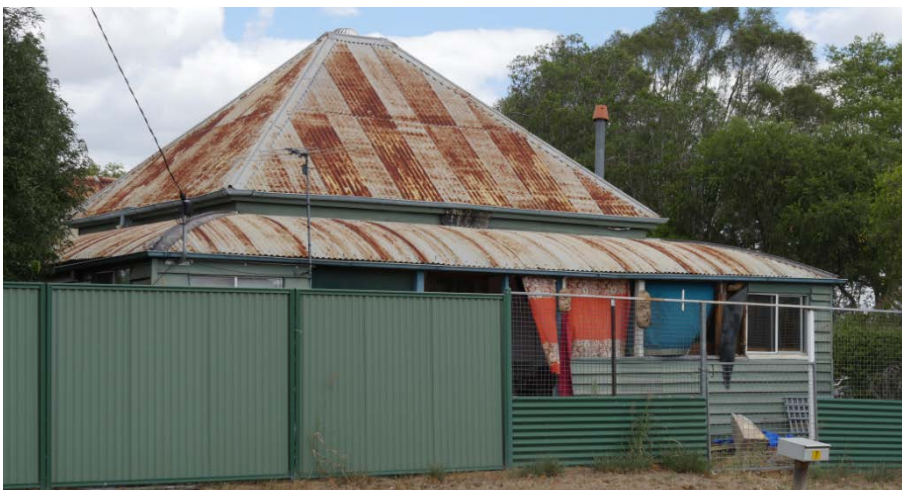
Photograph 6.59 House (H2C-19-H38)

Key elements		
House	Easting (GDA94 Z56)	Northing (GDA94 Z56)
<p>The house is a weatherboard clad colonial dwelling with a steep, corrugated iron, short-ridged hipped roof and a stepped, convex roofed verandah on three sides (National Trust of Queensland 1976; Rechner 1998). To the rear of the house is a small, gable roofed building which is now joined to the main dwelling but was formerly a separate kitchen.</p> <p>The building was noted as an 'attractive old timber dwelling' in the Brisbane Valley Townscape Study (National Trust of Queensland 1976) and was assessed as being of local heritage significance in the Expanded Ipswich Heritage Study (Buchanan Architects 1996). The building has been dated to c.1880 but, given the usually steep roof and the external kitchen, it may have been constructed in an earlier period (National Trust of Queensland 1976). It is listed on the Ipswich LHR.</p>	446962mE	6939765mN

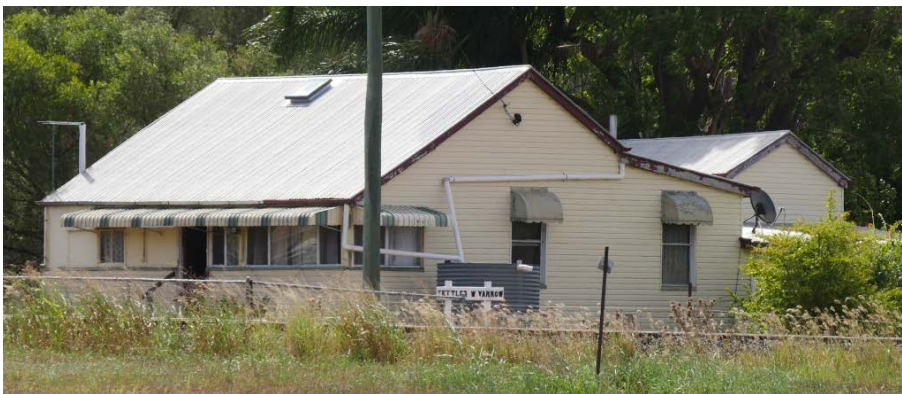
Photograph 6.60 Railway Residence (H2C-19-H39)

Key elements		
House	Easting (GDA94 Z56)	Northing (GDA94 Z56)
<p>A lowset colonial cottage (c.f. H2C-19-H28) with a corrugated iron gabled roof, and a rear skillion roof over what was probably once a verandah. Both front and back verandahs are enclosed, with the latter joining onto a small gable roofed structure that was formerly a detached kitchen. Some sash windows appear to remain, along with convex tin sunhoods.</p> <p>The dwelling is understood to be the porter's cottage for the Calvert Railway Station (Cash 2015). The Calvert Station (then Western Creek) opened in 1877, which is broadly consistent with the design of the cottage (Kerr 1990; National Trust of Queensland 1976).</p> <p>Assessed as being of local heritage significance in the Expanded Ipswich Heritage Study (Buchanan Architects 1996) and listed on the Ipswich LHR.</p>	452131mE	6939995mN

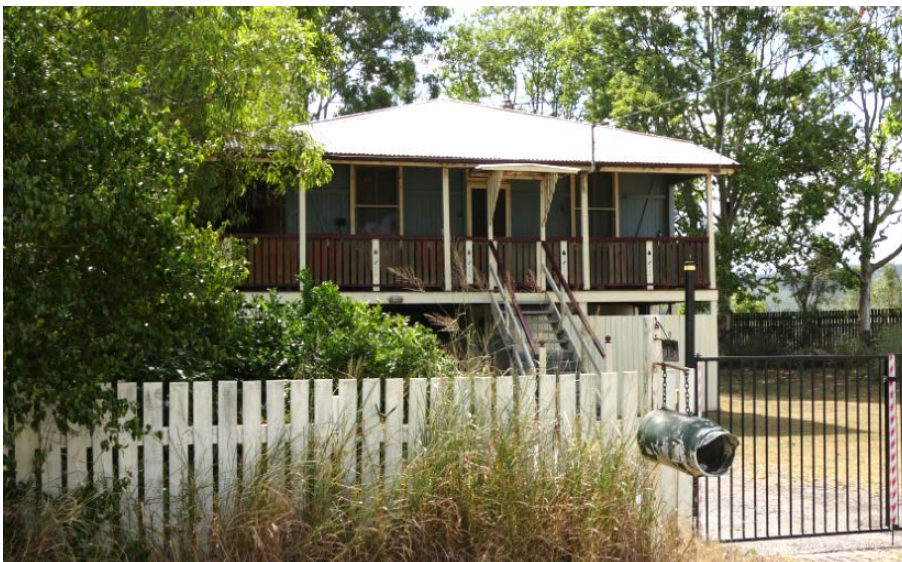
Photograph 6.61 Railway House (H2C-19-H40)

Key elements		
House	Easting (GDA94 Z56)	Northing (GDA94 Z56)
<p>The house is an early 20th century weatherboard clad bungalow with an L-shaped verandah (Rechner 1998). The corrugated iron, short ridge hipped roof is gabled on the northern façade and extends over a verandah on the southern and eastern sides. The interior verandah wall is single skinned, with exposed stud work, and the majority of windows appear to be original two paned sashes.</p> <p>Assessed as being an item of interest in the Expanded Ipswich Heritage Study (Buchanan Architects 1996), which associates the dwelling with the railway. Analysis of aerial photographs, however, indicates no evidence of the dwelling before the early 1960s (1963 QAP13680031), by which time the Calvert Railway Station had closed, and the site had become an unstaffed siding (Kerr 1966) (refer Section 4.2.4). This fact, added to the discrepancy between the apparent date of the building and its appearance in Calvert, suggests it may have been relocated from elsewhere.</p>	452429mE	6939928mN

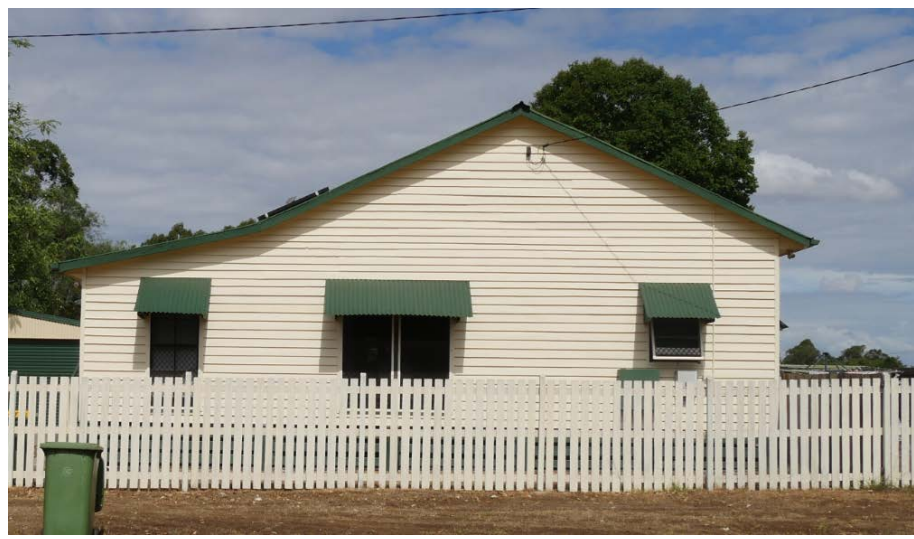
Photograph 6.62 Calvert Community Hall (H2C-19-H41)

Key elements		
Hall	Easting (GDA94 Z56)	Northing (GDA94 Z56)
<p>The hall was constructed in 1953, following an extensive fund-raising effort by the local community (<i>Queensland Times</i> 14 December 1953:4). By the mid-1990s, however, the building had fallen into disuse as the population of Calvert diminished with the closure of the railway station (Buchanan Architects 1996; Kerr 1966). A period of dereliction then followed, before the hall was renovated into a house.</p> <p>The original style of the building appears to have been very similar to the hall constructed in Grandchester in the same decade (refer H2C-19-H37): a simple weatherboard clad structure with a corrugated iron gabled roof that extends into a skillion roof on one side. The overall building envelope remains the same, but original features such as doors and windows have been removed and the fenestration altered.</p> <p>The building was identified as being an item of interest in the <i>Expanded Ipswich Heritage Study</i>. It is listed on the Ipswich LHR.</p>	447245mE	6939762mN

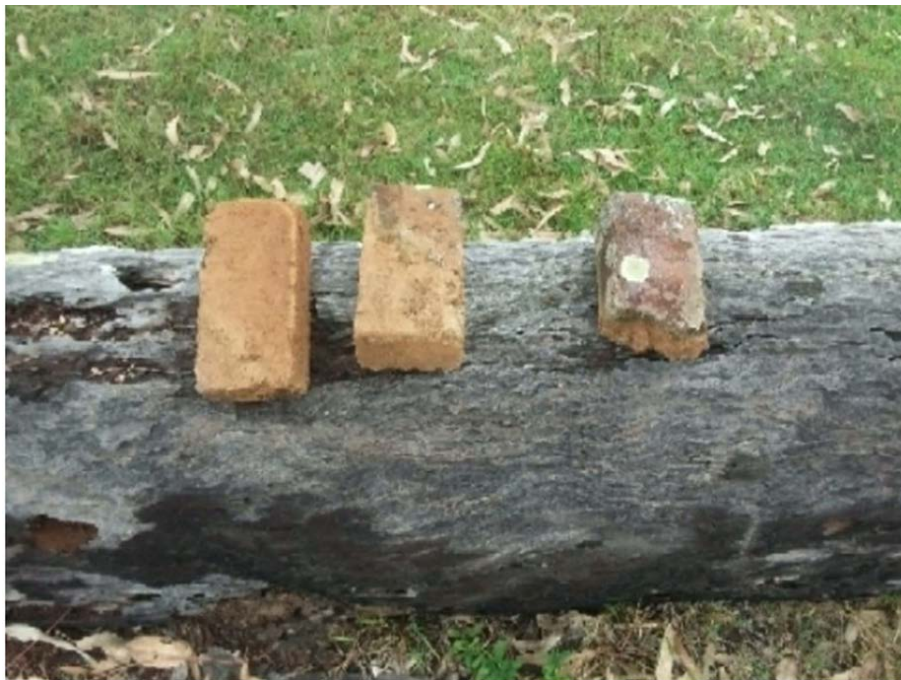
Photograph 6.63 Grandchester Archaeological Complex (adapted from Everick 2018) (H2C-19-H42)

Key elements		
Archaeological site	Easting (GDA94 Z56)	Northing (GDA94 Z56)
The Grandchester Archaeological Complex was identified by Everick Heritage Consultants during early works for the Project. Everick identified hand moulded bricks fired at low temperatures and depressions in the earth. It is possible that this site is a construction camp for the excavation of a tunnel (Six Chain Tunnel) immediately north of the site and west of Grandchester on the Main Line railway, the first railway in QLD and the first narrow gauge mainline railway in the British Colonies (Uniquist 1995, p. 32). Bricks found within the Grandchester Archaeological Complex match those in the current railway tunnels. Historical mapping demonstrates that this general area was within two railway reserves (R340 and R345) (refer Figure 6.1 and Figure 6.2). It seems most probably that these locations were staging grounds for construction equipment in the excavation and formwork for creation of the Six Chain Tunnel and potentially the larger Victoria Tunnel further up the line. These staging grounds would have been supported by the main railway camp, Bigge's Camp, later renamed Grandchester. However, a comparison of aerials from 1933 and 2017 indicate that the centre of the area has been heavily disturbed by the construction of a dam. Further investigation is therefore required to determine the nature, integrity and extent of the archaeological complex.	445448mE	6940666mN

Assessing the significance of archaeological sites holds particular challenges – it is unclear until excavation is undertaken what evidence may be found beneath the surface. The following significance assessment has been undertaken under the assumption that the ‘Grandchester Archaeological Complex’ has intact deposits relating to the construction of the Main Range Line. This significance assessment may require revision following further archaeological investigation.
