4.4 Terrestrial fauna

**Fitzroy to Gladstone Pipeline
Baseline Terrestrial and Aquatic
Ecology Technical Report
Figure 4-6q
Habitat Types Identified
Within the SGIC SDA Study Area**
000-G-MAP-2415 Version:3 Date:2022/09/12

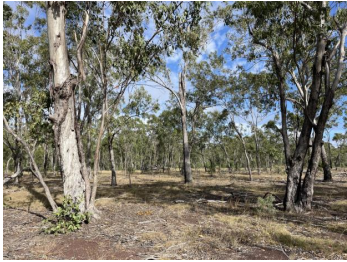
Habitat type	General characteristics and ecological values
<p>Mature eucalypt open woodland</p>

<ul style="list-style-type: none"> – Mature <i>Eucalyptus</i> species provides blossom and nesting opportunities for honeyeaters, flower peckers and parrots, and foraging habitat for flying-foxes. – Hollow-bearing trees are moderately dense, retaining small to medium sized hollows. Very few large hollows (> 30 cm) were observed. – Relatively complex ground-level microhabitats, with a high density of woody debris and leaf litter, and some ground logs. These microhabitats provide shelter and foraging microhabitat for ground-dwelling mammals, reptiles and amphibians. – Sparse, low ground cover, dominated by native grasses. Grasses provided food resources for some granivorous birds and herbivorous mammals. <p>MNES and MSES species:</p> <ul style="list-style-type: none"> – Potential foraging habitat for the squatter pigeon (southern) within 1 km (for breeding) and 3 km (for foraging) of a suitable, permanent or seasonal waterbody. – Potential foraging and denning habitat for the greater glider (southern and central) and yellow-bellied glider (south-eastern). – Potential foraging habitat for the powerful owl, koala and grey-headed flying-fox. – Potential foraging and breeding habitat for the ornamental snake (only woodland habitats retaining <i>Eucalyptus coolabah</i>).

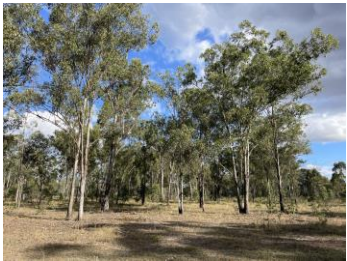
<p>Mixed <i>Eucalyptus/Corymbia</i> open woodland</p>

<ul style="list-style-type: none"> – Eucalypts provide blossoms and nesting opportunities for honeyeaters, and foraging habitat for flying-foxes. – Variety of koala food trees present, including <i>Eucalyptus tereticornis</i>, <i>E. crebra</i>, <i>E. coolabah</i>, <i>E. moluccana</i>, <i>E. exserta</i>, <i>Corymbia tessellaris</i>, <i>C. citriodora</i>, <i>C. erythrophloia</i>, <i>C. intermedia</i> and <i>Lophostemon suaveolens</i>. – Low density of hollow-bearing trees present. Hollows are relatively small, providing suitable habitat for hollow-nesting birds (i.e. parrots and lorikeets), small mammals (i.e. gliders) and arboreal reptiles and amphibians. – Ground-level microhabitats varied throughout vegetated areas. Moderately dense to sparse ground logs, woody debris, rocks and leaf litter were present, providing shelter and foraging habitat for small to medium sized mammals, reptiles and amphibians. – Decorticating bark provide refuge for microbats, reptiles and amphibians. – Groundcover densities varied throughout vegetated areas. A mixture of native and introduced grasses were present. <p>MNES and MSES species:</p> <ul style="list-style-type: none"> – Potential foraging habitat for the squatter pigeon (southern) within 1 km (for breeding) and 3 km (for foraging) of a suitable, permanent or seasonal waterbody. – Potential foraging habitat for the greater glider (southern and central) and yellow-bellied glider (south-eastern). – Potential foraging habitat for the koala and grey-headed flying-fox.

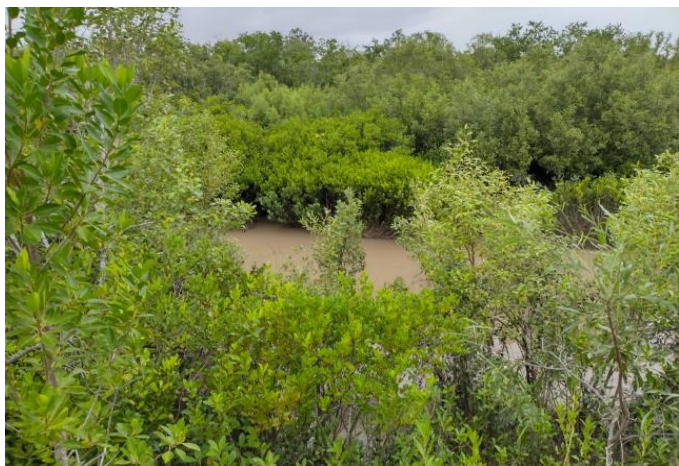
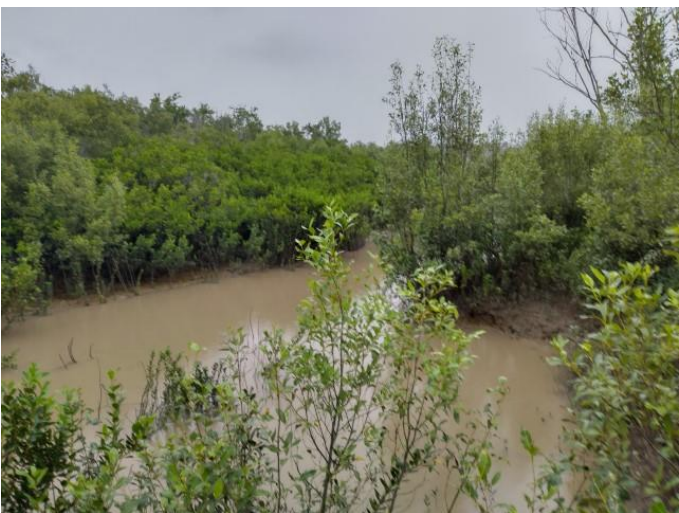
Site	Characteristics	Ecological values
Site 2 – Raglan Creek		
Upstream	<ul style="list-style-type: none"> – Tidal – tidal waterway mapped under the WWBW spatial layer. – Water was higher than the watermark and was an incoming tide at time of survey. – Channel width was approximately 8 m, and a depth of approximately 2 m. – The left bank was steep and approximately 5 m high, while the right bank has a low slope and only 2 m high. – Land use adjacent to the survey area on the left bank was subject to grazing while the right bank was natural and dense mangroves. – There was no evidence of erosion along the banks. – Water within creek was highly turbid. – Bed and bank substrate was primarily silt/clays. 	<ul style="list-style-type: none"> – Instream habitat consisted of a mangrove roots and some small woody debris. – The creek would support marine, estuarine and some freshwater fish species. – Mangrove and marine cooch species were recorded along the banks and in the riparian zone. – Site is marginal for sawfish and dugong and species are unlikely to occur. – White-throated snapping turtle habitat is unsuitable and the species is unlikely to occur. – Site optimal for estuarine crocodile foraging and refuge and the species is likely to occur at this site. – The site provides marginal foraging habitat for marine turtle species, green turtle is likely to occur.

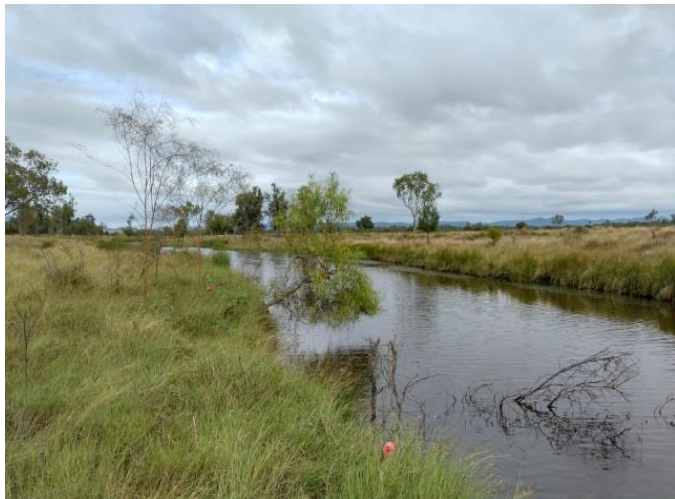
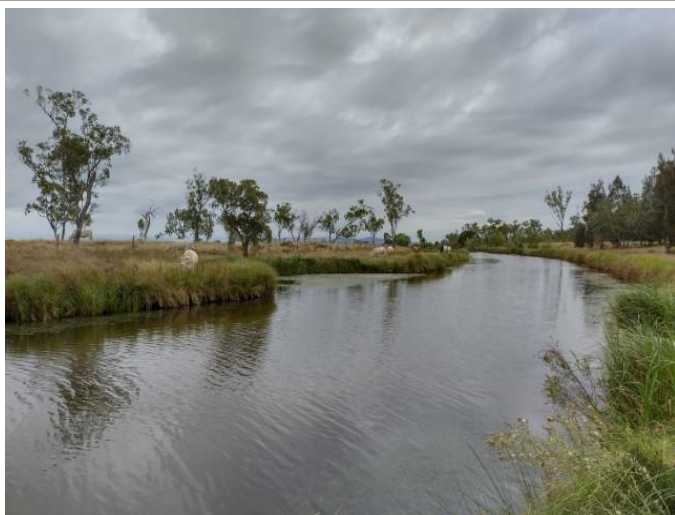
Site	Characteristics	Ecological values
Site 3 – Twelve Mile Creek		
Upstream	<ul style="list-style-type: none"> – Purple – major risk waterway mapped under the WWBW spatial layer. – Twelve Mile Creek at site 3 is a mildly sinuous channel that was approximately 10 m wide, and an average depth >1.5 m. – Water flow was still at the time of the survey but was above the watermark. – Water clarity was clear. – Land use adjacent to the survey area on both banks was cattle grazing. – Bed substrate was stable, with deposition of silt upon the substrate. – The left bank had a low slope and was approximately 1 m high, while the right bank has a flat slope and was 0.5 m high, both banks were concave in shape. – Riparian vegetation was continuous on both banks with moderate amounts of grasses and sedges, and scattered <i>Eucalyptus</i> trees >10 m high, providing >5% shading. 	<ul style="list-style-type: none"> – Overall habitat condition rating was fair (59). – A culvert was located approximately 1 km upstream of the study site. – Instream habitat consisted of deep pools, and some submerged aquatic macrophytes. – The creek would support small to large estuarine and freshwater fish species. – The site provides habitat for freshwater turtle species. – Site is sub-optimal for estuarine crocodile foraging, with sub-optimal breeding habitat and the species may occur at this site. – Optimal foraging and burrowing habitat present for platypus and species is likely to occur.

The Fitzroy River turtle is only known to occur within the main river system of the Fitzroy River and is unlikely to occur at any waterway crossings within the SGIC SDA. No observations of this species occurred throughout the surveys within the SGIC SDA and therefore the species is unlikely to occur. During the surveys within the SGIC, only one freshwater turtle was observed, an adult Krefft's river turtle, which was captured at Twelve Mile Creek (site 3).

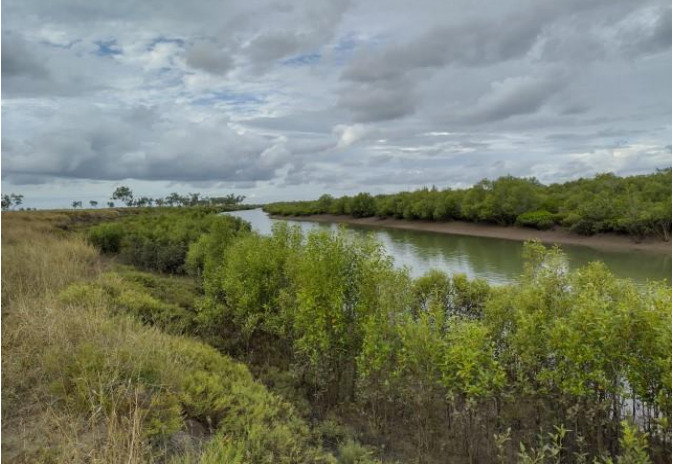
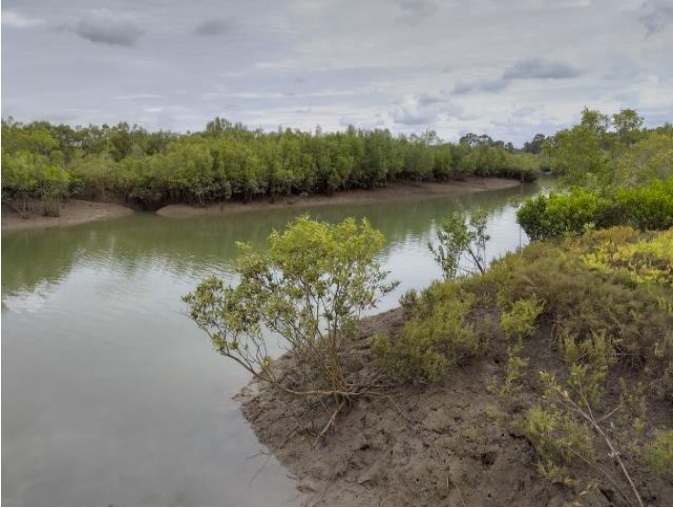
Site	Characteristics	Ecological values
Site 4 – Inkerman Creek		
Upstream	<ul style="list-style-type: none"> – Tidal – tidal waterway mapped under the WWBW spatial layer. – Inkerman Creek at site 4 consisted of a mildly sinuous channel that was approximately 18 m wide and approximately 5 m deep. – Water flow was slow and on the incoming tide at the time of the survey and was below the mangrove leaf line. – Water clarity was turbid. – Land use adjacent to the survey area on the left bank was dense native mangrove forest, while the land use adjacent to the right bank was grazing. – Bed substrate was stable, with deposition of silt upon the substrate. – The left bank had a low slope and was approximately 2 m high, while the right bank has a steep slope and was 8 m high. – Riparian vegetation was continuous on both banks with several species of mangroves. 	<ul style="list-style-type: none"> – Instream habitat consisted of roots from various mangrove species. – The creek would support small to large estuarine and freshwater fish species. – A green turtle , was observed at the site at the time of survey. – The site provides sub-optimal habitat for other marine turtle species. – Site is marginal for sawfish and dugong species and the species is unlikely to occur. – Site is optimal foraging and marginal breeding habitat for the estuarine crocodile habitat and the species is likely to occur.

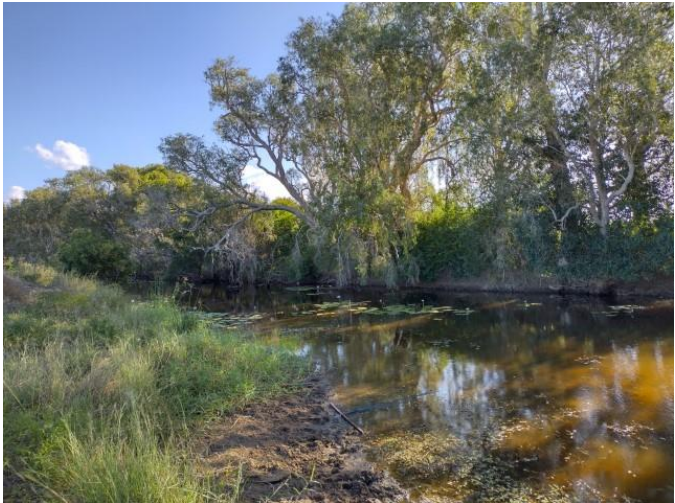
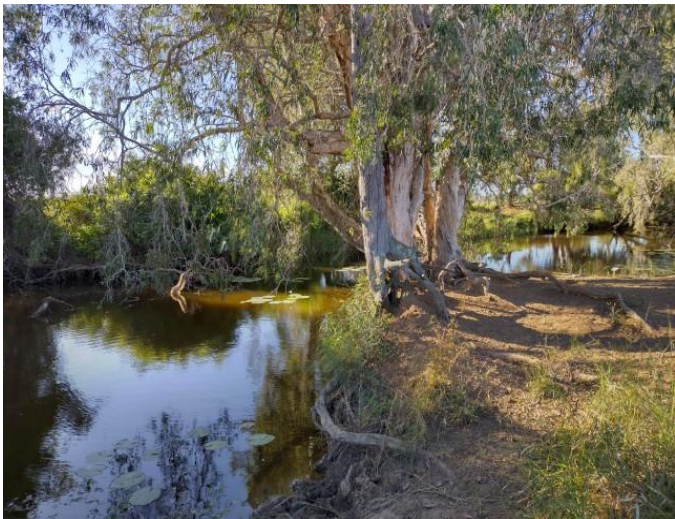
Site	Characteristics	Ecological values
Site 5 – Bobs Creek		
<p>Upstream</p>

<ul style="list-style-type: none"> – Purple – major risk waterway mapped under the WWBW spatial layer. – Bobs Creek at Site 5 consisted of a mildly sinuous channel with a bank full width that was approximately 10 m wide. – The average depth was 1.4 m and a maximum depth of 2 m and a wetted width of 4 m. – There was no flow at the time of the survey, and the water level was below the watermark. – Water clarity was slightly turbid. – Land use adjacent to the survey area on both banks were subject to cattle grazing. – There was a moderate amount of erosion present and compacted bed substrate that consisted of 20% sand and 80% silt/clay. – The left bank had a steep slope, while the right bank had a vertical slope. Both banks were 4 m high and with a high level of erosion. 	<ul style="list-style-type: none"> – Overall habitat condition rating was fair (45). – Instream habitat consisted of deep and shallow pools, with large woody debris and beds of water lily. – This location provides suitable habitat for many fish and turtle species. – Optimal foraging and burrowing habitat present for platypus and species is likely to occur. – Outside of any known range for any other threatened aquatic species.

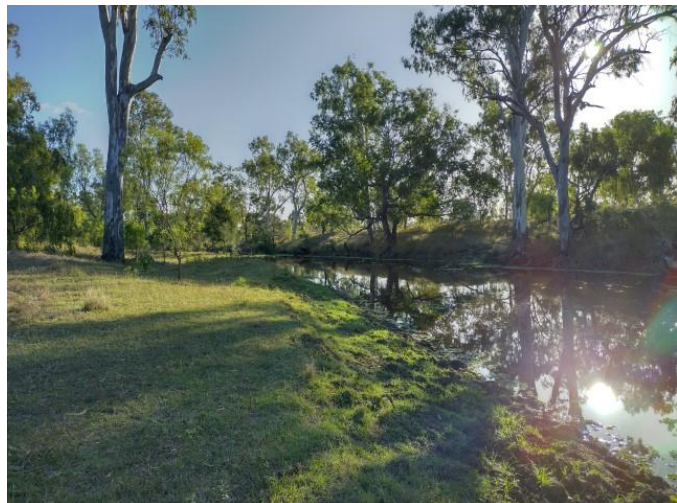
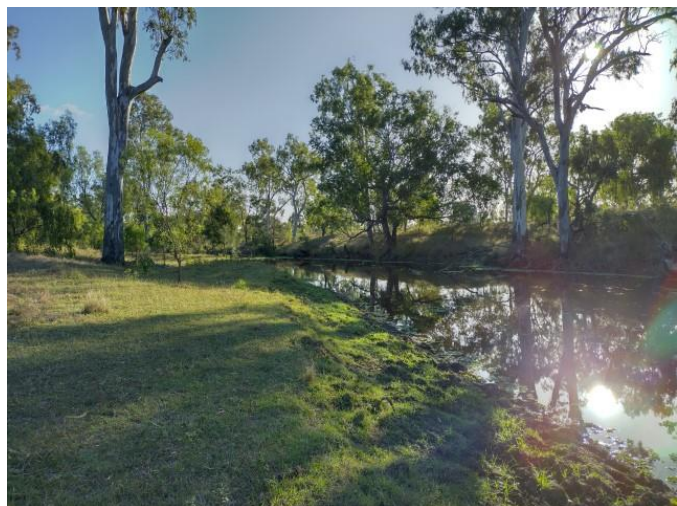
Site	Characteristics	Ecological values
Site 7 – Unnamed waterway		
Upstream	<ul style="list-style-type: none"> – Red – high-risk waterway mapped under the WWBW spatial layer. – Site 7 consisted of an irregularly meandering channel with a bank full width of 10 m. – Water was absent during the survey. – Land use adjacent to the survey area was grazing. – Bed substrate was moderately eroded, with some deposition upon the substrate. – Bed substrate comprised of 5% bedrock, 5% cobble, 20% pebble, 30% gravel, 30% sand, and 10% silt/clay. – The banks were moderately stable, with some evidence of local catchment erosion. – The banks on both sides of the river were steep, and concave in shape and were 4 m high. – Riparian vegetation was semi-continuous on both banks with moderate amounts of <i>Eucalyptus</i>, <i>Melaleuca</i>, and <i>Casuarina</i> trees >10 m high and <10 m high providing the site with 25% shading and 15% trailing bank vegetation. – The riparian zone also contained some bare ground, grasses, and shrubs. 	<ul style="list-style-type: none"> – Overall habitat condition rating was fair (57). – Instream habitat consisted of pool, run, and riffle sections, as well as undercut banks. – This location would provide suitable habitat for many fish species during wet periods. – Outside of any known range for threatened aquatic species.

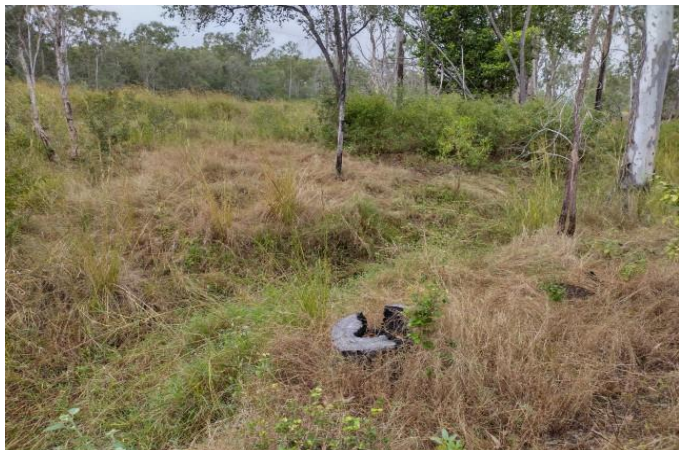
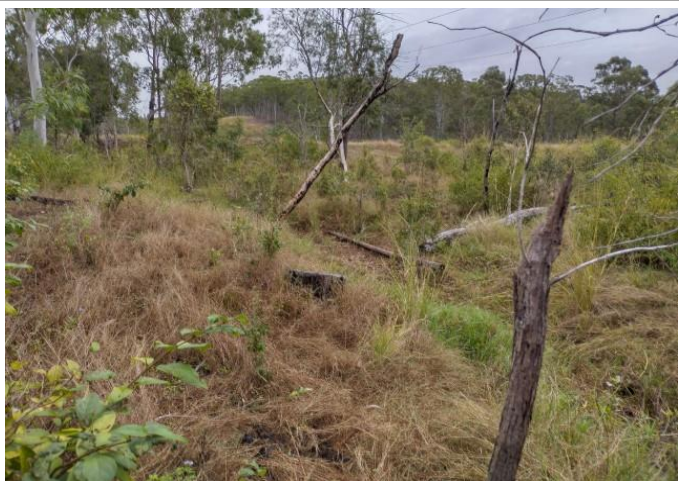
Site	Characteristics	Ecological values
Site 8 – Unnamed Creek		
Upstream	<ul style="list-style-type: none"> – Orange – moderate risk waterway mapped under the WWBW spatial layer. – The unnamed creek at Site 8 consisted of an irregular meandering channel with a bank full width of 3 m. – Water was absent during the survey. – Land use adjacent to the survey area was grazing. – Bed substrate was moderately aggregated, with some deposition upon the substrate. – Bed substrate comprised of 20% pebble, 30% gravel, 30% sand, and 20% silt/clay. – The left bank was moderately steep and 2 m high, while the right bank had a low slope and was 1 m high. – There was little local catchment erosion present. – The riparian zone was semi-continuous on both banks with some of <i>Eucalyptus</i>, <i>Melaleuca</i> and <i>Casuarina</i> trees >10 m and <10 m high providing the site with 25% shading and 25% trailing bank vegetation. – The riparian zone also contained a moderate proportion of grasses and shrubs. 	<ul style="list-style-type: none"> – Overall habitat condition rating was fair (47). – Giant rat's tail grass (<i>Sporobolus pyramidalis</i>) present throughout site. – Instream habitat consisted of pool, run, and riffle sections. – There were no aquatic macrophyte species present. – This location would provide sub-optimal habitat for small bodied fish species for a short duration during wet periods. – Outside of any known range for threatened aquatic species.

The bioassessments of five waterways listed as low and moderate risks (green and amber) waterways by the WWBW spatial layer (Table 4-20) resulted in one site as being assessed as in fair condition (site 8), while the remaining four sites were in poor condition. All sites whilst scoring well in bank vegetation and stability category, scored poorly in most categories, indicating that these sites have limited habitat complexity due to some erosion, channel alteration and substrates dominated by silt/clay.

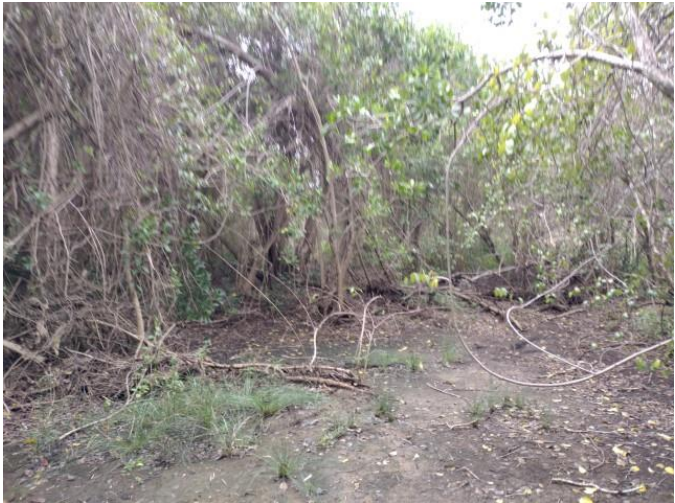
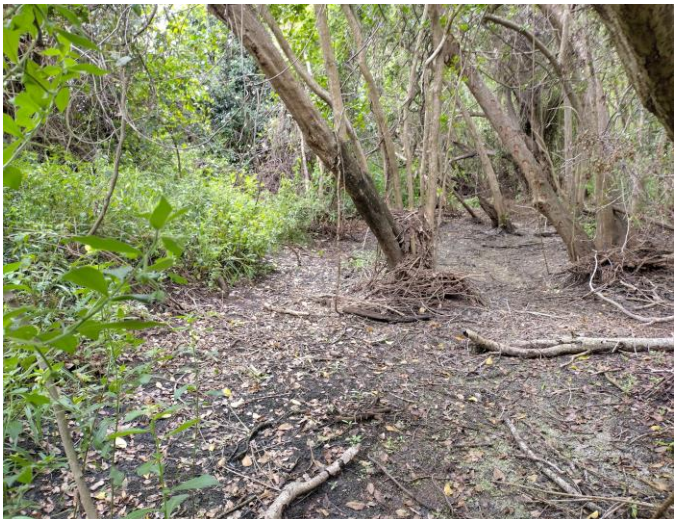
Site	Characteristics	Ecological values
Site 9 – Horrigan Creek		
<p>Upstream</p>

<ul style="list-style-type: none"> – Purple / tidal – major/tidal risk waterway mapped under the WWBW spatial layer. – The site is located where the tidal mapped area connects with the major risk mapped waterway and is list as a major risk and tidal waterway. – Horrigan Creek at Site 9 consisted of a regular meandering channel with a bank full width of 8 m. – Water was absent during the survey. – Land use adjacent to the survey area on the left bank was cleared for cattle grazing and the right bank is vegetated floodplain and forest. – Bed substrate was moderately aggregated, with some compaction of the substrate. – Bed substrate comprised of 100% silt/clay. – The left bank was moderately steep and 3 m high, while the right bank had a flat slope and was 0.5 m high. – The was no evidence of local catchment erosion present. – The riparian zone was continuous on both banks with a moderate amount of mangrove trees and exotic trees species >10 m and <10 m high providing the site with 50% shading and 25% trailing bank vegetation. – The riparian zone also contained a moderate proportion of grasses, some shrubs and bare ground. 	<ul style="list-style-type: none"> – Overall habitat condition rating was fair (46). – A culvert was located approximately 1 km upstream of the study site. – Instream habitat consisted of mangroves and woody debris. – This location would provide suitable habitat for many fish species during wet periods. – Outside of any known range for threatened aquatic species.

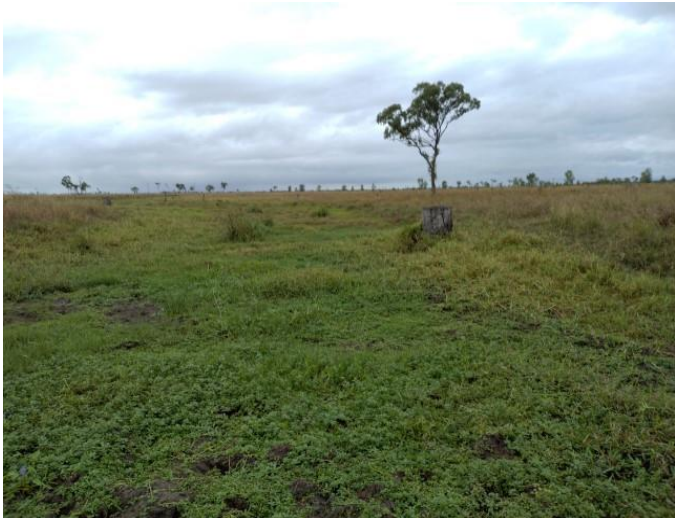
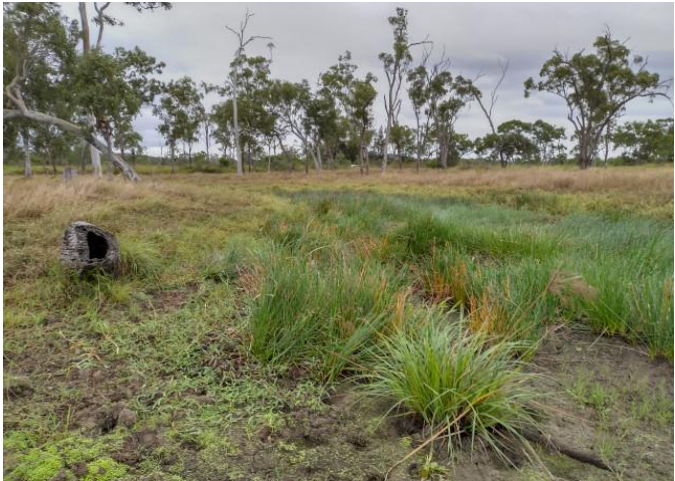
Site	Characteristics	Ecological values
Site 10 – Pelican Creek		
Upstream	<ul style="list-style-type: none"> – Red – high-risk waterway mapped under the WWBW spatial layer. – Pelican Creek at site 10 consisted of an irregularly meandering channel with a bank full width of 3 m. – Water was absent during the survey. – Land adjacent to the survey area on both banks cleared for cattle grazing. – Bed substrate was moderately aggregated, with heavy compaction of the substrate. – Bed substrate comprised of 100% silt/clay. – The left bank had a low slope, while the right bank had a flat slope. Both banks were 1 m high. – There was some local catchment erosion present. – The riparian zone was continuous on both banks with grasses, and a moderate amount of exotic grass species present. – There were no trees present within site and no shading present. 	<ul style="list-style-type: none"> – Overall habitat condition rating was poor (37). – Instream habitat consisted of a shallow run and some emergent macrophytes. – This location would provide limited habitat for many fish species during wet periods. – Outside of any known range for threatened aquatic species.

The bioassessments of four waterways listed as high-risk (red) waterways by the WWBW spatial layer resulted in two sites assessed to be in fair condition (sites 7 and 11) and two sites in poor condition (sites 10 and 18) as shown in Table 4-19. All of the high-risk waterways assessed were ephemeral, and either had no surface water present or were reduced to small isolation pools. The majority of sites whilst scoring well in bank vegetation and stability category, also scored poorly in the bottom substrate and embeddedness, indicating that these sites have limited habitat complexity due to some erosion and substrates dominated by silt/clay.

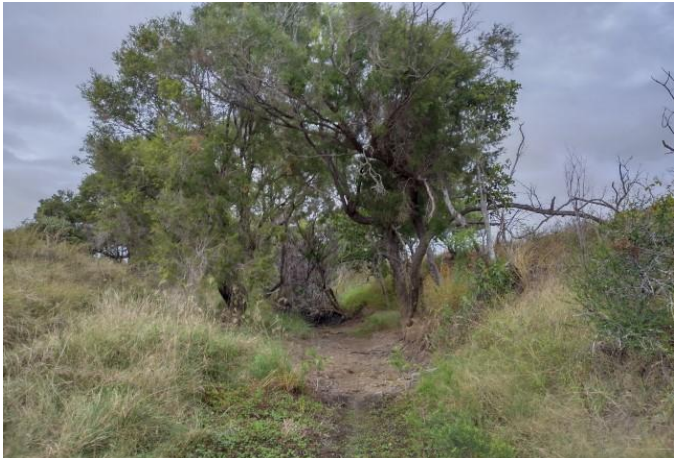
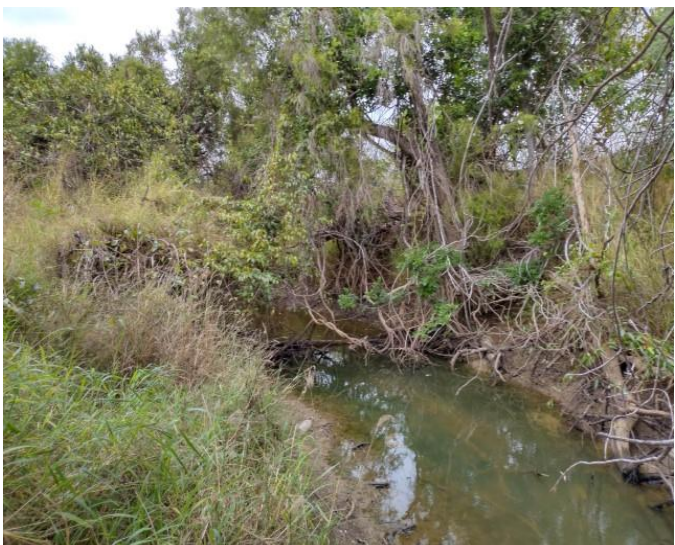
Site	Characteristics	Ecological values
Site 11 – Marble Creek		
<p>Upstream</p>

<ul style="list-style-type: none"> – Red – high-risk waterway mapped under the WWBW spatial layer. – Marble Creek at site 11 consisted of an irregularly meandering channel with a wetted width of 3 m. – Water was present in a small, isolated pool that was 0.3 m deep. – Land adjacent to the survey area on both banks cleared for cattle grazing. – Bed substrate was moderately aggregated, with heavy compaction of the substrate. – Bed substrate comprised of 100% silt/clay. – The left bank had a steep slope, while the right bank had a moderate slope. Both banks were 3 m high. – There was a moderate level of local catchment erosion present. 	<ul style="list-style-type: none"> – Overall habitat condition rating was fair (41). – Instream habitat consisted of a shallow run and some tree roots. – This location would provide limited habitat for many fish species during wet periods. – Outside of any known range for threatened aquatic species.

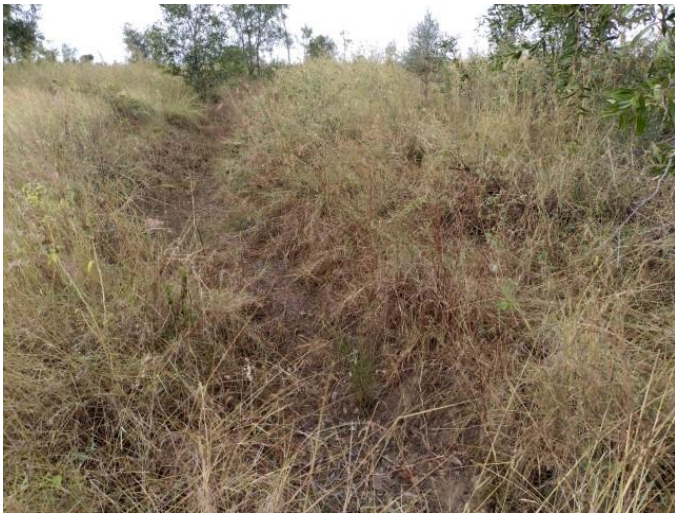
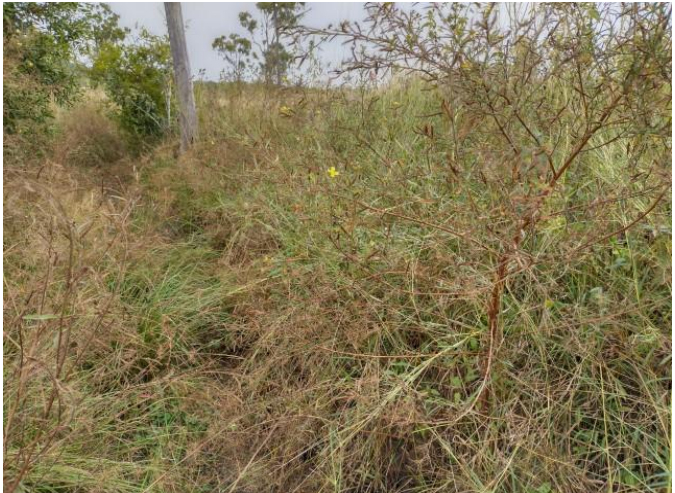
Site	Characteristics	Ecological values
Site 12 – Unnamed waterway		
Upstream	<ul style="list-style-type: none"> – Green – minor risk waterway mapped under the WWBW spatial layer. – The unnamed creek at Site 12 consisted of a mildly sinuous creek with a bank full width of 2 m. – Water was absent during the survey. – Land adjacent to the survey area on both banks cleared for cattle grazing. – Bed substrate was moderately eroded, with a low level of compaction of the substrate. – Bed substrate comprised of 2% gravel, 5% sand, and 93% silt/clay. – Both banks had a steep slope, were benched and were 1 m high. – There was some local catchment erosion present and moderate bank stability. – The riparian zone was isolated/scattered on both banks, with extensive amounts of exotic species of grasses, with a little amount of bare ground and shrubs. – There were no trees present within site and no shading present. 	<ul style="list-style-type: none"> – Overall habitat condition rating was poor (35). – Instream habitat consisted of shallow runs, pools and undercut banks. – This location would provide limited habitat for many fish species during wet periods. – Outside of any known range for threatened aquatic species.

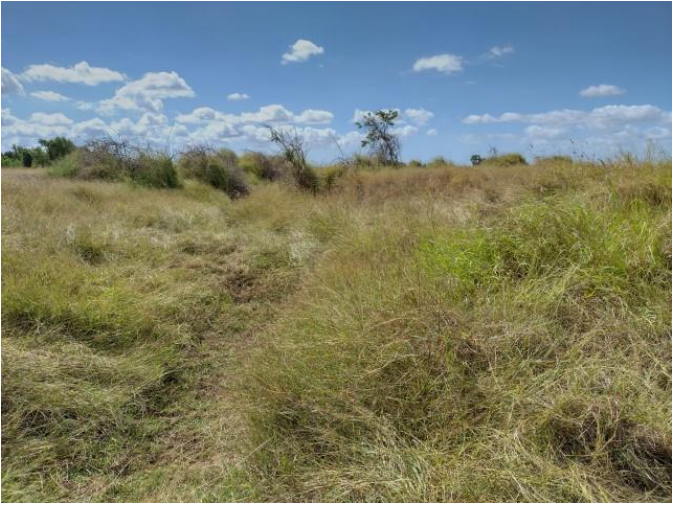
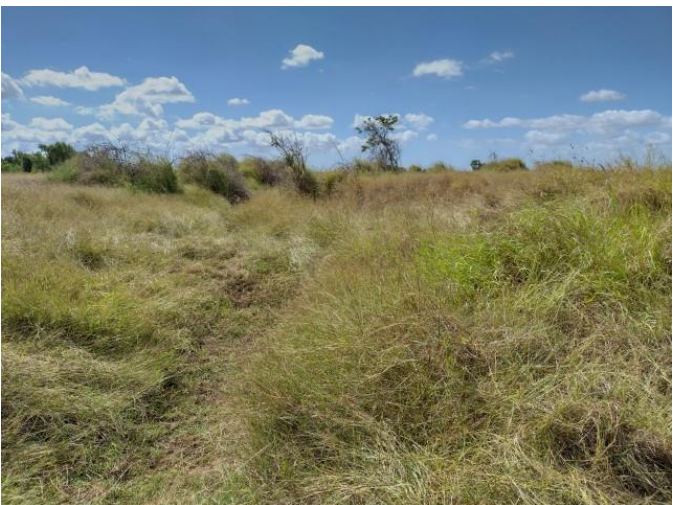
Site	Characteristics	Ecological values
Site 13 – Unnamed waterway		
Upstream	<ul style="list-style-type: none"> – Orange – moderate risk waterway mapped under the WWBW spatial layer. – The unnamed creek at Site 13 consisted of a mildly sinuous creek with a wetted width of 2 m. – Water was present in a small, isolated pool with a green coloration containing scum and was 0.3 m deep. – Land adjacent to the survey area on both banks cleared for cattle grazing. – Bed substrate was moderately aggregated, with a low level of compaction of the substrate. – Bed substrate comprised of 100% silt/clay. – Both banks had a steep slope, were benched and were 2 m high. – There was some local catchment erosion present and high bank stability. – There was no riparian zone, only with extensive amounts of exotic species of grasses along the banks. – There were no trees present within site and no shading present. 	<ul style="list-style-type: none"> – Overall habitat condition rating was poor (14). – Instream habitat consisted of shallow runs, and some emergent macrophytes. – This location would provide limited habitat for many fish species during wet periods. – Outside of any known range for threatened aquatic species.

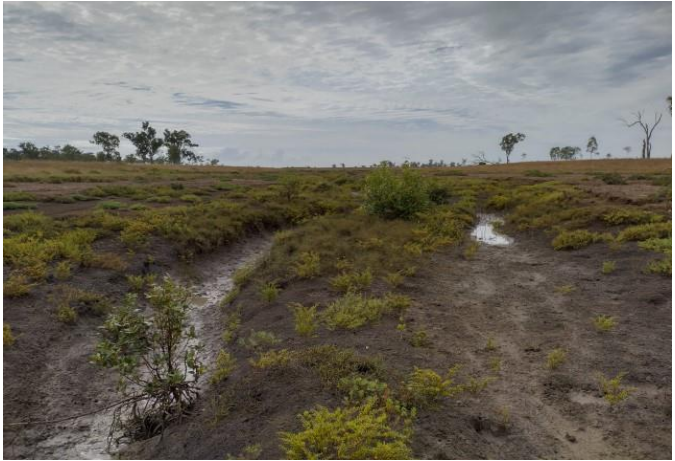
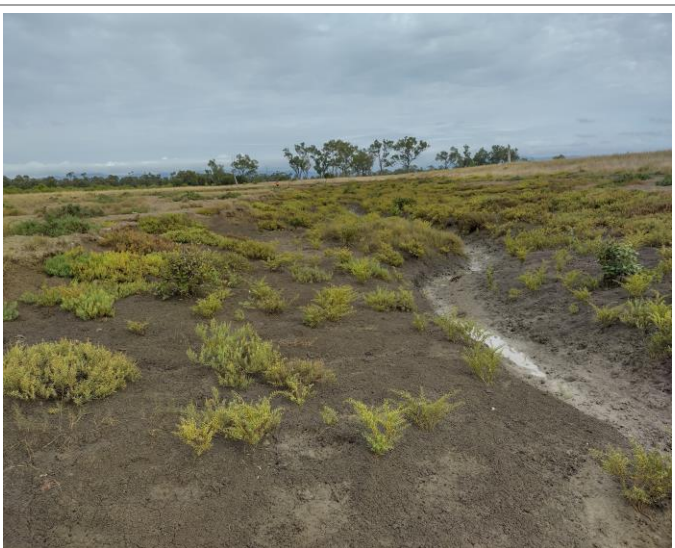
Site	Characteristics	Ecological values
Site 14 – Anabranh of Inkerman Creek		
Upstream	<ul style="list-style-type: none"> – Purple – major risk waterway mapped under the WWBW spatial layer. – The anabranh of Inkerman Creek at site 14 consisted of an irregularly meandering creek with a wetted width of 0.5 m. – Water was present in a small creek bed that was 0.2 m deep and below the watermark. – Land adjacent to the survey area on both banks cleared for cattle grazing. – Bed substrate was moderately eroded, with a tightly compacted substrate. – Bed substrate comprised of 100% silt/clay. – Both banks had a low slope, were convex in shape and were 1 m high. – There was some local catchment erosion present and high bank stability. – The riparian zone contained occasional clumps of mangrove and marine grass species along both banks. – The riparian zone consisted of a moderate amount of bare ground, some grasses, and shrubs. There were no trees present within site and no shading present. 	<ul style="list-style-type: none"> – Overall habitat condition rating was fair (53). – Juvenile mangroves present within the waterway. – Instream habitat consisted of shallow runs, and some emergent macrophytes. – This location would provide limited habitat for many fish species during wet periods. – Outside of any known range for threatened aquatic species.

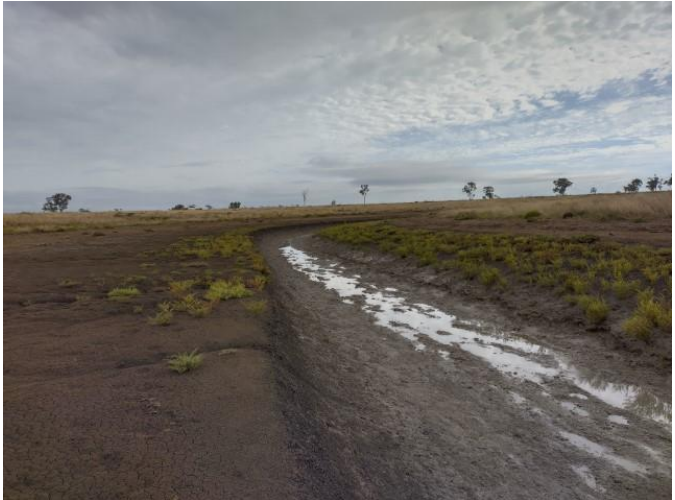
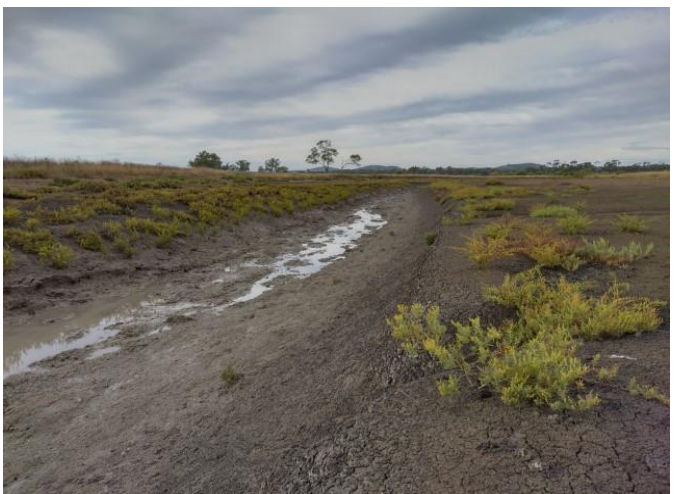
Site	Characteristics	Ecological values
Site 15 – Anabranh of Inkerman Creek		
<p>Upstream</p>

<ul style="list-style-type: none"> – Purple – major risk waterway mapped under the WWBW spatial layer. – The anabranh of Inkerman Creek at site 15 consisted of an irregular meandering creek with a wetted width of 1 m. – Water was slowly flowing in a small creek bed that was 0.3 m deep and below the watermark. – Land adjacent to the survey area on both banks cleared for cattle grazing. – Bed substrate was moderately eroded, with a tightly compacted substrate. – Bed substrate comprised of 100% silt/clay. – The left bank had a steep slope and convex shape, the right bank had a moderate slope and a concave shape. Both banks were 2 m high. – There was some local catchment erosion present and high bank stability. – The riparian zone contained occasional clumps of marine grass species along both banks. – The riparian zone consisted of a moderate amount of bare ground, some grasses and shrubs. There were no trees present within site and no shading present. 	<ul style="list-style-type: none"> – Overall habitat condition rating was fair (49). – Instream habitat consisted of shallow runs, and some emergent macrophytes. – This location would provide limited habitat for many fish species during wet periods. – Outside of any known range for threatened aquatic species.

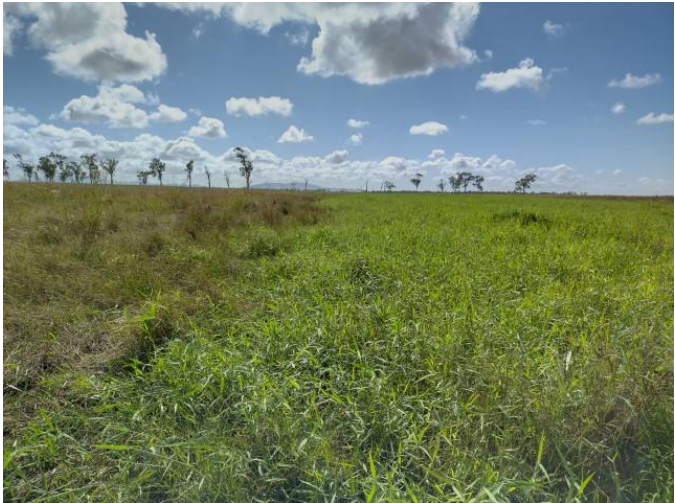
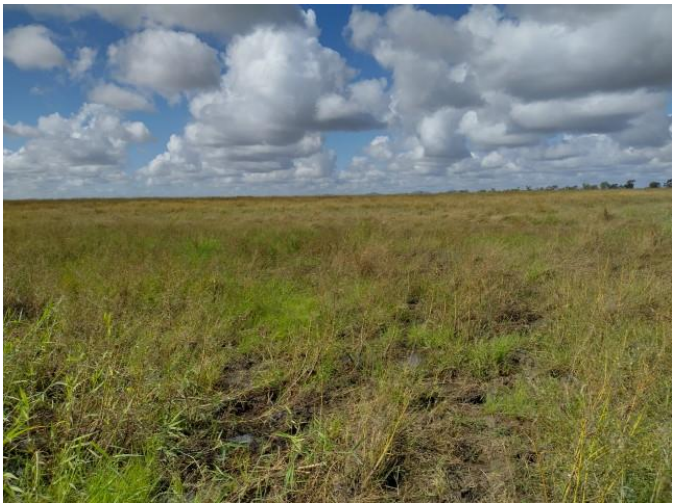
Site	Characteristics	Ecological values
Site 16 – Unnamed waterway		
<p>Upstream</p>

<ul style="list-style-type: none"> – Orange – moderate risk waterway mapped under the WWBW spatial layer. – The unnamed creek at site 16 consisted of a straight channel with a bank full width of 30 m. – Water was absent during the survey. – Land adjacent to the survey area on both banks cleared for cattle grazing. – Bed substrate was moderately aggregated, with a moderate level of compaction of the substrate. – Bed substrate comprised of 100% silt/clay. – Both banks had a low slope, were concave in shape. The left bank was 2 m high, and the right bank was 1 m high. – There was some local catchment erosion present and high bank stability. – There was no riparian zone, only with extensive amounts of exotic species of grasses along the banks. 	<ul style="list-style-type: none"> – Overall habitat condition rating was poor (22). – Instream habitat consisted of shallow runs and emergent macrophytes (paragrass). – This location would provide limited habitat for many fish species during wet periods. – Outside of any known range for threatened aquatic species.

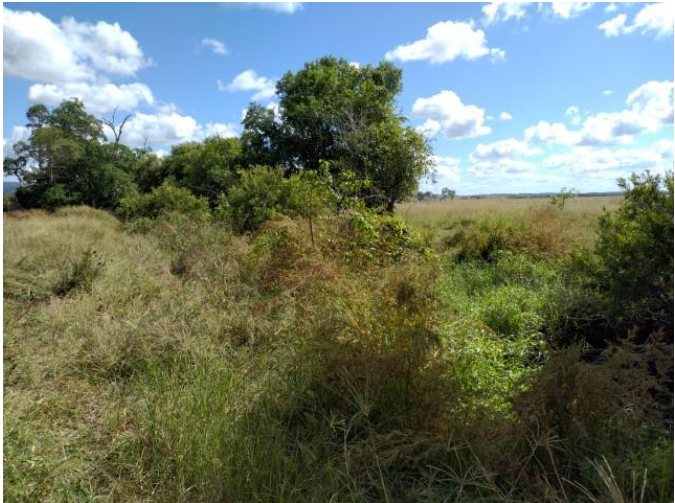
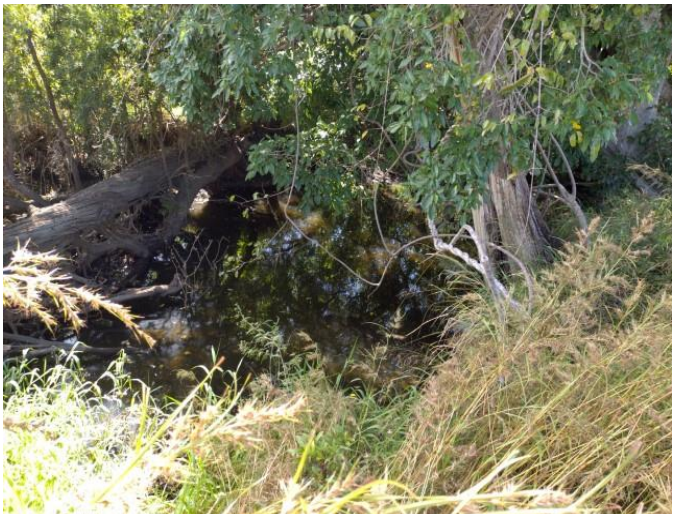
Site	Characteristics	Ecological values
Site 17 – Station Creek		
<p>Upstream</p>

<ul style="list-style-type: none"> – Purple – major risk waterway mapped under the WWBW spatial layer. – Station Creek at site 17 consisted of a mildly sinuous channel with a wetted width of 4 m. – Water was present in a small, isolated pool that was 0.2 m deep. – Land adjacent to the survey area on both banks cleared for cattle grazing. – Bed substrate was moderately aggregated, with a moderate compaction of the substrate. – Bed substrate comprised of 100% silt/clay. – Both banks had a vertical slope and were benched. Both banks were 3 m high. – There was a moderate level of local catchment erosion present. – The riparian zone was thick in clumps and sparse through most of the reach. There were some <i>Eucalyptus</i> trees <10 m high, providing the site with 15% shading and 25% trailing bank vegetation. – The riparian zone also contained an extensive proportion of grasses and some shrubs including exotic species. 	<ul style="list-style-type: none"> – Overall habitat condition rating was poor (30). – Instream habitat consisted of deep pools, runs, undercut banks, large woody debris, and emergent macrophytes (paragrass). – This location would provide optimal habitat for small bodied fish and sub-optimal habitat for large bodied fish species during wet periods. – Outside of any known range for threatened aquatic species.

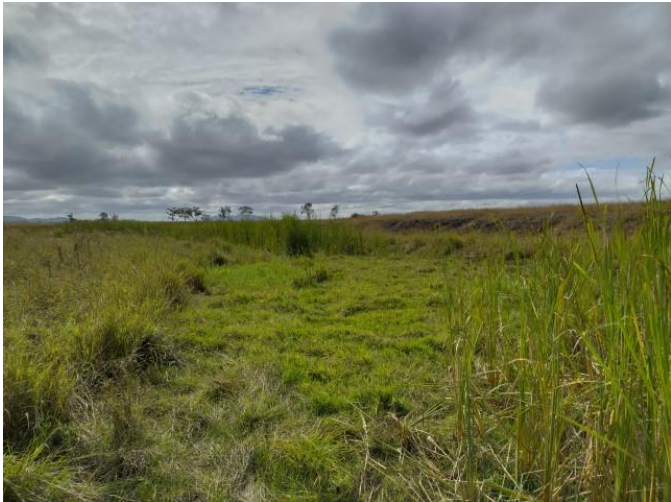
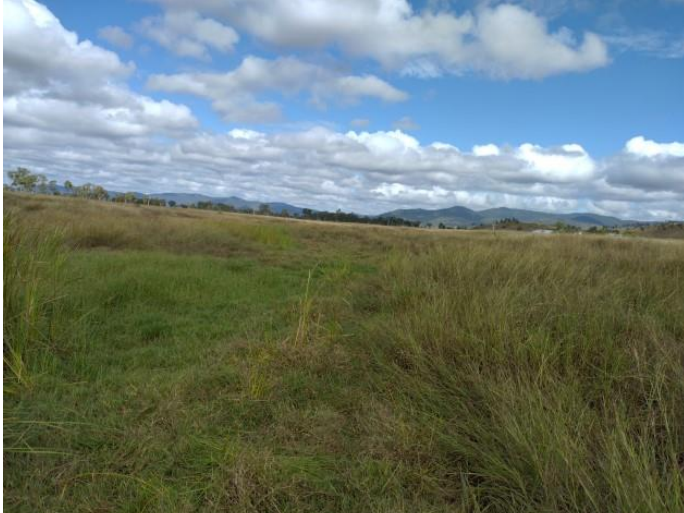
Site	Characteristics	Ecological values
Site 18 – Unnamed waterway		
Upstream	<ul style="list-style-type: none"> – Red – high-risk waterway mapped under the WWBW spatial layer. – The unnamed creek at site 18 consisted of a mildly sinuous channel with a bank full width of 5 m. – Water was absent during the survey. – Land adjacent to the survey area on both banks cleared for cattle grazing. – Bed substrate was severely aggregated, with a tightly compacted substrate. – Bed substrate comprised of 100% silt/clay. – Both banks had a low slope and a concave shape. The left bank was 2 m high, and the right bank was 1 m high. – There was some local catchment erosion present and moderate bank stability. – There was a continuous riparian zone comprised exclusively by grasses along the banks, many of which were exotic species. – There were no trees present within site and no shading present. 	<ul style="list-style-type: none"> – Overall habitat condition rating was poor (17). – Instream habitat consisted of shallow runs, and emergent macrophytes (<i>Typha sp.</i>). – This location would provide some habitat for fish species during wet periods. – Outside of any known range for threatened aquatic species.

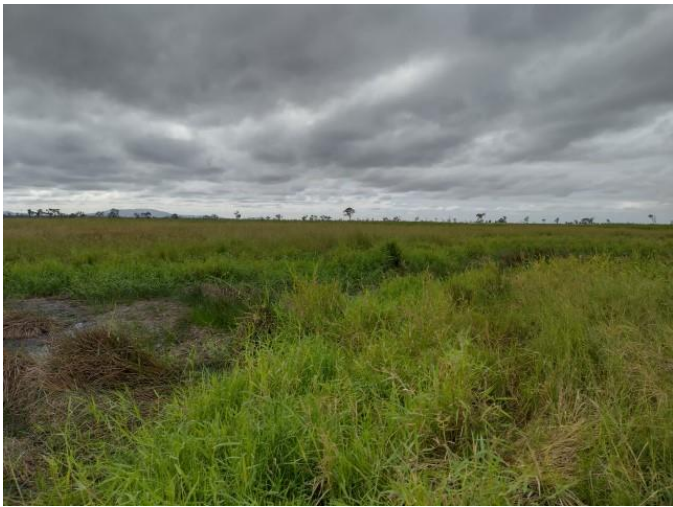
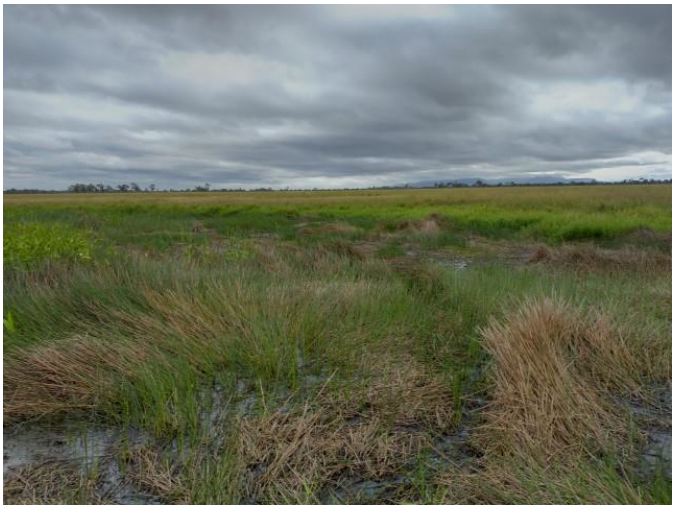
Site	Characteristics	Ecological values
Site 19 – Unnamed waterway		
<p>Upstream</p>

<ul style="list-style-type: none"> – Amber – moderate risk waterway mapped under the WWBW spatial layer. – The unnamed creek at site 19 consisted of a regularly meandering channel with a minimum bank full width of 5 m and a maximum bank full width of 30 m. – Water was present in a small, isolated pool that was 0.1 m deep. – Land adjacent to the survey area on both banks cleared for cattle grazing. – Bed substrate was severely aggregated, with a moderately compacted substrate. – Bed substrate comprised of 100% silt/clay. – Both banks had a moderate slope and a concave shape. Both banks were 0.5 m in height. – There was some local catchment erosion present and high level of bank stability. – There was a continuous riparian zone comprised exclusively by grasses along the banks, many of which were exotic species. – There were no trees present within site and no shading present. 	<ul style="list-style-type: none"> – Overall habitat condition rating was poor (30). – Instream habitat consisted of shallow pools, and emergent macrophytes including <i>Juncus sp.</i> and paragrass. – This location would provide limited habitat for many fish species during wet periods. – Outside of any known range for threatened aquatic species.

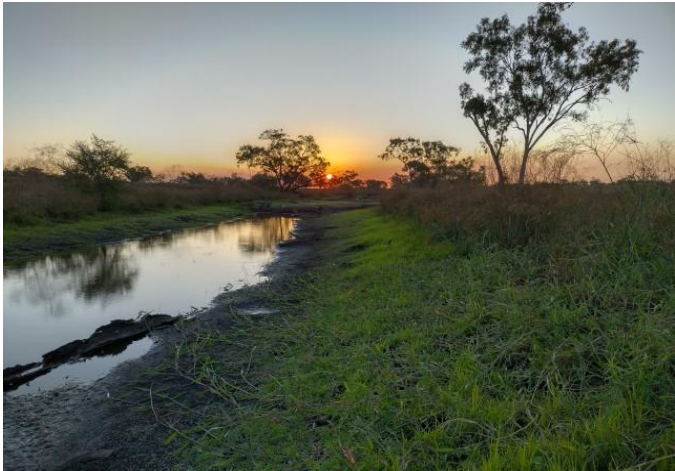
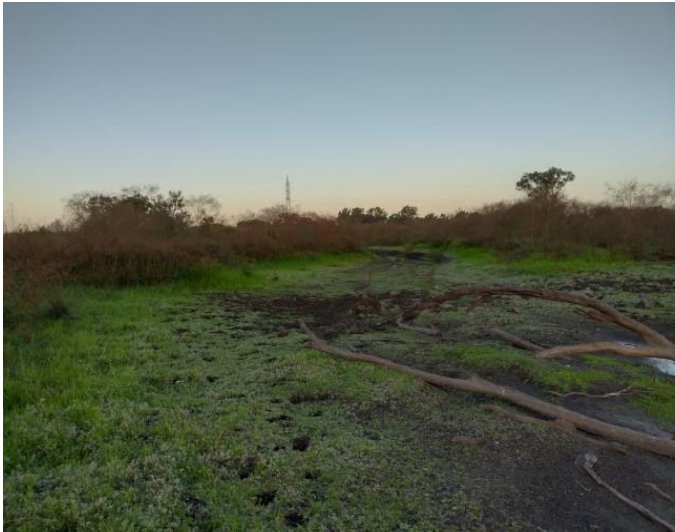
Site	Characteristics	Ecological values
Site 24 – Oaky Creek		
<p>Upstream</p>

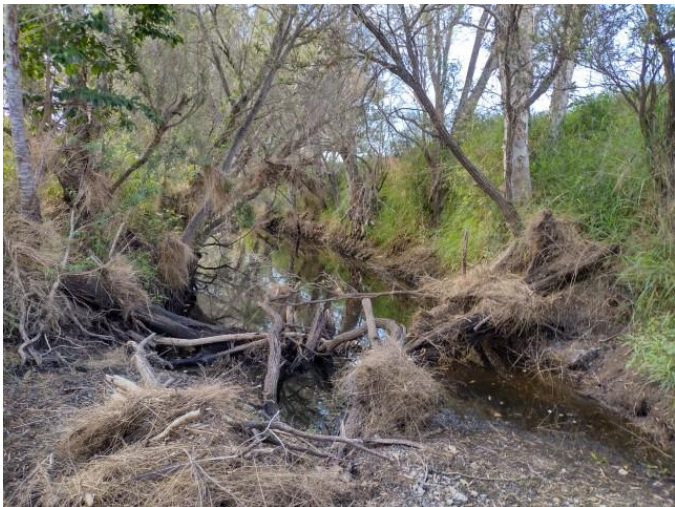
<ul style="list-style-type: none"> – Purple – major risk waterway mapped under the WWBW spatial layer. – Oaky Creek at site 24 consisted of a mildly sinuous channel with wetted width of 3 m. – Water was present in an isolated pool that was 0.2 m deep. – Land adjacent to the survey area on both banks cleared for cattle grazing. – Bed substrate was moderately aggregated, with a moderately compacted substrate. – Bed substrate comprised of 5% cobble, 15% pebble, 20% gravel, 30% sand, and 30% silt/clay. – Both banks had a vertical slope and a benched shape. Both banks were 4 m in height. – There was a little evidence of local catchment erosion present and high level of bank stability. – There was a regularly spaced riparian zone along both banks that contained a moderate amount of grasses and shrubs, and some trees <10 m in height. Some of the species present were exotic. – Shading was 75% and trailing bank vegetation 50%. 	<ul style="list-style-type: none"> – Overall habitat condition rating was fair (70). – Instream habitat consisted of shallow pools, and large woody debris – This location would provide optimal habitat for many fish species during wet periods. – Outside of any known range for threatened aquatic species.

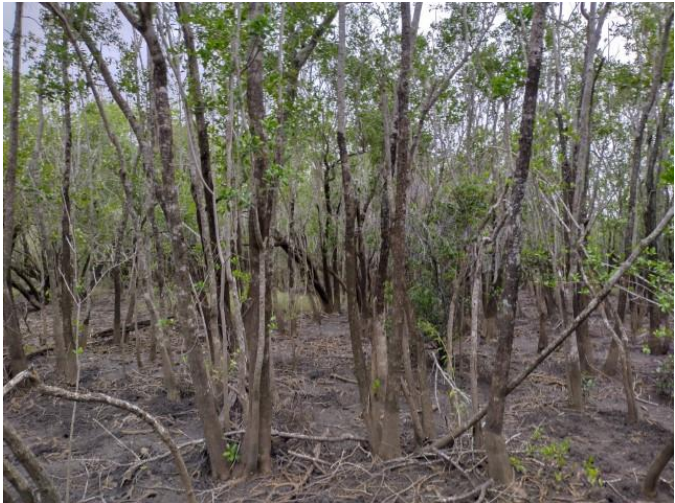
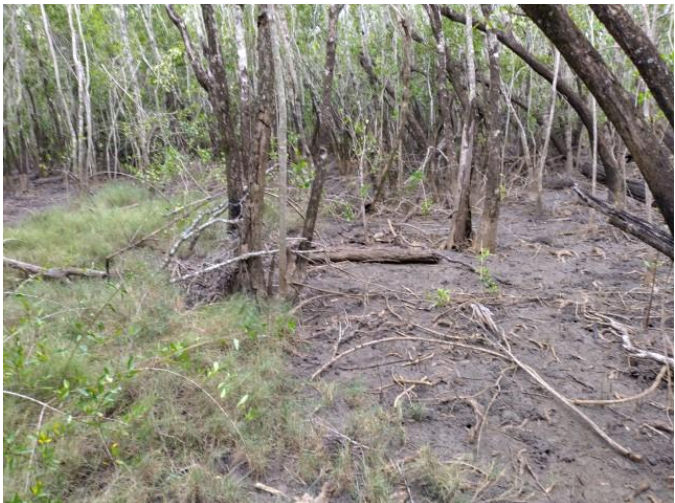
Site	Characteristics	Ecological values
Site 26 – Unnamed wetland near Raglan Creek		
<p>Photo 1</p>

<ul style="list-style-type: none"> – Mapped HSE wetland. – The wetland type is described as an upper mangrove wetland. – The site was dry during the survey with no evidence of recent inundation. – The site is located less than 100 m Raglan Creek and would be inundated during spring high tides and during floods. – Adjacent land use is natural, with evidence of horse grazing. – Mangrove species dominated the tree canopy level, while patches of marine couch dominated the understory. – The substrate was stable with little signs of erosion. 	<ul style="list-style-type: none"> – The site was dominated entirely by grasses and mangroves. There was some large and small woody debris present that when inundated by water would provide the site with some habitat and refugia. Overall, with the absence of surface waters the site is marginal for aquatic species and only for a short period of time when inundated. – Site not suitable for foraging, refuge or breeding of any marine aquatic species. – Site not suitable for foraging, refuge or breeding of any freshwater aquatic species. – Site not suitable for estuarine crocodile refuge, foraging or nesting.
