4.4 Terrestrial fauna

**Fitzroy to Gladstone Pipeline
Baseline Terrestrial and Aquatic
Ecology Technical Report
Figure 4-6q
Habitat Types Identified
Within the SGIC SDA Study Area**
000-G-MAP-2415 Version:3 Date:2022/09/12

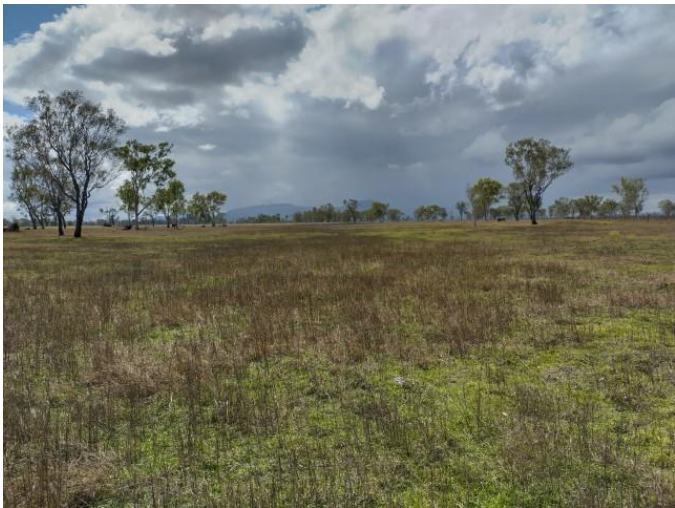
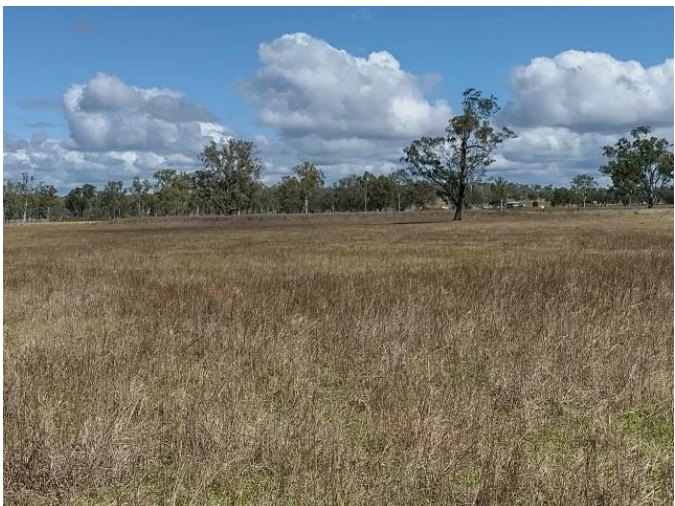
Site	Characteristics	Ecological values
Site 27 – Unnamed wetland		
<p>Upstream</p>

<ul style="list-style-type: none"> – Mapped HSE wetland. – The wetland type is described as an open wetland with grass understorey. – The site was dry during the survey with no evidence of recent inundation. – The wetland and land adjacent to the survey area was cleared for cattle grazing. – Bed substrate was severely aggregated, with a tightly compacted substrate. – Bed substrate comprised of 100% silt/clay. – Both banks had a flat slope and a concave shape. – There was little local catchment erosion present and moderate bank stability. – There was a continuous riparian zone comprised exclusively by grasses in the bed and along the banks, many of which were exotic species. – There were no trees present within site and no shading present. 	<ul style="list-style-type: none"> – A dam wall that was approximate 3 m high was located approximate 300 m downstream of the site and another of the same height located approximately 1 km upstream of the site. – Instream habitat was minimal and consisted of terrestrial grasses. – This location would provide limited habitat for many fish species during wet periods. – Outside of any known range for threatened aquatic species. –

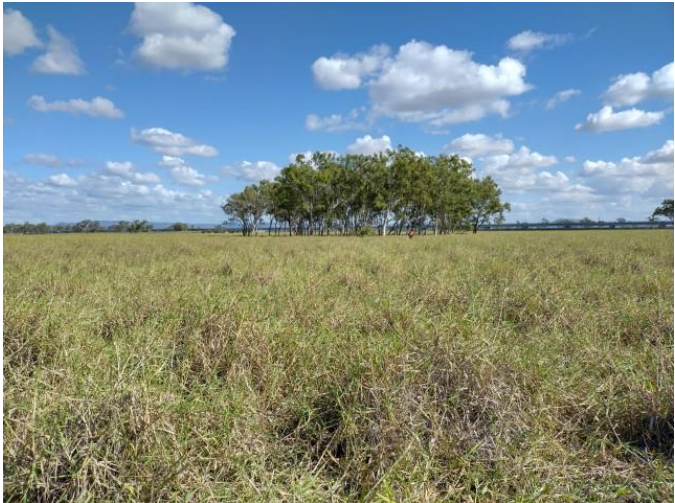
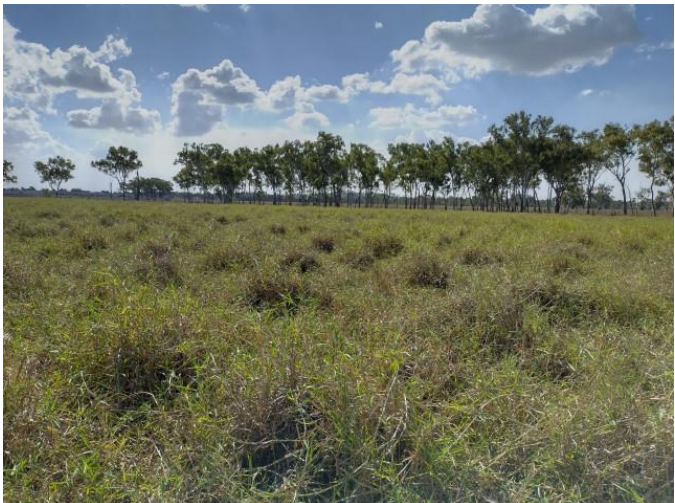
Site	Characteristics	Ecological values
Site 28 – Unnamed wetland		
<p>Photo 1</p>

<ul style="list-style-type: none"> – Mapped HSE wetland. – The wetland type is described as an open wetland with grass understorey. – The site was dry during the survey with no evidence of recent inundation. – The wetland and land adjacent to the survey area was cleared for cattle grazing. – Bed substrate was severely aggregated, with a tightly compacted substrate. – Bed substrate comprised of 100% silt/clay. – Both banks had a flat slope and a concave shape. – There was little local catchment erosion present and moderate bank stability. – There was a continuous riparian zone comprised exclusively by grasses in the bed and along the banks, many of which were exotic species. – There were no trees present within site and no shading present. 	<ul style="list-style-type: none"> – Instream habitat was minimal and consisted of terrestrial grasses. – This location would provide limited habitat for many fish species during extremely wet periods. – Outside of any known range for threatened aquatic species.

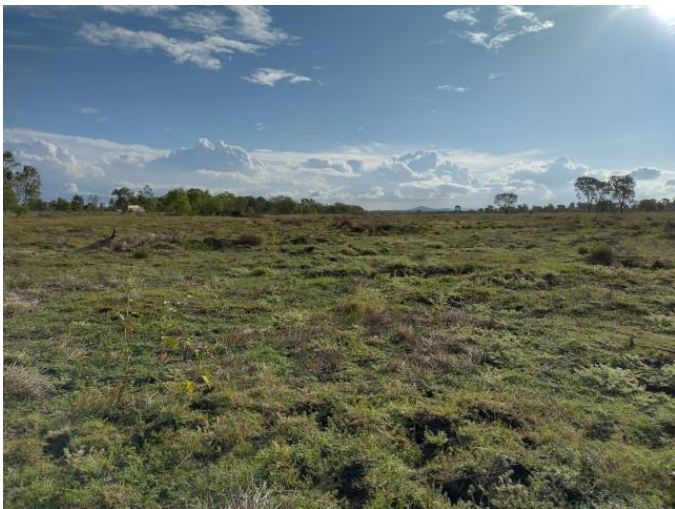
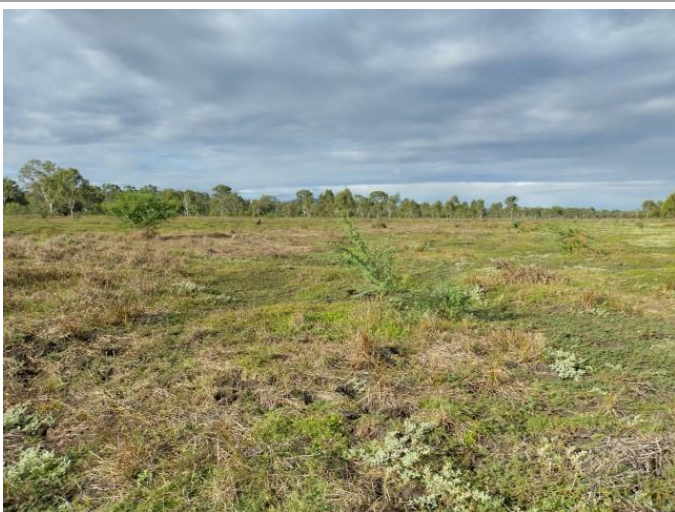
Site	Characteristics	Ecological values
Site 29 – Unnamed wetland		
<p>Upstream</p>

<ul style="list-style-type: none"> – Mapped HSE wetland. – The wetland type is described as an open floodplain watercourse with grass understorey. – The site was dry during the survey with no evidence of recent inundation. – The wetland and land adjacent to the survey area was cleared for cattle grazing. – Bed substrate was severely aggregated, with a tightly compacted substrate. – Bed substrate comprised of 100% silt/clay. – Both banks had a flat slope and a concave shape. – There was little local catchment erosion present and moderate bank stability. – There was a continuous riparian zone comprised exclusively by grasses in the bed and along the banks, many of which were exotic species. – There were no trees present within site and no shading present. 	<ul style="list-style-type: none"> – Instream habitat was minimal and consisted of terrestrial grasses. – This location would provide limited habitat for many fish species during wet periods. – Outside of any known range for threatened aquatic species.

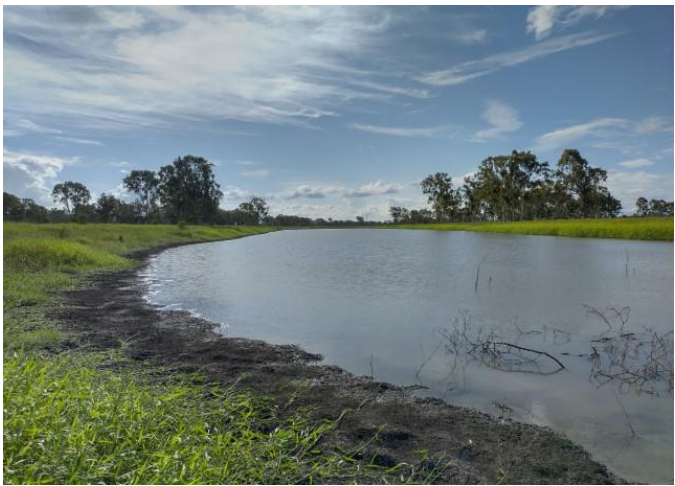
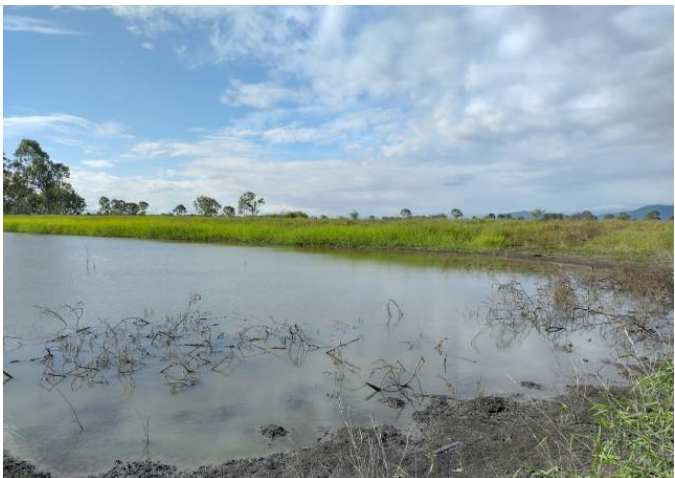
Site	Characteristics	Ecological values
Site 30 – Unnamed wetland		
<p data-bbox="210 258 293 284">Photo 1</p>

<ul style="list-style-type: none"> – Mapped HSE wetland. – The wetland type is described as a floodplain billabong. – The site was wet during the survey, and water level below the watermark. – Water was turbid. – The wetland dimensions were approximately 1500 m long by 100 m wide and greater than 1.5 m deep. – Connection to other waterbodies only occurs during floods. – The wetland and land adjacent to the survey area was cleared for cattle grazing. – Bed substrate was severely aggregated, with a tightly compacted substrate. – Bed substrate comprised of 100% silt/clay. – Both banks had a flat slope and a concave shape. – There was little local catchment erosion present and moderate bank stability. – There was a continuous riparian zone comprised exclusively by grasses in the bed and along the banks, many of which were exotic species. – There were no trees present within site and no shading present. 	<ul style="list-style-type: none"> – Habitat large shallow pool, with deep middle. – Small woody debris present – Site not suitable for white-throated snapping turtle refuge or nesting. – Site not suitable for platypus refuge or borrowing opportunities. – Site sub-optimal for estuarine crocodile refuge or nesting and may occur.

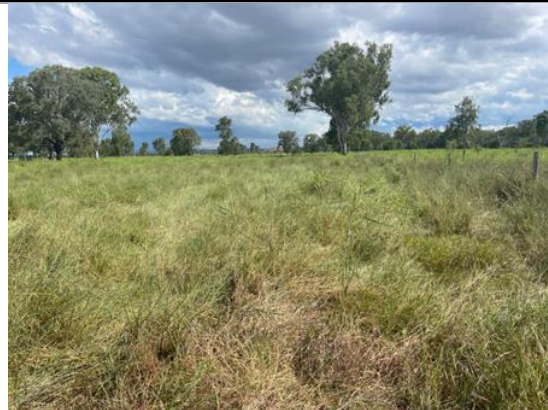
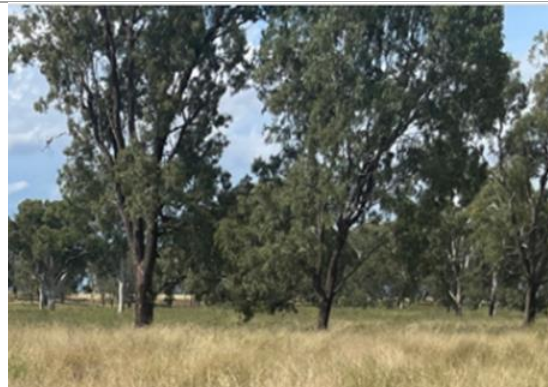
Location	Mapped RE	Field verified RE	Field description	Representative photograph
-23.369, 150.400	Category B 11.3.3/ 11.3.4	Category X	<p>E – <i>Eucalyptus tereticornis</i>, <i>Lysiphyllum</i> sp., <i>E. coolabah</i>, <i>Corymbia tessellaris</i> (14-20 m tall, 4% cover)</p> <p>G – <i>Megathyrsus maximus</i>*, <i>Urochloa mutica</i>*, <i>Dichanthium aristatum</i>*, <i>Eriochloa pseudoacrotricha</i>, <i>Echinochloa colona</i>*, <i>Parthenium hysterophorus</i>*, <i>Aeschynomene indica</i>*, <i>Sesbania cannabina</i>, <i>Macroptilium lathyroides</i>*, <i>Sida</i> spp. (1 m tall, 95% cover).</p> <p>Landform: alluvial plain</p> <p>Note: A substantial portion of the mapped polygon within study corridor lacks sufficient tree cover to meet remnant or Category C status.</p>

Category B 11.3.3/ 11.3.4	<p>T1 — <i>Eucalyptus tereticornis</i>, <i>E. coolabah</i> (12 – 18 m tall, 20 % cover).</p> <p>T2 — <i>Eucalyptus tereticornis</i>, <i>Lysiphyllum hookeri</i>, <i>E. coolabah</i>, <i>Corymbia tessellaris</i> (6-10 m tall, 10 % cover).</p> <p>G — <i>Eriochloa pseudoacrotricha</i>, <i>Megathyrsus maximus</i>*, <i>Urochloa mutica</i>*, <i>Parthenium hysterophorus</i>*, <i>Aeschynomene indica</i>*, <i>Sesbania cannabina</i>, <i>Macroptilium lathyroides</i>*, <i>Sida</i> spp. (0.3-1 m tall, 85% cover).</p>

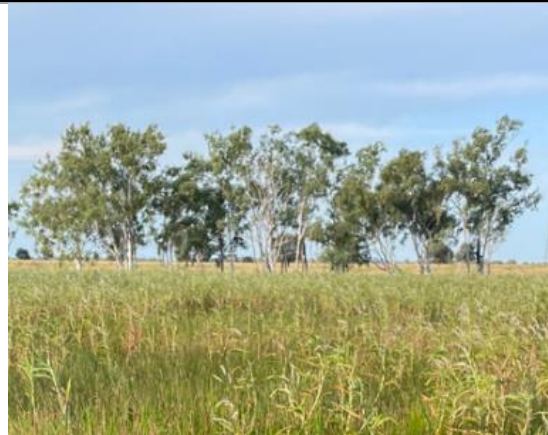
Location	Mapped RE	Field verified RE	Field description	Representative photograph
-23.3462, 150.4052	Category B 11.3.25/11.3.27 c	Category B 11.3.4	Aerial and hillshade imagery indicate lack of defined drainage line. Rather, vegetation occupies an alluvial plain surrounding shallow depression and is representative of 11.3.4.

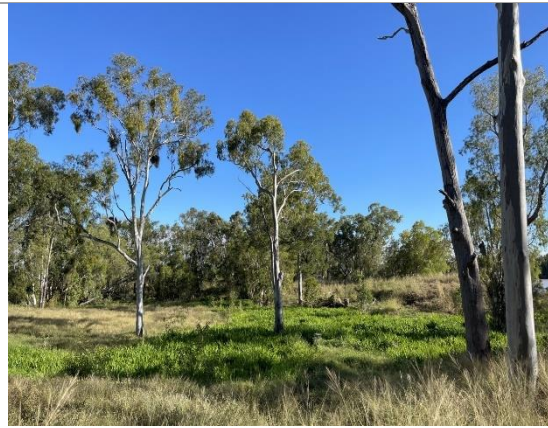
-23.2949, 150.4361	Category R 11.3.3	Category R 11.3.25e	<p>T1 – <i>Eucalyptus camaldulensis</i>, <i>Melaleuca leucandendra</i> (18-23 m tall, 10 % cover)</p> <p>T2 – <i>Casuarina cunninghamiana</i> (2% cover)</p> <p>S1 – <i>E. camaldulensis</i> (1-2 m tall)</p> <p>G – <i>Megathyrsus maximus</i>*, <i>387oriacea387t amplexicaulis</i>*, <i>Passiflora foetida</i>*, <i>Alternanthera sp.</i>, <i>Echinochloa sp.</i> (0.2-1 m tall, 90% cover)</p> <p>Landform: watercourse</p>

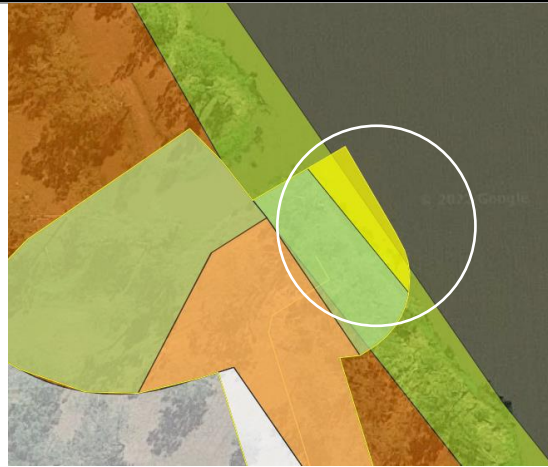
Location	Mapped RE	Field verified RE	Field description	Representative photograph
-23.2947, 150.4367	11.3.25f	Water	Adjustment made to polygon boundary to more accurately reflect site observations and aerial imagery

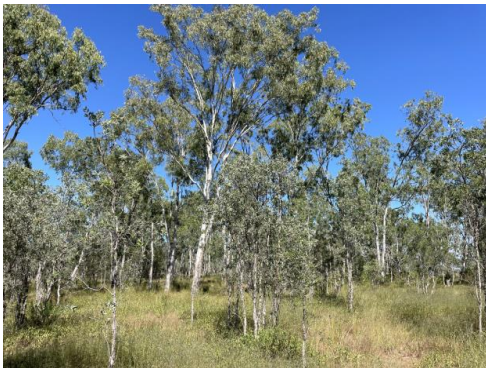
Habitat type	General characteristics and ecological values
<p>Regrowth and scattered <i>Eucalyptus/Corymbia/Acacia</i> trees</p>

<ul style="list-style-type: none"> Characterised by low to moderate density of mature and regrowth vegetation and is dominated by introduced pasture grasses. Eucalypts provide blossoms and nesting opportunities for honeyeaters, and foraging habitat for flying-foxes. Variety of koala food trees present, including <i>Eucalyptus tereticornis</i>, <i>E. populnea</i> and <i>E. crebra</i>. Few hollow-bearing trees present. Arboreal termite mounds with an excavated hole provide suitable nesting sites for bird species, including the laughing kookaburra, blue-winged kookaburra and forest kingfisher. Shrub layer was very sparse, consisting of various shrub species and juvenile canopy species. The shrub layer that does exist provides some nesting and foraging resources for shrub-nesting birds such as finches. Ground-level microhabitats (e.g. logs, woody debris, leaf litter) was very sparse. These microhabitats provide shelter and foraging microhabitat for ground-dwelling mammals and reptiles. Ground cover was relatively dense with a mixture of introduced grasses herbaceous weeds. Grasses provide food resources for some granivorous birds and herbivorous mammals. Small, isolated patches of <i>Casuarina cristata</i> occurred within the landscape. <p>MNES and MSES species:</p> <ul style="list-style-type: none"> Potential foraging habitat for the squatter pigeon (southern) within 1 km (for breeding) and 3 km (for foraging) of a suitable, permanent or seasonal waterbody. Potential foraging habitat for the koala.

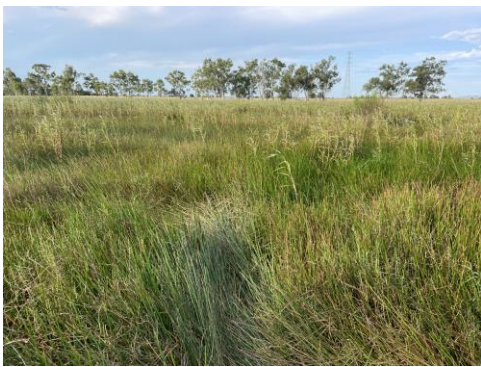
<p>Freshwater waterbodies and seasonal wetlands</p>

<ul style="list-style-type: none"> Permanent to semi-permanent waterbodies (i.e. wetlands) provide foraging, breeding and nesting habitat for a range of waterbirds, such as the plumed whistling duck (<i>Dendrocygna eytoni</i>), Australian pelican (<i>Pelecanus conspicillatus</i>) and white-faced heron (<i>Egretta novaehollandiae</i>). Within the context of the local environment, permanent waterbodies provide an important reliable source of drinking water for birds, macropods, reptiles and amphibians. These features are particularly important during times of drought. Waterbodies support local food webs. A local abundance of invertebrates provides prey items for microbats and amphibians. In turn, these attract predators including snakes, waterbirds, and raptors. Canopy and/or shrub layer was either very sparse or absent. Wetlands contained dense sedges, rushes and grasses, as well as dead stags within small (<10 cm) hollows, ground logs and woody debris. Low density of deep cracking clays present. <p>MNES and MSES species:</p> <ul style="list-style-type: none"> Potential foraging habitat for the Australian painted-snipe and migratory bird species. Potential foraging habitat for the squatter pigeon (southern).

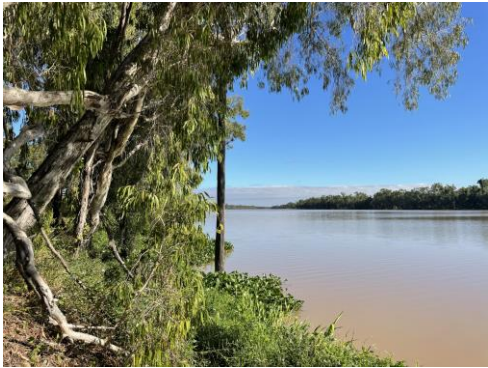
Habitat type	General characteristics and ecological values
<p>Fringing riparian vegetation</p>

<ul style="list-style-type: none"> – Fringing riparian vegetation along the banks of the Fitzroy River was dominated by <i>Melaleuca</i> sp. With associated <i>Eucalyptus camaldulensis</i>. – <i>Eucalyptus</i> and <i>Melaleuca</i> species provide blossoms and nesting opportunities for honeyeaters and parrots, and foraging habitat for flying-foxes. – Low density of small (< 10 cm) tree hollows along the banks of the Fitzroy River. Small hollow-bearing trees provide suitable habitat for microbats, snakes and tree frogs. – Fringing <i>Melaleuca</i> trees is moderately dense providing shelter and nesting habitat for finches, fairy-wrens and other shrub-dwelling birds. – Ground-level microhabitats, including coarse woody debris and dense ground cover, provide shelter and foraging habitat for a variety of reptile and frog species. – An important movement corridor for native mammals, birds, reptiles and amphibians, and are important foraging routes and flyways for microbats. – Important source of drinking water that is utilised by a variety of fauna species for months after the wet season has ended. <p>MNES and MSES species:</p> <ul style="list-style-type: none"> – Potential foraging habitat for the koala. – Potential foraging habitat for the squatter pigeon (southern). – Potential foraging habitat for migratory bird species.

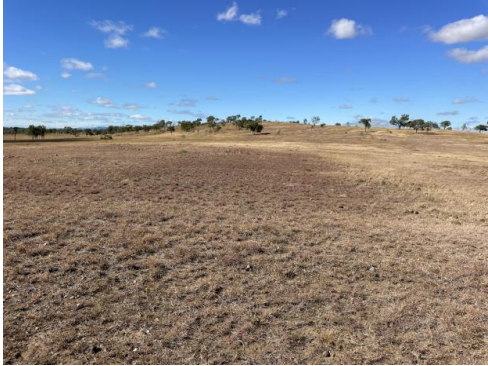
<p>Cleared and highly modified landscapes</p>

<ul style="list-style-type: none"> – Characterised by the absence or very low density of canopy and shrub vegetation and is dominated by introduced pasture grasses. – Very low density of koala food trees present (< 1 tree per ha), including <i>Eucalyptus</i>, <i>Corymbia</i> and <i>Acacia</i> species. – Introduced grass species provide food resources for some grassland birds, and herbivorous mammals such as macropods. – The open landscape provides foraging habitat for raptors and snakes. – Ground-level microhabitats have been historically cleared and lack structural complexity. – In most areas, the ground-layer has been heavily altered by cattle grazing and trampling, and intensive cultivation. These alterations have reduced the presence of suitable microhabitats for a range of fauna species. <p>MNES and MSES species:</p> <ul style="list-style-type: none"> – No suitable habitat for conservation significant fauna species.

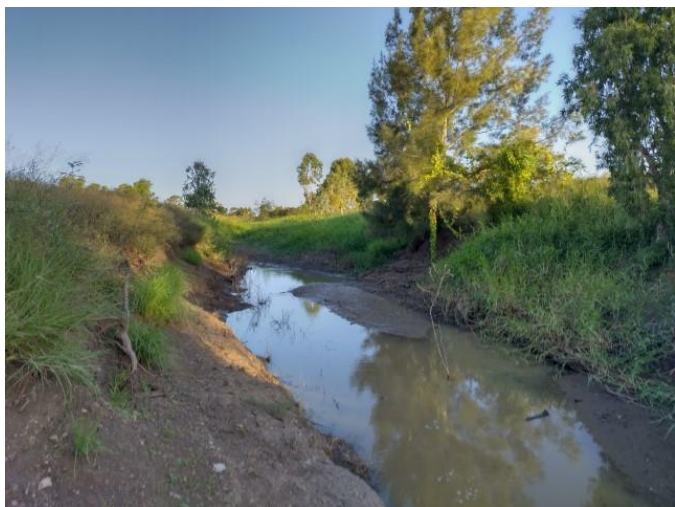
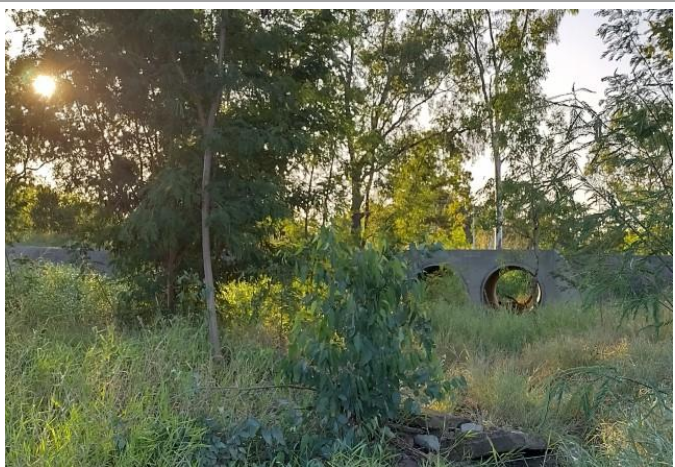
Site	Characteristics	Ecological values
Site 22 – unnamed waterway		
Upstream	<ul style="list-style-type: none"> Orange – moderate risk waterway mapped under the WWBW spatial layer. Water was isolated in a small pool within the main channel. Channel width was approximately 9 m, with vertical banks on both banks 2.5 m high. The wetted width of the pool at this location was approximately 4.5 m, and was 17 m long, the maximum depth was approximately 0.3 m. Land use adjacent to the survey area was subject to cattle grazing. Adjacent riparian zone had no bare ground and was covered extensively in grass. Large barrier immediately upstream of the study site. There was evidence of scouring occurring in the reach from the culvert upstream and moderate erosion of the streambed. Water within pool was highly turbid. Bed substrate was primarily silt/clays, with some cobbles, pebbles, and gravel. 	<ul style="list-style-type: none"> Overall habitat condition rating was poor (44). Instream habitat consisted of a small pool that contained some small woody debris. The pool would support some small bodied fish species, for a limited time, with the ephemeral nature of the waterway the pool is likely to dry out during the dry season. During large flows the pool would provide refuge and habitat for transient fish species. No aquatic plant species were recorded. Large culvert upstream of site likely to cause some restriction on aquatic fauna movement. Site not suitable for white-throated snapping turtle foraging or nesting. Site not suitable for Fitzroy River turtle foraging or nesting. Site not suitable for platypus foraging or borrowing opportunities. Site not suitable for estuarine crocodile refuge or nesting.

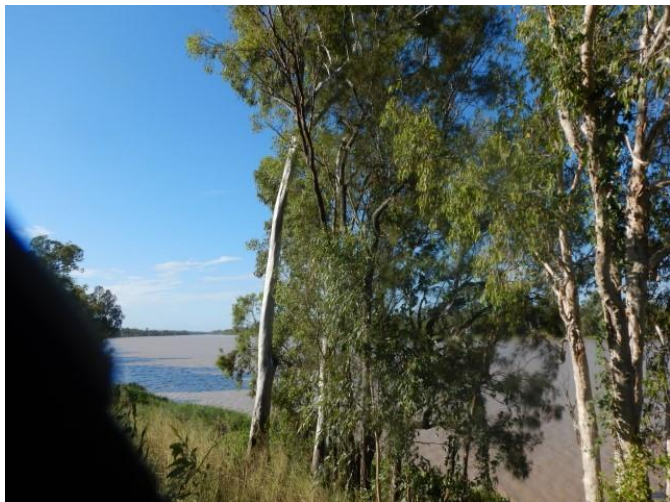
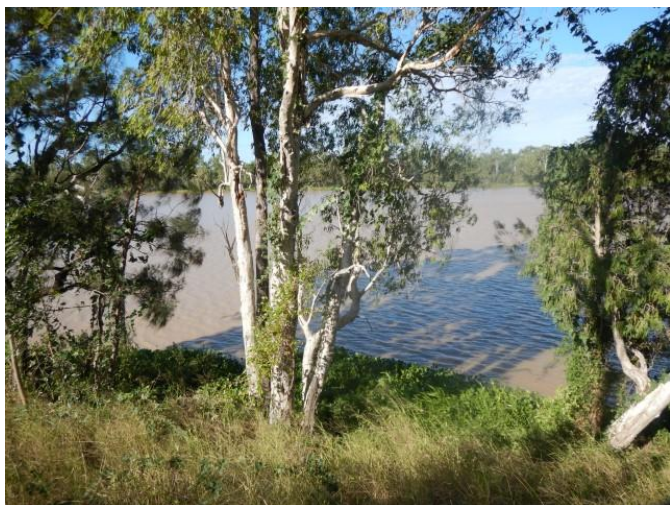
Site	Characteristics	Ecological values
Site 23 – Fitzroy River		
Upstream	<ul style="list-style-type: none"> – Purple – major risk waterway mapped under the WWBW spatial layer. – The Fitzroy River at Site 23 consisted meandering channel that was approximately 350 m wide. – Water flow was only very slow at the time of the survey but was above the watermark. – Water clarity was very turbid. – Land use adjacent to the survey area was native forest, national park and cattle grazing. – Bed substrate was stable, with deposition of silt upon the substrate. – The banks on both sides of the river were moderately steep, moderately stable and concave in shape with little erosion. – Riparian vegetation was semi-continuous on both banks with moderate amounts of <i>Eucalyptus</i> and <i>Melaleuca</i> trees >10 m high, and a moderate amount of grasses. 	<ul style="list-style-type: none"> – Overall habitat condition rating was good (75). – Instream habitat consisted of deep pools, and aquatic macrophytes that consisted of the exotic water hyacinth (<i>Eichhornia crassipes</i>) and other grass like species. – The Fitzroy River at this location provides suitable habitat for many fish and turtle species, platypus, as well as estuarine crocodiles. – Optimal foraging habitat for white-throated snapping turtle and likely to occur. Unlikely to support aggregated nesting, however isolated nesting may occur. – Optimal foraging habitat for Fitzroy River turtle and likely to occur. Unlikely to support aggregated nesting, however isolated nesting may occur. – Provides optimal habitat and likely optimal burrowing opportunities for platypi and is therefore likely to occur at this site. – Optimal foraging habitat occurs at this site, as well as sub-optimal breeding habitat for estuarine crocodile and therefore the species is likely to occur at this site.

The overall condition of the Fitzroy River at site 23, the location of the intake structure, was assessed as 'good', with a score of 75. The site characteristics of bottom substrate and embeddedness consisted of large woody debris and rocky habitats. The riffle/run, run/bend ratio categories were assessed as poor. This reach of the Fitzroy River is a large slow flowing channel with lack of riffles and runs due to the barrage downstream. The banks of the river are well vegetated with large trees, grasses and aquatic macrophytes creating stable banks and streamside cover in excellent condition.

Previous records of platypus have been observed in the Fitzroy River in the reaches near site 23 (ALA 2022). Habitat conditions, such as large woody debris, tree roots and aquatic macrophytes present at site 23 provide optimal foraging habitat for the species. Due to safety reasons associated with the potential presence of estuarine crocodiles, a confirmation on the presence of burrows was unable to occur. However, suitable observations of the bank conditions and visual habitats present were assessed and the site considered likely to contain suitable burrowing habitat. The remaining locations, sites 22, 25, 31, and 32, had little or no surface water present and therefore were not suitable to maintain the species throughout the year, no individuals or evidence of burrows were observed whilst undertaking surveys at these sites.

Similar to the platypus, previous records of estuarine crocodiles have been observed in the Fitzroy River in the reaches near site 23 (ALA 2022). Optimal foraging habitat for crocodiles occurs at this site, as well as sub-optimal breeding habitat. The remaining locations, sites 22, 25, 31, and 32, had little or no surface water present and therefore were not suitable to maintain the species throughout the year, no individuals or evidence of nesting were observed whilst undertaking surveys at these sites.

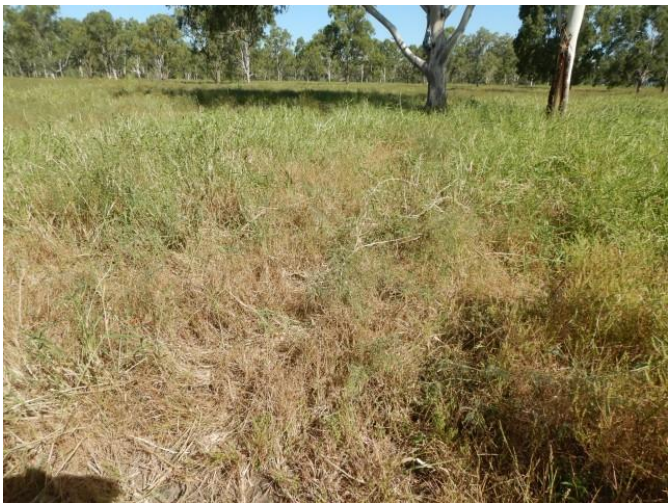
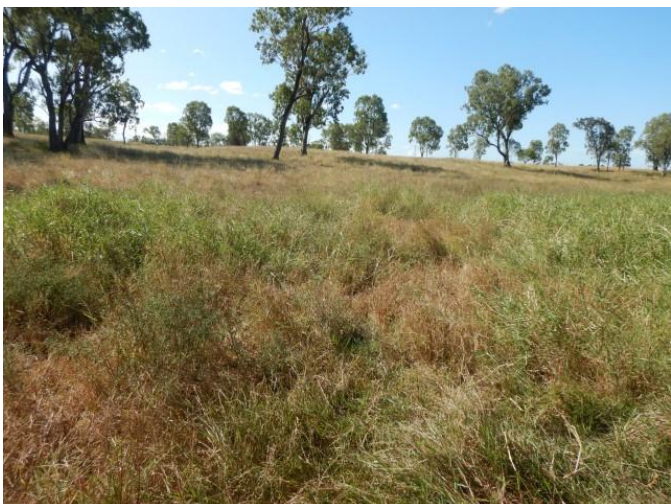
Site	Characteristics	Ecological values
Site 25 – Lion Creek, Upstream of Lions Lagoons		
<p>Upstream</p>

<ul style="list-style-type: none"> – Purple – major risk waterway mapped under the WWBW spatial layer. – The location at the time of survey was dry. – The site was a low-lying area with no defined creek bed or banks. – Land use adjacent to the survey area was predominantly cattle grazing and land clearing. – The substrate was stable, with moderate compaction and comprised entirely of silt/clay. – The bank consisted of material similar to the substrate at the survey site and has a low to flat slope. – Riparian vegetation was moderately disturbed and consisted of a eucalypt and melaleuca canopy and in the understorey. – The riparian vegetation was isolated along the banks and semi-continuous with the study location and provided vegetation for cover. 	<ul style="list-style-type: none"> – Overall habitat condition rating was fair (49). – The site was dominated entirely by terrestrial trees and grasses. There was some large and small woody debris present that when inundated by water would provide the site with some habitat and refugia. Overall site not suitable for aquatic species. – Site not suitable for white-throated snapping turtle refuge or nesting. – Site not suitable for Fitzroy River turtle refuge or nesting. – Site not suitable for platypus refuge or borrowing opportunities. – Site not suitable for estuarine crocodile refuge or nesting.

Site 25 is located on Lion Creek and is upstream of Lions Lagoon. The overall condition of site 25 was assessed as 'fair', with a score of 49. This site performed poorly in the bottom substrate, embeddedness, velocity and depth, and riffle/run, run/bend ratio categories due mainly to the absence of surface water within the reach. The channel alteration, bottom scouring and deposition, and the bank stability categories were assessed as in excellent condition.

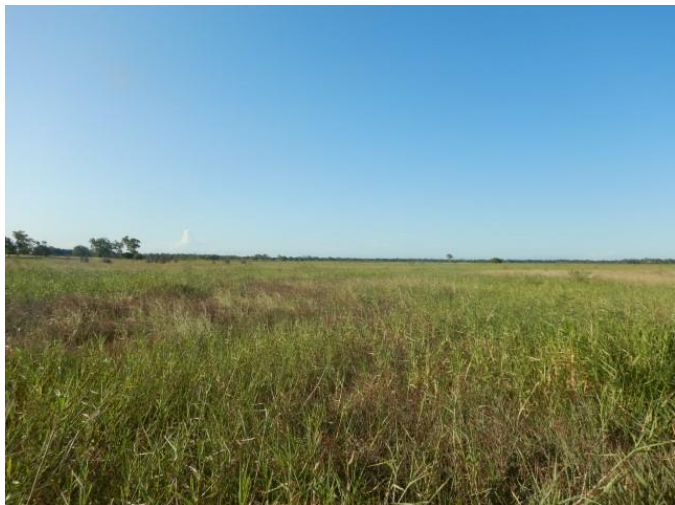
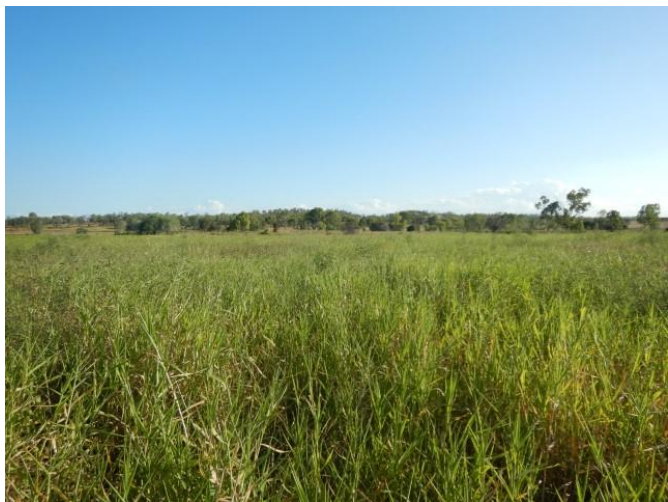
Site	Characteristics	Ecological values
Site 31 – unnamed, upstream of Gracemere Lagoon		
Upstream	<ul style="list-style-type: none"> – Mapped HSE wetland. – The wetland type is described as an open wetland with grass understorey. – The site was dry during the survey with no evidence of recent inundation. – The site is located less than 200 m from the nearest wetland which contained water at the time of survey. – Adjacent land use is predominantly used for cattle grazing. – No native aquatic plant species was present. – The site had a high proportion of weeds present, including <i>Parthenium hysterophorus</i>. – Tall trees were rare, all were eucalypts. – The banks were stable with little signs of erosion, similarly to the substrate. 	<ul style="list-style-type: none"> – The site was dominated entirely by grasses. There was some large and small woody debris present that when inundated by water would provide the site with some habitat and refugia. Overall, with the absence of surface waters the site is not suitable for aquatic species. – Site not suitable for white-throated snapping turtle refuge or nesting. – Site not suitable for Fitzroy River turtle refuge or nesting. – Site not suitable for platypus refuge or borrowing opportunities. – Site not suitable for estuarine crocodile refuge or nesting.

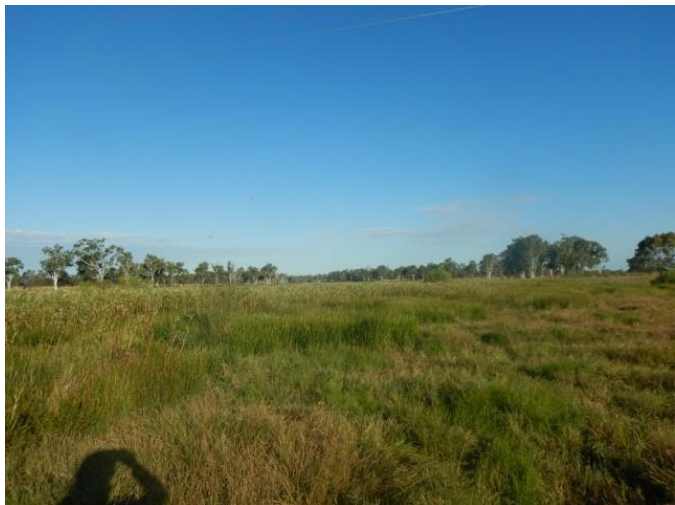
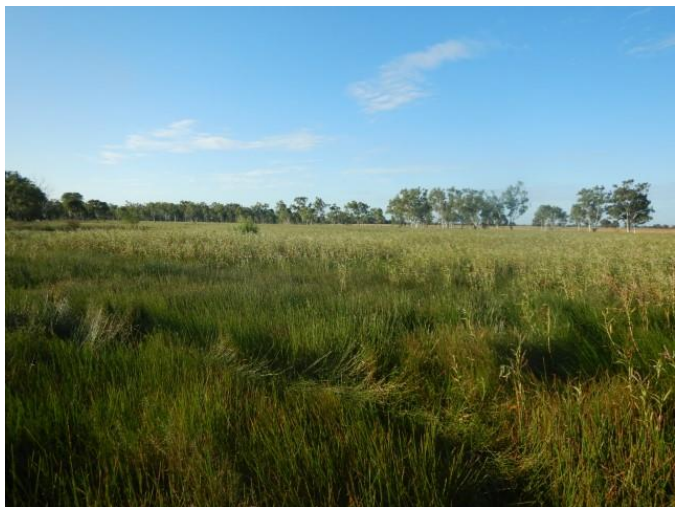
Site	Characteristics	Ecological values
Site 32 – Lion Lagoon		
Upstream	<ul style="list-style-type: none"> – Mapped HSE wetland. – The site was dry during the survey with no evidence of recent inundation. – The wetland type is described as an open wetland with grass understorey. – The site is located less than 200 m from the nearest wetland which contained water during the time of survey. – Adjacent land use is predominantly used for cattle grazing. – Native aquatic species included <i>Eleocharis</i> sp., <i>Persicaria attenuate</i>, <i>Cyperus difformis</i>, <i>Ludwigia peploides</i>, and nardoo. – Exotic aquatic plant species present included <i>Eichhornia crassipes</i>. – The site had grass weeds present, including <i>Parthenium hysterophorus</i>. – Tall and medium sized trees were frequent, all were eucalypts. – The banks were stable with little signs of erosion, similarly to the substrate. 	<ul style="list-style-type: none"> – The site was dominated entirely by grasses. There was some large and small woody debris present that when inundated by water would provide the site with some habitat and refugia. Overall, with the absence of surface waters the site is not suitable for aquatic species. – Site not suitable for white-throated snapping turtle refuge or nesting. – Site not suitable for Fitzroy River turtle refuge or nesting. – Site not suitable for platypus refuge or borrowing opportunities. – Site not suitable for estuarine crocodile refuge or nesting.
