INLAND
RAIL

Terrestrial and Aquatic Ecology Technical Report

CALVERT TO KAGARU ENVIRONMENTAL IMPACT STATEMENT

Aquatic Ecology Survey Sites

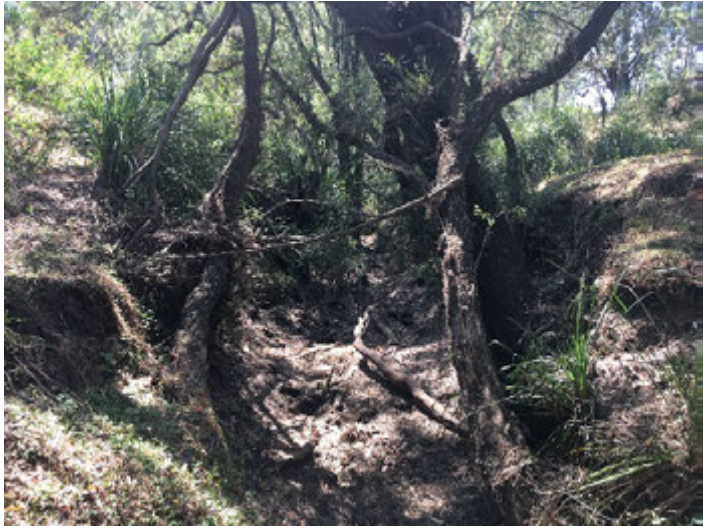
Site	Description	Photo
1A	The site is located on Western Creek, at the proposed Project alignment waterway crossing location. No artificial bank protected measures were present. The riparian vegetation was disturbed at the crossing location.

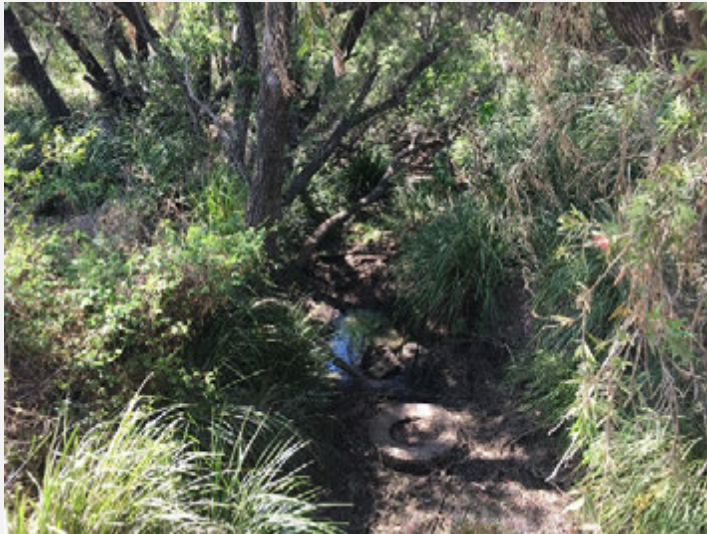
1A (alt)	Site located on Western Creek, downstream of the Project alignment. Artificial bank protection measures present include a timber wall present associated with the bridge crossing. Lots of riparian vegetation surrounding the site.

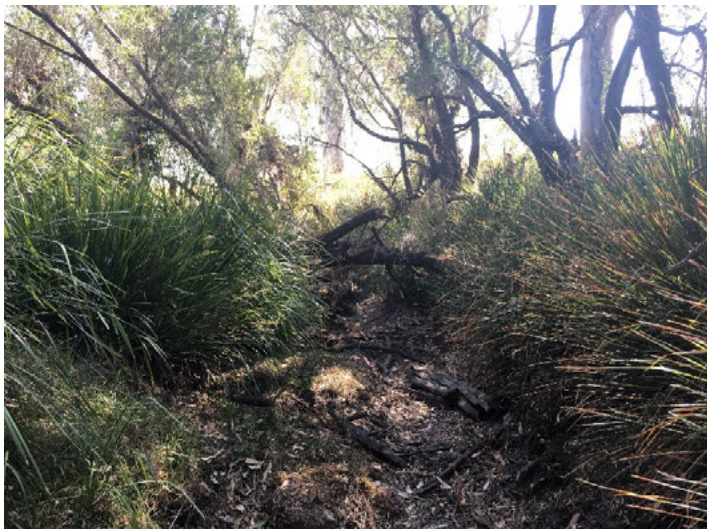
2A	Site is located on the Bremer River, at the proposed Project alignment waterway crossing location. At the time of assessment, the channel was dry. Artificial bank protection measures were present in the form of a dam wall.

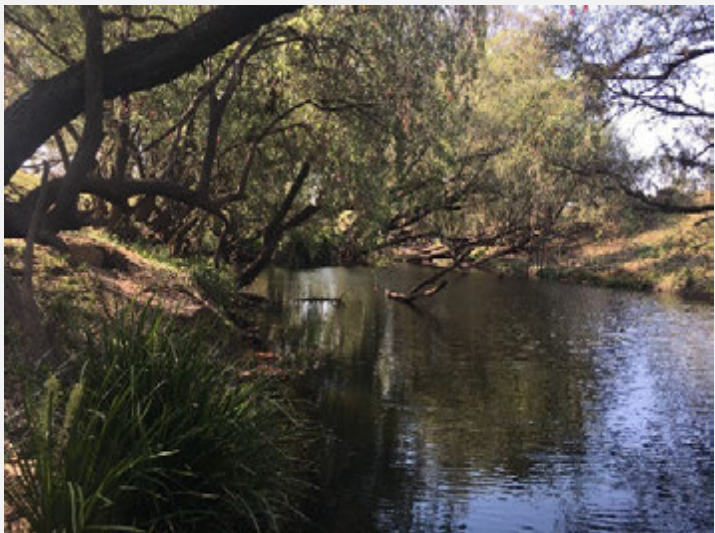
Site	Description	Photo
3A	Site located on Warrill Creek, at the proposed Project alignment waterway crossing location. No artificial bank protected measures were present. A pump was presentation potentially used for water extraction.

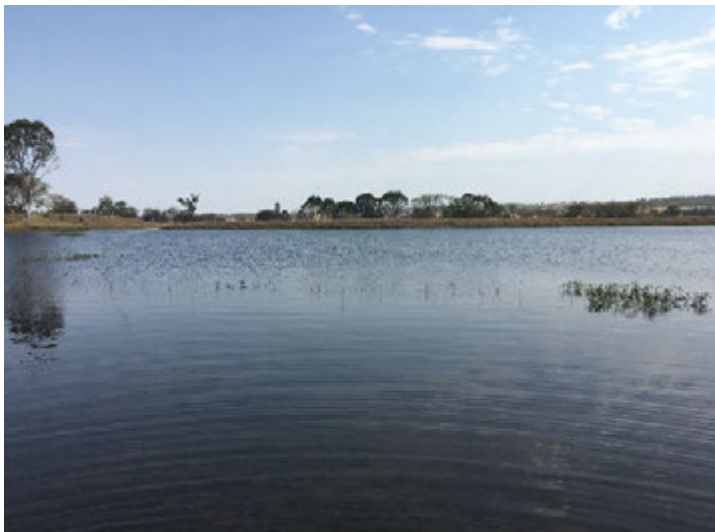
5A	Site was located in a private rural farm dam located downstream of the Project alignment. Artificial bank protection measures were present in the form of an approximate 20 m section of concrete channel lining along the bank.

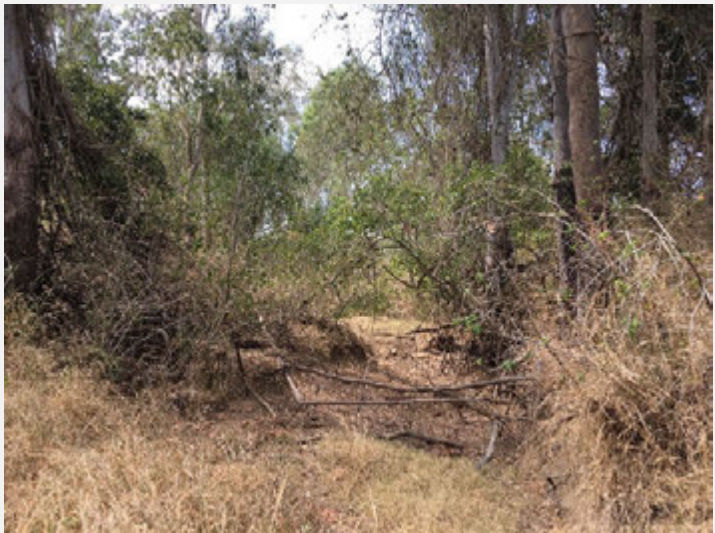
5A (1)	Site was located on an unnamed waterway the proposed alignment crossing. The creek was dry at the time of assessment. There were no artificial bank protection measures present. Bed level crossing, grazing and fences were present along the creek. The riparian zone was highly disturbed.

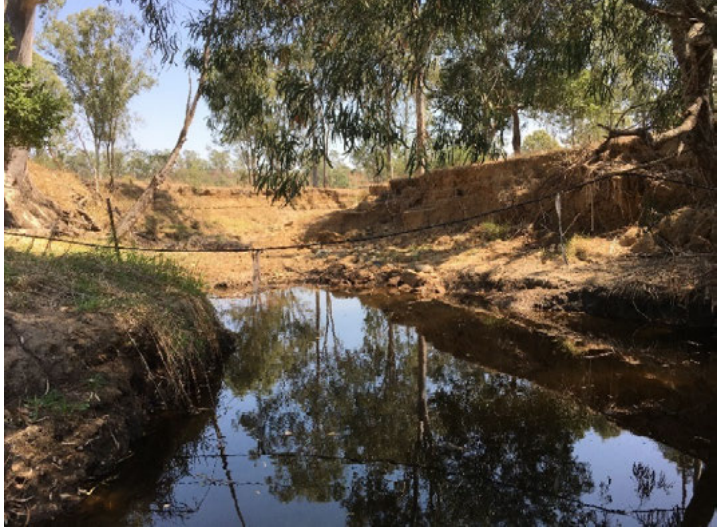
Site	Description	Photo
6A	Site located on the upper tributary of Purga Creek, upstream of the Project alignment. Banks were eroded, potentially affected by cleared vegetation, stock access, human access and the road crossing and associated culvert (approximately 30cm in diameter). Artificial bank measures include a rock layer associated with the road crossing.

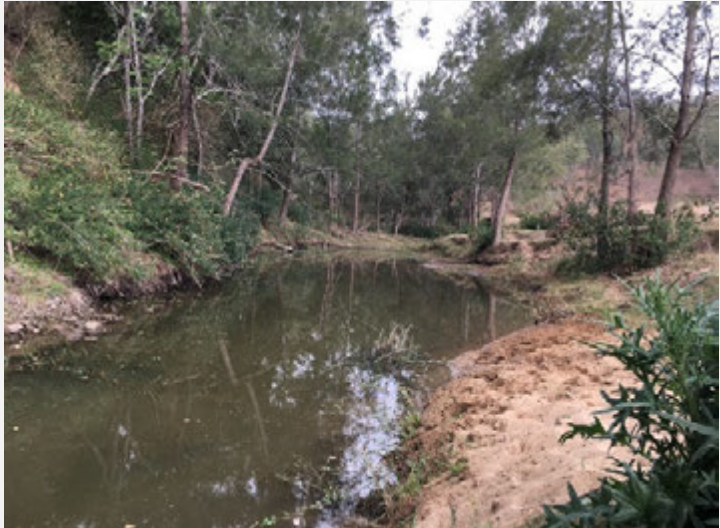
7A	Site was located on an unnamed waterway, upstream of the Project alignment. Banks are highly eroded, potentially affected by cleared vegetation, stock access and human access. There were no artificial bank protection measures present at site. Cattle was present and using the site

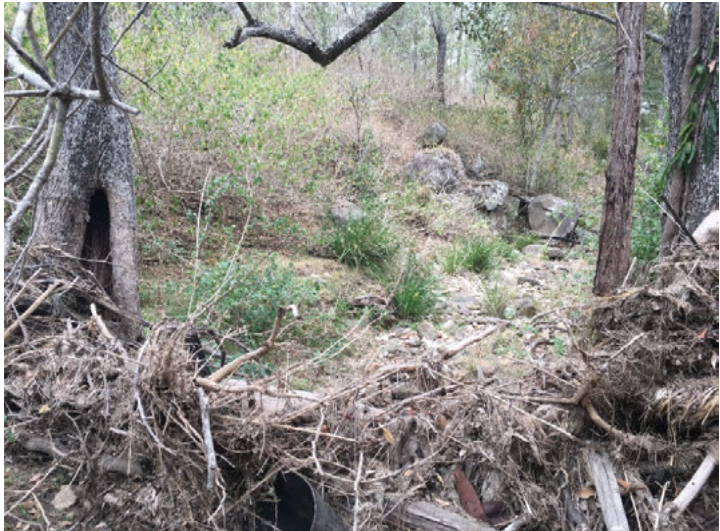
7A (alt)	Site was located on an unnamed waterway, upstream of the Project alignment. At the time of assessment, the waterway was dry. There were no artificial bank protection measures present

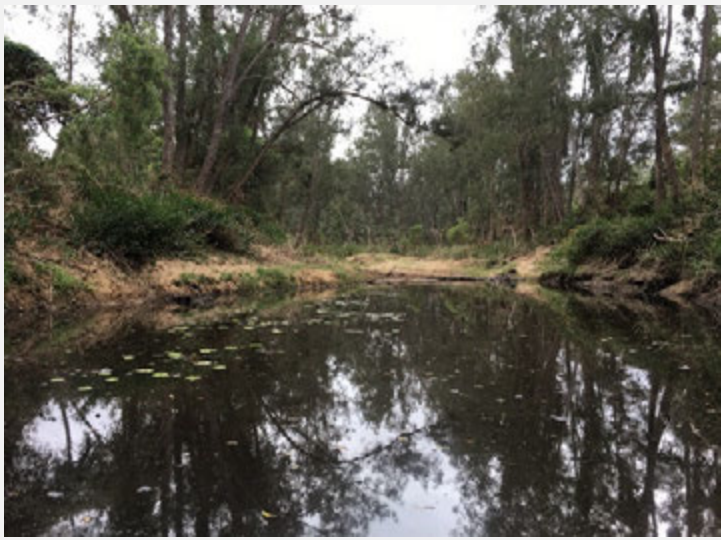
Site	Description	Photo
8A	Site was located on an unnamed waterway, at the proposed crossing location. The bank was highly eroded potentially affected by stock access and human access. There were no artificial bank protection measures present.

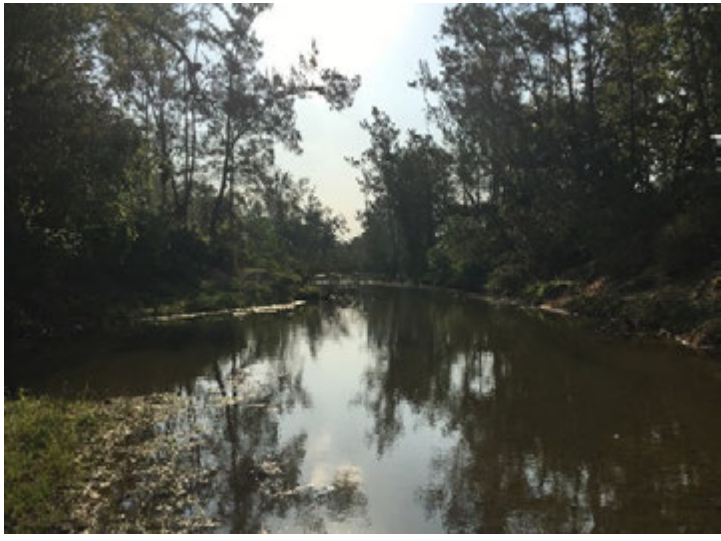
9A	Site located on the Woollamen Creek, upstream of the Project alignment in road crossing over a small bridge. Lots of riparian bank vegetation present. Bank eroded potentially affected by cleared vegetation, stock access, cattle were noted drinking at the site. Additionally, rip rap was present along the bank as a protected measure.

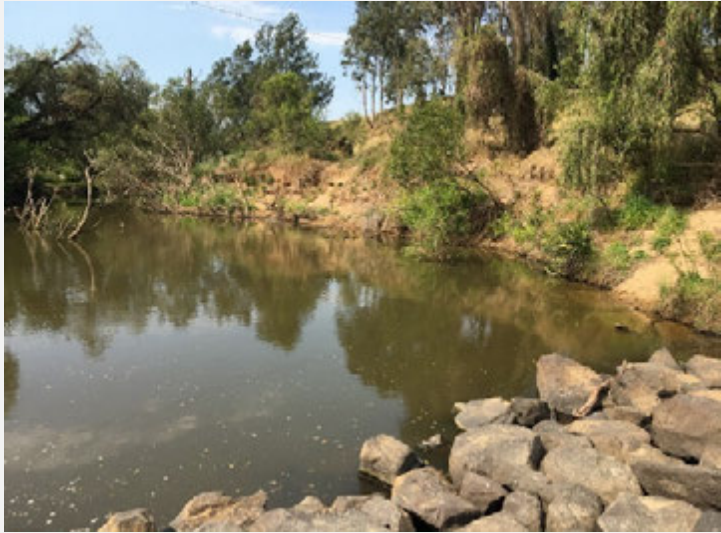
10A	Site located on the Tevoit Brook River over a road crossing. Artificial bank measures were present in the form of a rock wall, fence structures and remains of a sediment fence were present. 3RCP present. Banks are eroded potentially affected by cleared vegetation, stock access and human access. Vegetation is present along the banks.

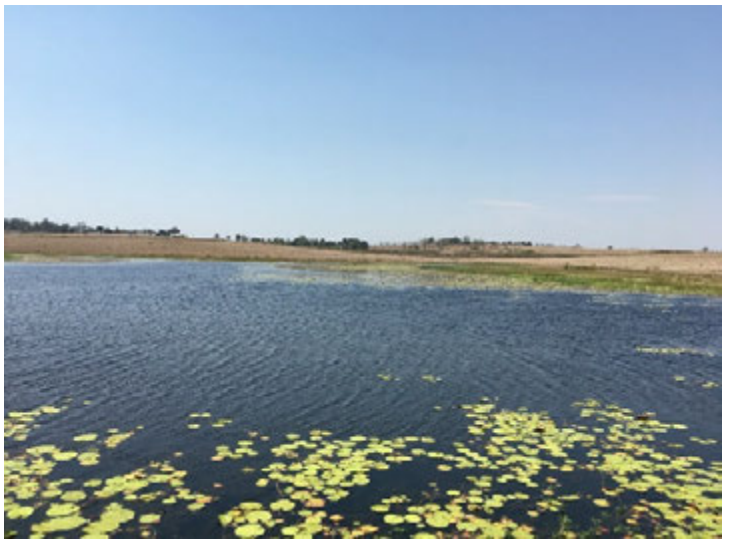
Site	Description	Photo
11A	Site was located in a private rural farm dam, downstream of the Project alignment. Site is flat with minimal vegetation present. Dam is used by stock

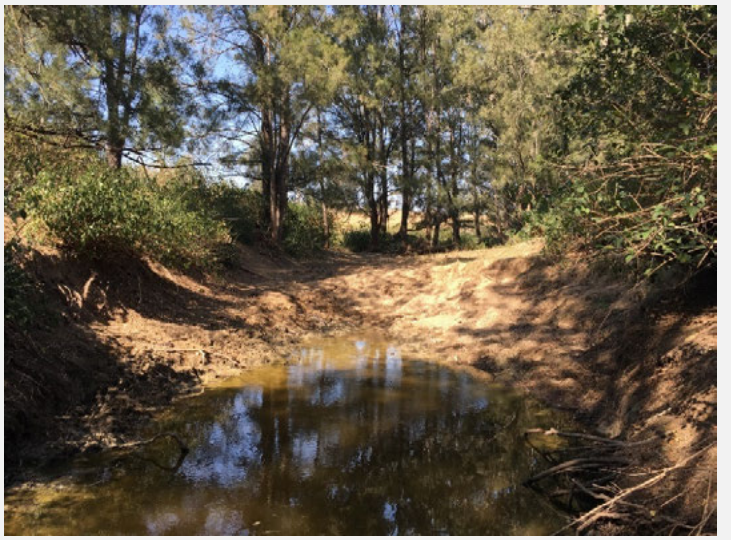
12A	Site was located on an unnamed waterway, upstream of the Project alignment. Banks were eroded, potentially affected by stock access, human access and feral animals. There were no artificial bank protection measures present.

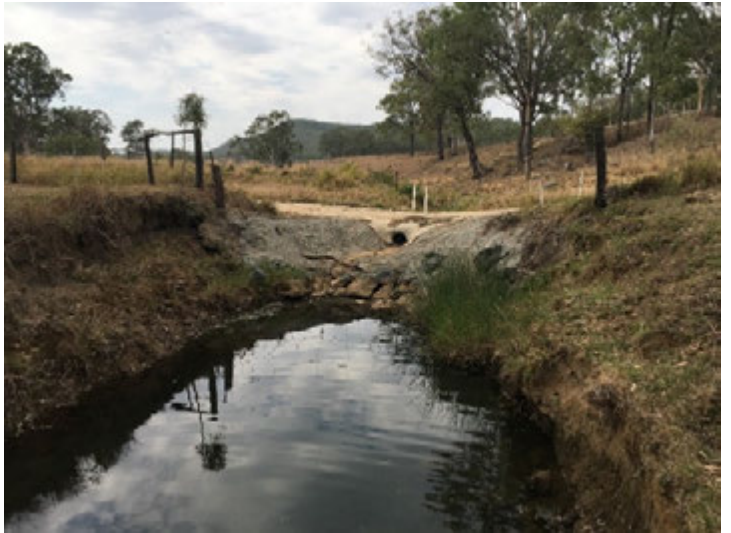
13A	Site was located on the upper tributary of Purga Creek at the proposed alignment crossing. A single RCP culvert design was present, with an additional rock layer associated with the road crossing as an artificial bank measure and concrete channel lining was also present
