B.8 Waterway Barrier Works Technical Report

Waterway investigation and fish community survey in relation to the Scenic Rim Agricultural Industrial Precinct project.

Technical Report – April 2020

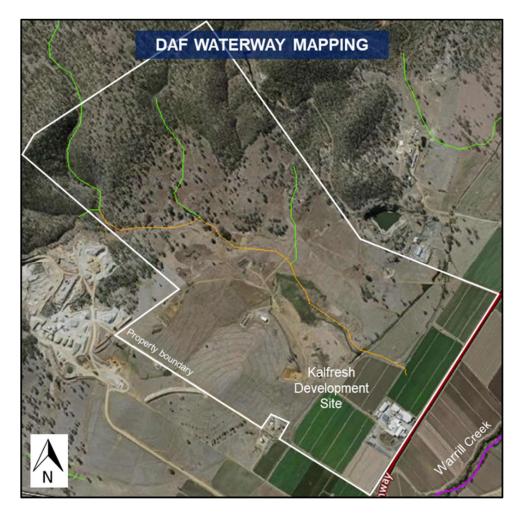
The Impact Assessment Report (RPS, 2020) describes the existing on-site hydrology. Within the elevated land in the northern portion of the site, ephemeral gullies exist that flow after seasonal rainfall. There are several existing farm dams on site for watering livestock. Department of Agriculture and Fisheries (DAF) waterway mapping indicates that there are three green 'low-risk' waterways and a single amber 'moderate-risk' waterway within the site (Figure 1). The mapping indicates that there is no waterway connectivity through the cropping area to Warrill Creek.

Figure 1. Study area showing DAF waterway mapping layer, including amber, green waterways and downstream purple waterway (Warrill Creek).

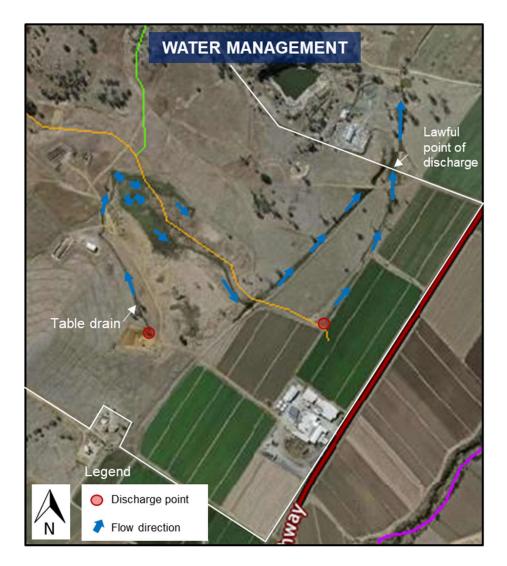
The existing vegetable processing and packing facilities utilise bore water that is pumped from the facility to two discharge points. The first is a high point west of the processing facility where water is discharged to a perched table drain. The water then runs north down this table drain to the centre of the site, where it is treated via overland flow through a very broad and flat basin. The overland flow is captured at the bottom of the basin by a channel adjacent to the existing levee bank and directed to the lawful point of discharge (Figure 2).

The second point of discharge is a constructed drain northeast of the processing facilities. The water flows northwards within the drain to the lawful point of discharge.

Figure 2. Processing water discharge points.

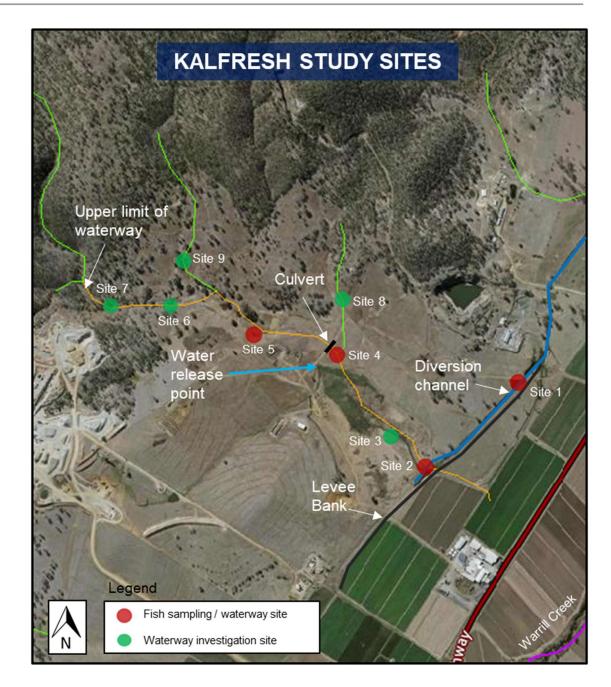
Figure 3. Waterway and fish sampling investigation sites within the Kalfresh site. DAF mapped green and amber waterways are shown as well as historical levee bank (black line), and location of diversion channel (blue line).

This investigation confirmed that the DAF waterway mapping layer has accurately mapped a discontinuation of the waterway through downstream cropping areas (Figure 3). As within the cropping area below the levee bank and constructed drainage channel no waterway features currently exist.

It is likely that the classification as an amber 'moderate risk' waterway is a result of the low gradient of the land in combination with the waterway mapping capturing the gullies as green waterways. Based on the findings above, this investigation recommends reclassifying the amber waterway as green 'low risk' waterway (Table 1). The characteristics of this waterway indicate it has a lower risk to fish passage consistent with a green 'low risk' waterway classification. This study also confirms that upper waterway limit is the upper extent of the mapped amber waterway (Figure 3).

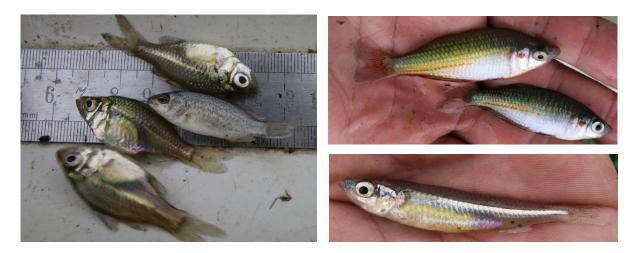
Overall Mosquito fish dominated the fish catches within all study sites representing 83% of the total number of fish recorded (Table 2). Four of the native fish species recorded within the proposed development are shown below in Figure 4.

Figure 4. Four of the native fish species recorded including olive perchlet (left top and bottom), spangled perch (left middle), Crimson-spotted rainbowfish (right top) and Majorie's hardyhead (right bottom).
